# Kerferd Rd, Montague St, Herbert St - Intersection, Albert Park

**Road Safety Audit**

Audit Stage: Existing Conditions

Report for City of Port Phillip

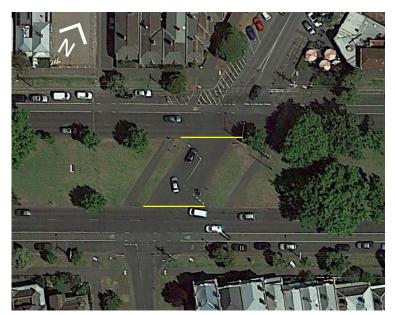
#### 1. Closing the median break.

This would eliminate many of the conflict points at this intersection. It is predicted that traffic distribution will mean vehicles move to safer intersections and routes. The Auditors also consider the amount of permeability across Kerferd Road to be excessive for passenger vehicles with four crossing points within ~500m in this section. There are low risk u-turn opportunities within close proximity to this intersection providing ample local access.

The design could consider measures to retain cyclist permeability across the intersection. This could be achieved via low cost treatments or a more permanent infrastructure.

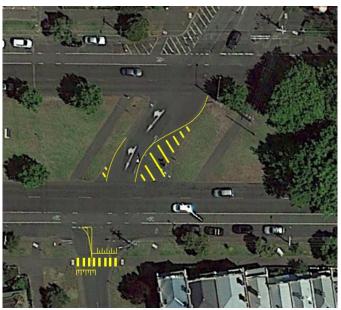
#### 2. **Partial Median Closure**

If there are concerns about the traffic impact on Ferrars Street/Canterbury Road intersection, a partial closure would reduce the risk by squaring the crossing and simplifying the crossing point. It should be noted that this will not be as effective in risk reduction as the full closure.

This option should be complemented with treatments #5, #6 and #7 below.

This could be achieved via low cost treatments or a more permanent infrastructure.

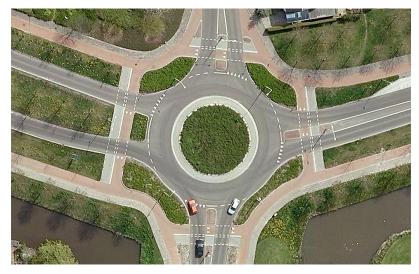
7. **Converting the intersection** to a protected roundabout ie. with appropriate pedestrian and cyclist facilities.

(the picture to the right is a Dutch style protected roundabout. Similar examples can be seen on Moray Street, South Melbourne. Design work would be required to cater for the intersection stagger between side roads)

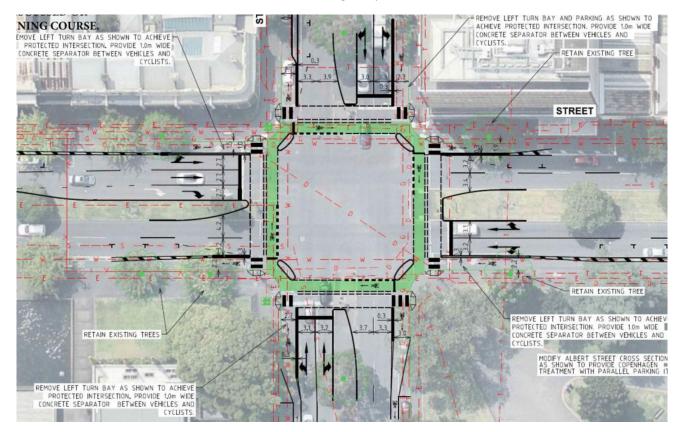
8. Converting the passive controlled intersection to a protected signalised intersection (similar to Albert Street/Lansdowne Street, East Melbourne (design snip below)).

It should be noted that both these options (#7 and #8) are high cost and would not be as effective in reducing risk as the intersection closure. Further detailed work would be required to determine the most appropriate treatment between a roundabout or traffic signals, and how the treatment best caters for pedestrians and cyclists.
