Attachment 2: Tree Impact Assessment of trees within proposed new access crossover for Elwood Diversion Drain

RE: Tree Impact Assessment of trees within proposed new access crossover for Elwood Diversion Drain

Tree Logic Project 2021_13209

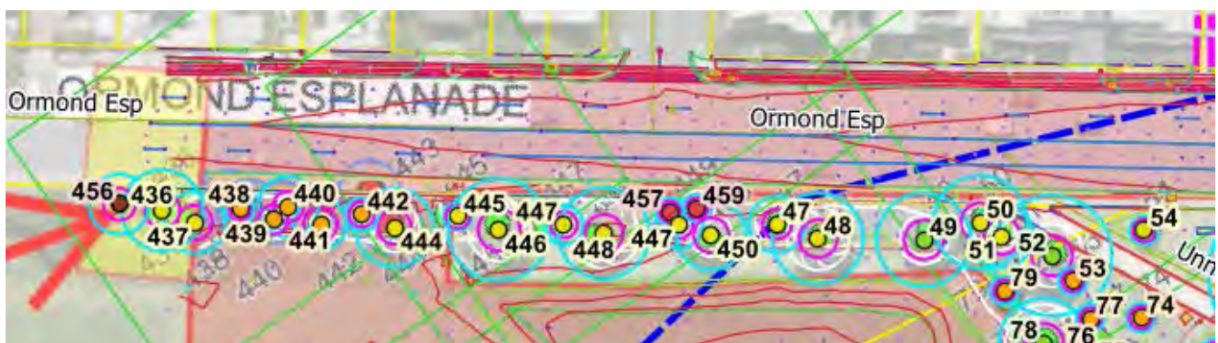
While there some discrepancy of approximately 1.5 metres was identified in more densely treed areas, the majority of trees were closely aligned to the surveyor points. Each of the tree points within or adjacent to the proposed new driveway and crossover were corrected and aligned to the F&L: survey points. The greatest point of confusion then stemmed from the fact that the surveyor had not identified one (1) of the Tree Logic trees, namely Tree 437, being a maturing Norfolk Island Hibiscus tree.

All other trees within the design crossover & driveway were accurately aligned to the F&L survey plan including trees extending further east to Head Street Reserve as well as collecting one (1) additional tree to the west of Tree 436 being a Pohutukawa (*Metrosideros excelsa*) that is readily identifiable as it is almost entirely dead with only some basal sprouts. This tree has been assigned tree number 456.

Refer to Plate 1 below for amended tree point locations showing trees aligned to F&L survey plan (white lines)

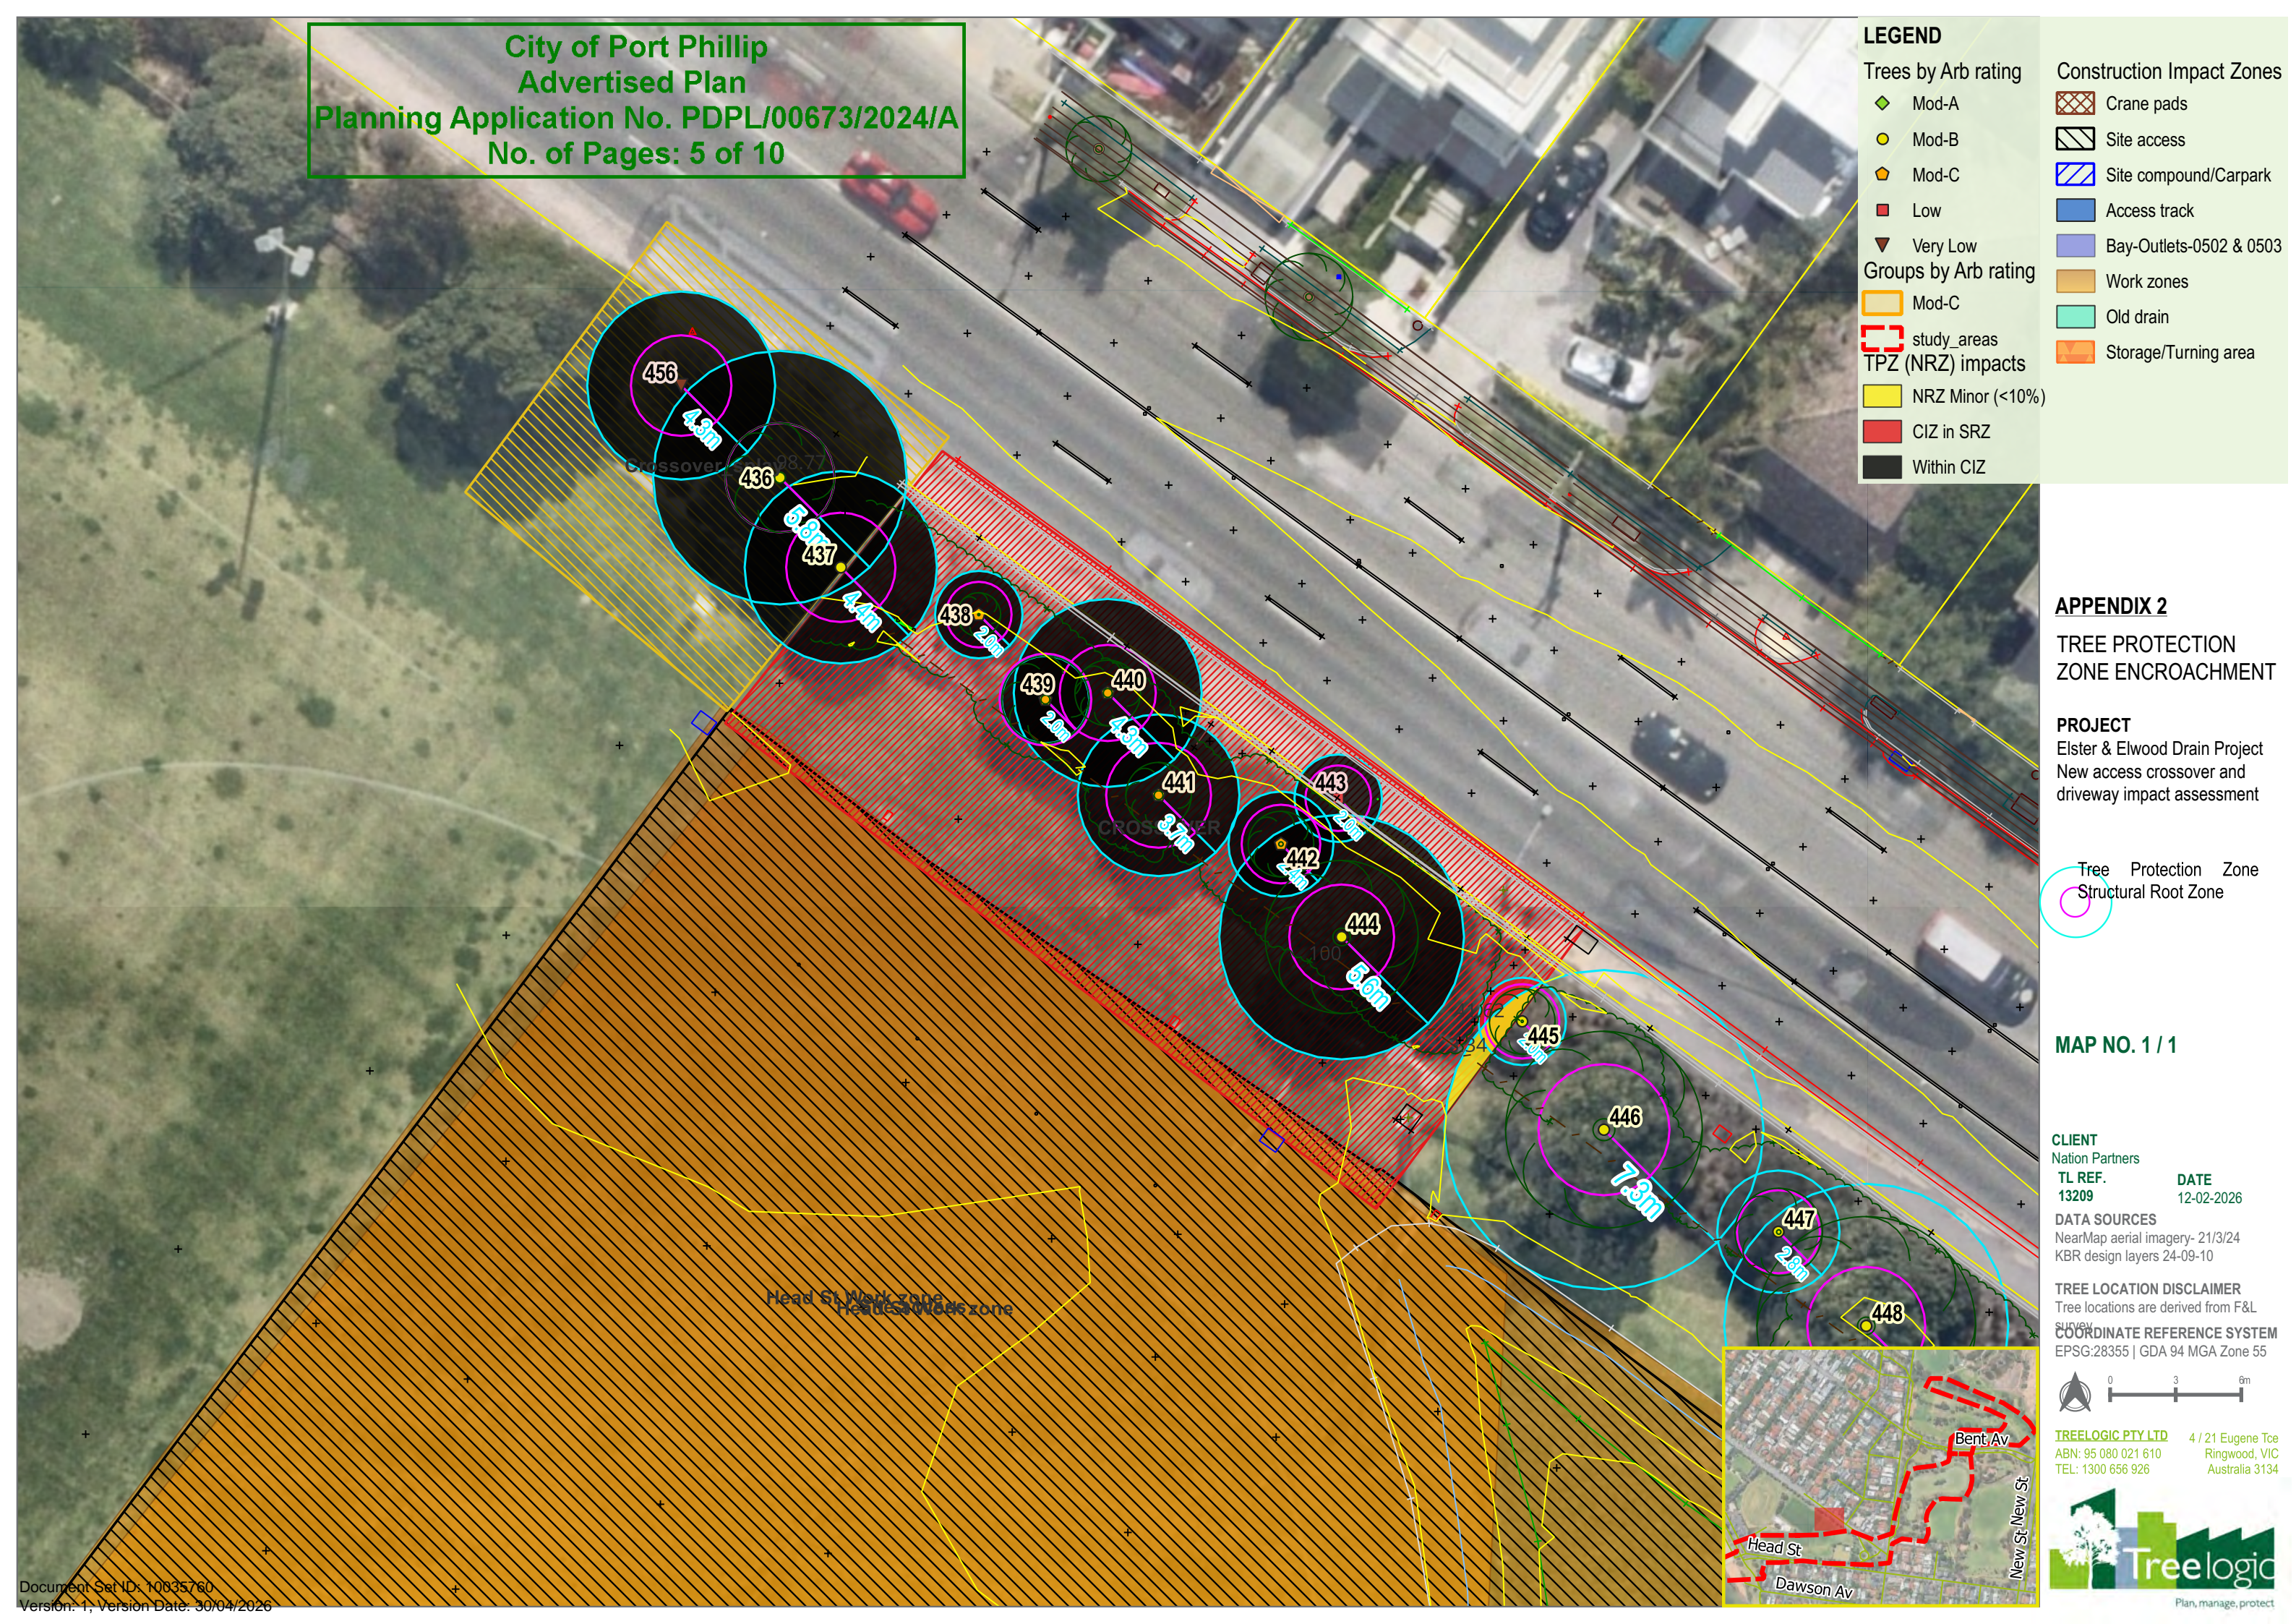
TREE PROTECTION ZONE ENCROACHMENT

Under the current driveway and crossover alignment shown it is determined that Trees 437 to 445 exist within the new crossover footprint and are identified to be removed. Trees 436 and 456 are within an adjacent area where the crossover splay may encroach the recommended TPZ and impact these 2 trees.

Tree 446 could be retained with Tree Protection Fencing (TPF) established at the edge of the driveway crossover and maintained for the duration of works on site. Trees within the driveway crossover or with SRZ impacts will be unsustainable and will be required to be removed. They can be replaced in the new landscape at completion of works and decampment.

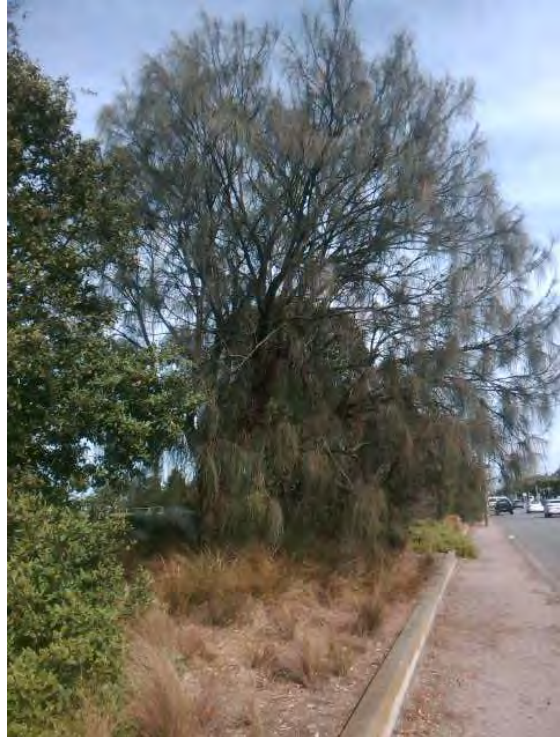
Tree ID:436. *Allocasuarina verticillata* (Drooping She-oak),
Maturing Victorian native. DSH: 44cm. HxW (m): 7 x 10.
Health: Good. Structure: Fair. Arb. Rating: Mod.B. Acute
forks, included bark forks, over-extended limbs developing,
nth.. NRZ (rad. m): 5.3. SRZ (rad. m): 2.5.
NRZ Impact: **Within** - Crossover - 2.74%, Crossover
_splay - 96.03%. Permit: DDO10, PP_Undersize.

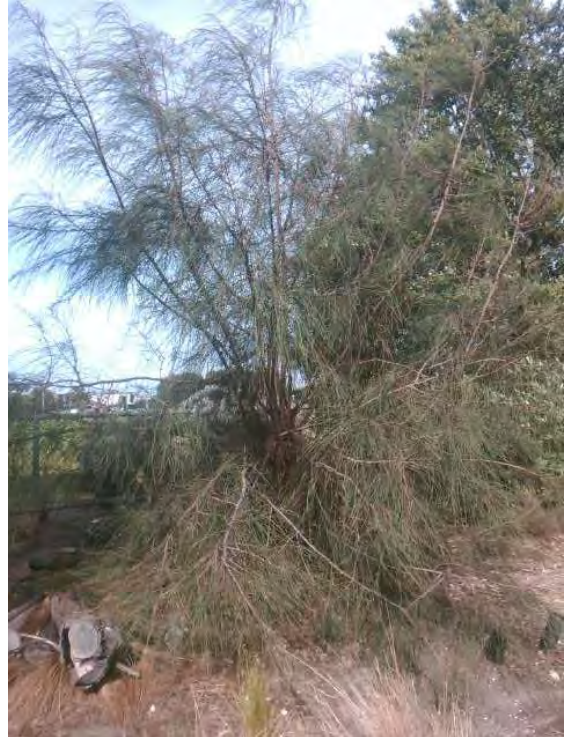
Tree ID:438. *Allocasuarina verticillata* (Drooping She-oak),
Semi-mature Victorian native. DSH: 11cm. HxW (m): 4 x 4.
Health: Fair. Structure: Fair to Poor. Arb. Rating: Mod.C.
Congested primary union, lopped.. NRZ (rad. m): 2. SRZ
(rad. m): 1.5.
NRZ Impact: **Within** - Crossover - 100.01%. Permit:
DDO10, PP_Undersize.

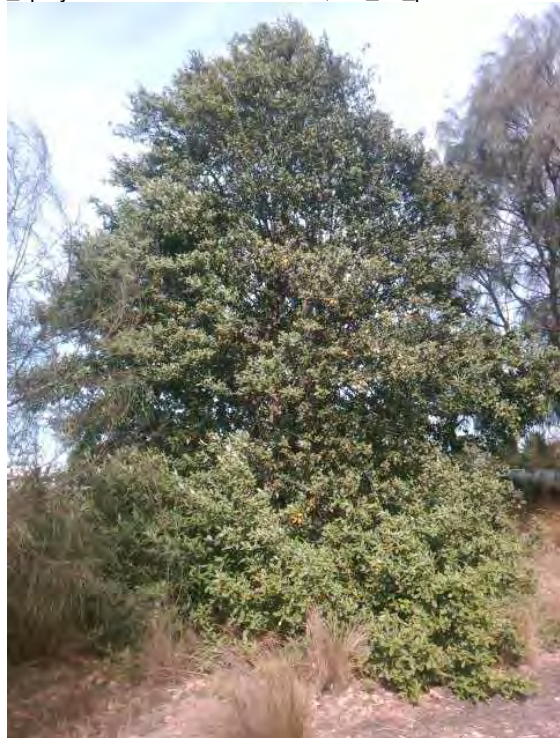
Tree ID:437. *Lagunaria patersonia* (Norfolk Island Hibiscus),
Early-mature Australian native. DSH: 23,20,15,14cm. HxW
(m): 7 x 9. Health: Fair. Structure: Fair. Arb. Rating: Mod.B.
Multi-stemmed.. NRZ (rad. m): 4.4. SRZ (rad. m): 2.5.
NRZ Impact: **Within** - Crossover - 45.49%, Crossover
_splay - 51.26%. Permit: DDO10, PP_LL_permit.

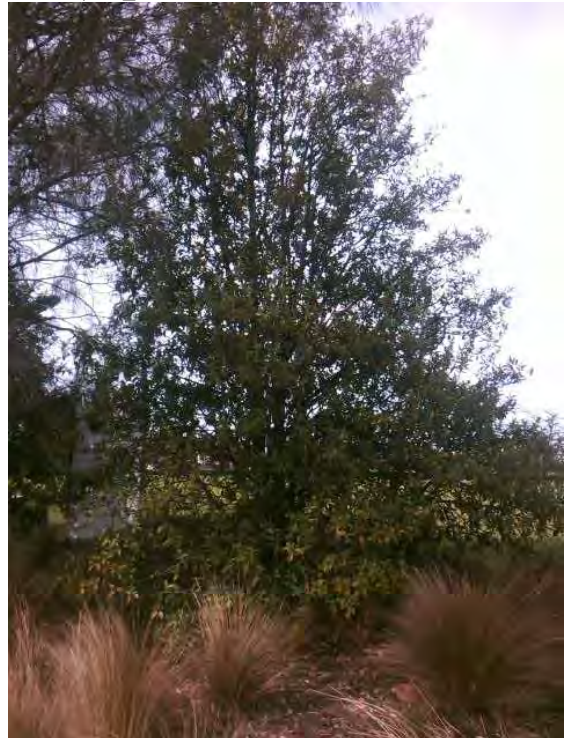
Tree ID:439. *Lagunaria patersonia* (Norfolk Island Hibiscus),
Early-mature Australian native. DSH: 13,10,7,7cm. HxW
(m): 6 x 5. Health: Fair. Structure: Fair to Poor. Arb. Rating:
Mod.C. Multi-stemmed.. NRZ (rad. m): 2. SRZ (rad. m): 2.1.
NRZ Impact: **Within** - Crossover - 100.01%. Permit:
DDO10, PP_Undersize.

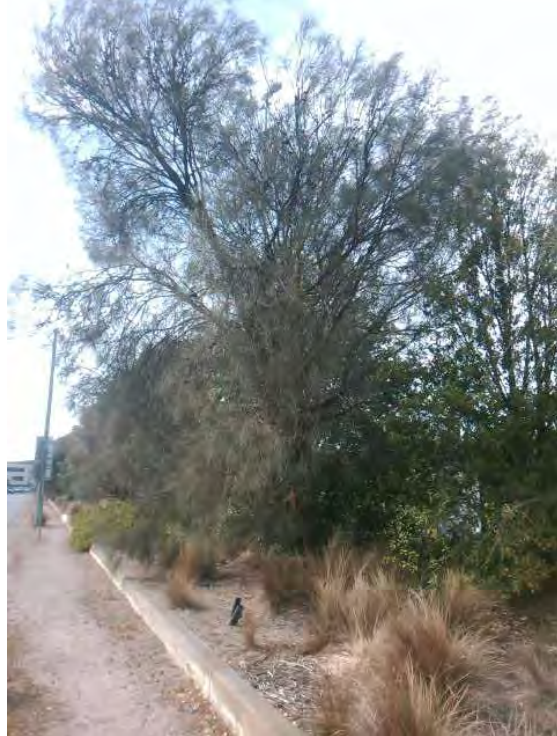
Tree ID:440. *Allocasuarina verticillata* (Drooping She-oak),
 Maturing Victorian native. DSH: 36cm. HxW (m): 7 x 8.

Health: Fair. Structure: Fair to Poor. Arb. Rating: Mod.C.
 Included bark forsw compression flaring.. NRZ (rad. m): 4.3.
 SRZ (rad. m): 2.2.
 NRZ Impact: **Within** - Crossover - 100.0%. Permit: DDO10,
 PP_Undersize.

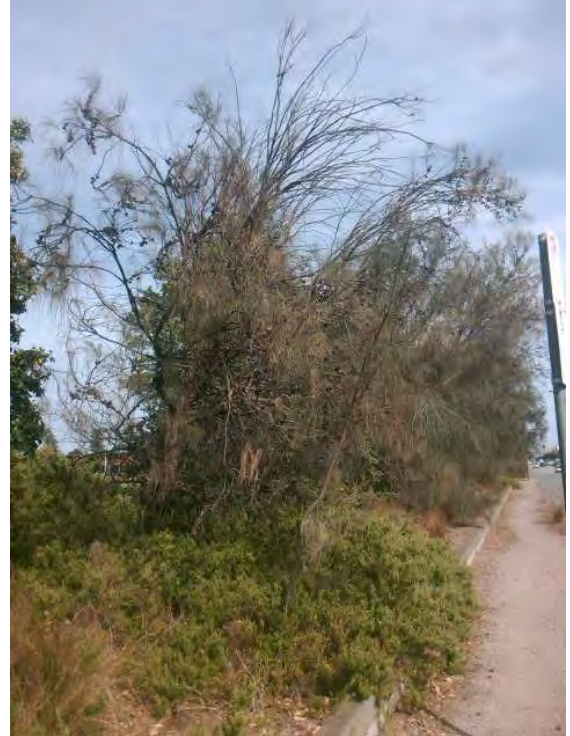
Tree ID:442. *Allocasuarina verticillata* (Drooping She-oak),
 Early-mature Victorian native. DSH: 20cm. HxW (m): 5 x 6.

Health: Fair to Poor. Structure: Fair to Poor. Arb. Rating:
 Mod.C. Dieback, main leader dead, partly suppressed -
 crown bias, nth.. NRZ (rad. m): 2.4. SRZ (rad. m): 1.8.
 NRZ Impact: **Within** - Crossover - 99.99%. Permit: DDO10,
 PP_Undersize.

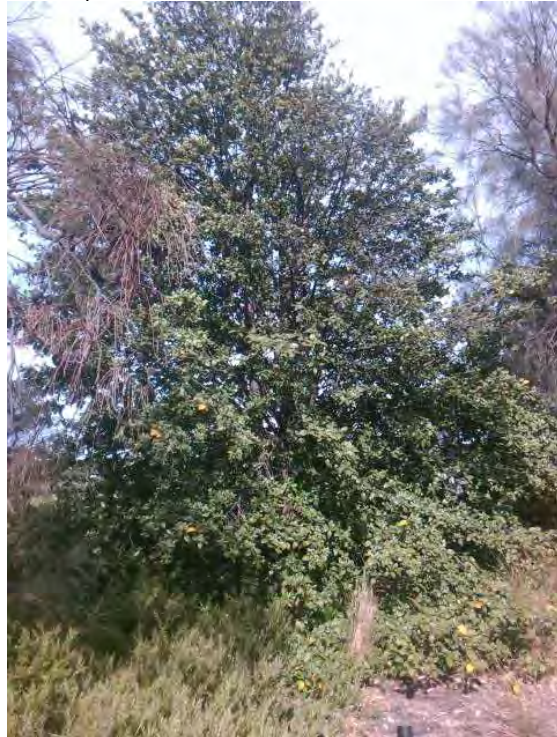
Tree ID:441. *Lagunaria patersonia* (Norfolk Island Hibiscus),
 Early-mature Australian native. DSH: 22,22,9cm. HxW (m):
 7 x 7. Health: Fair. Structure: Fair to Poor. Arb. Rating:
 Mod.C. Co-dominant stems, included bark.. NRZ (rad. m):
 3.7. SRZ (rad. m): 2.4.
 NRZ Impact: **Within** - Crossover - 100.0%. Permit: DDO10,
 PP_LL_permit.

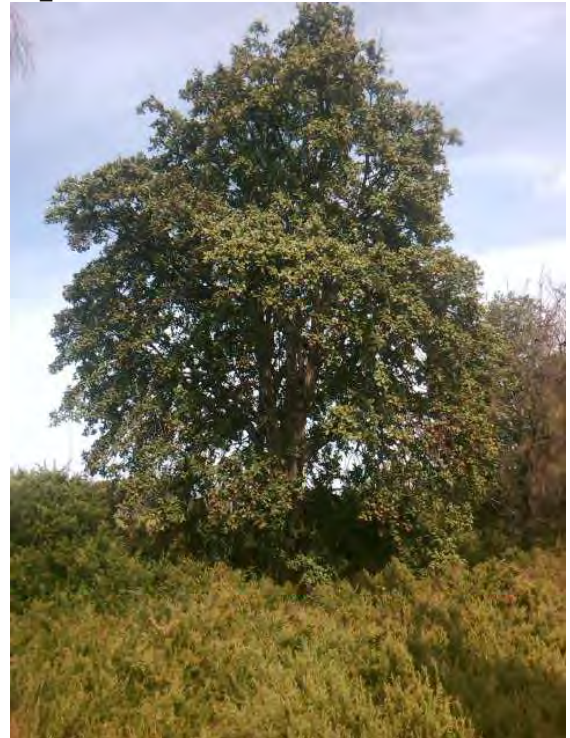
Tree ID:444. *Lagunaria patersonia* (Norfolk Island Hibiscus),
 Maturing Australian native. DSH: 47cm. HxW (m): 7 x 7.
 Health: Fair. Structure: Fair. Arb. Rating: Mod.B. . NRZ (rad.
 m): 5.6. SRZ (rad. m): 2.4.
 NRZ Impact: **Within** - Crossover - 100.0%. Permit: DDO10,
 PP_Undersize.

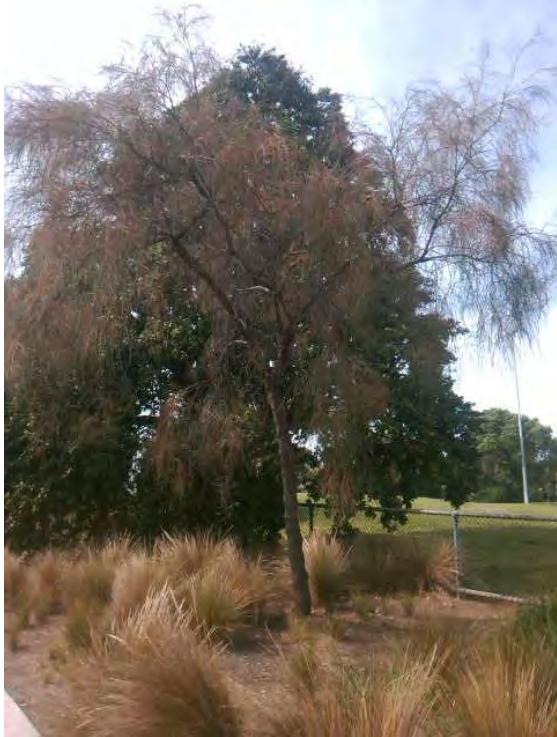
Tree ID:445. *Allocasuarina verticillata* (Drooping She-oak), Semi-mature Victorian native. DSH: 15cm. HxW (m): 5 x 6. Health: Fair. Structure: Fair. Arb. Rating: Mod.B. . NRZ (rad. m): 2. SRZ (rad. m): 1.6. NRZ Impact: **SRZ** - Crossover - 41.62%. Permit: DDO10, PP_Undersize.

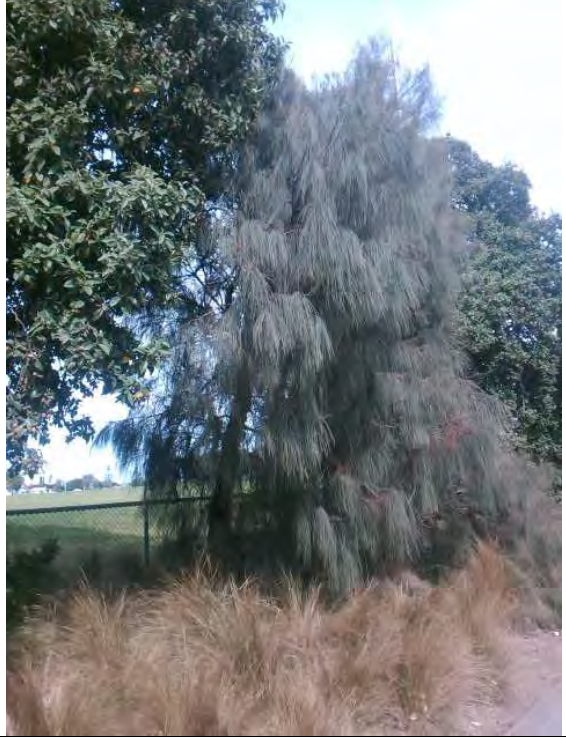
Tree ID:447. *Allocasuarina verticillata* (Drooping She-oak), Early-mature Victorian native. DSH: 23cm. HxW (m): 5 x 6. Health: Good. Structure: Fair. Arb. Rating: Mod.B. . NRZ (rad. m): 2.8. SRZ (rad. m): 1.9. NRZ Impact: **None** - NA. Permit: DDO10, PP_Undersize.

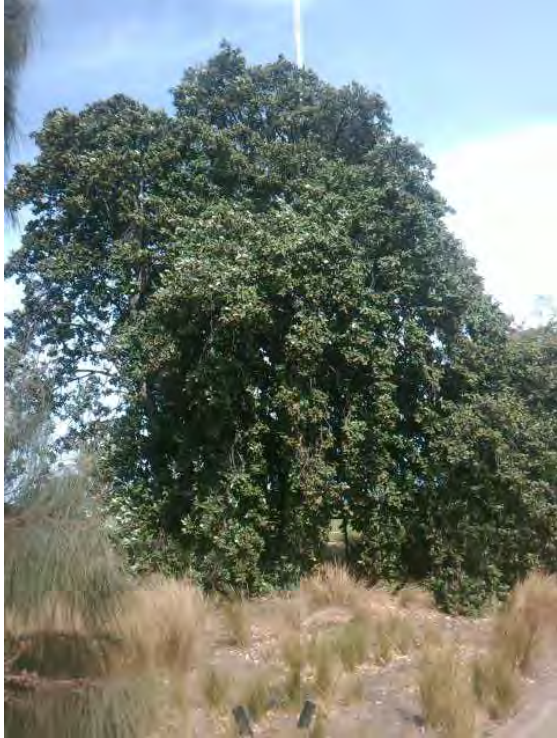
Tree ID:446. *Lagunaria patersonia* (Norfolk Island Hibiscus), Maturing Australian native. DSH: 61cm. HxW (m): 9 x 10. Health: Fair. Structure: Fair. Arb. Rating: Mod.B. . NRZ (rad. m): 7.3. SRZ (rad. m): 3. NRZ Impact: **NRZ Minor (<10%)** - Crossover - 3.34%. Permit: DDO10, PP_LL_permit.

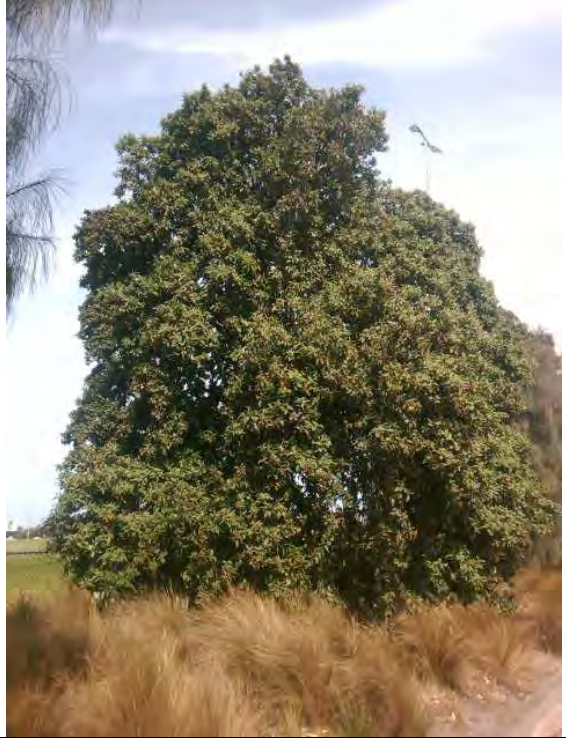
Tree ID:448. *Lagunaria patersonia* (Norfolk Island Hibiscus), Maturing Australian native. DSH: 54cm. HxW (m): 8 x 9. Health: Fair. Structure: Fair. Arb. Rating: Mod.B. . NRZ (rad. m): 6.5. SRZ (rad. m): 2.7. NRZ Impact: **None** - NA. Permit: DDO10, PP_LL_permit.

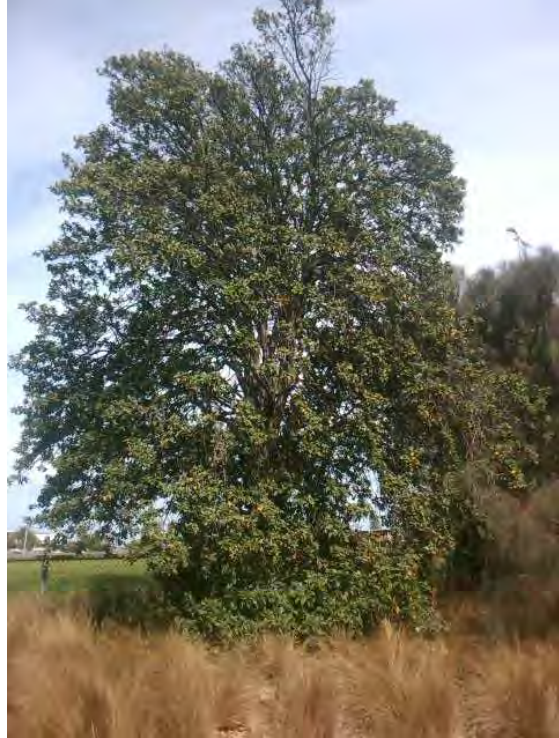
Tree ID:450. *Lagunaria patersonia* (Norfolk Island Hibiscus), Maturing Australian native. DSH: 42cm. HxW (m): 8 x 7. Health: Fair. Structure: Fair. Arb. Rating: Mod.B. . NRZ (rad. m): 5. SRZ (rad. m): 2.5. NRZ Impact: **None** - NA. Permit: DDO10, PP_Undersize.

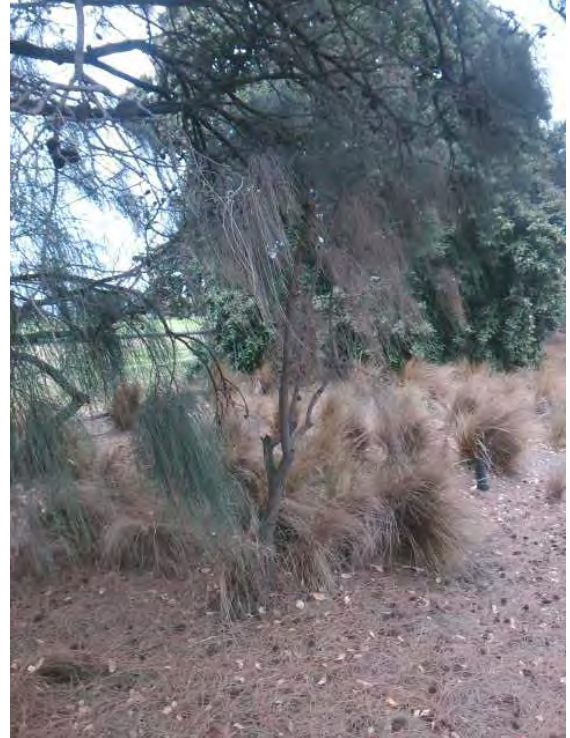
Tree ID:457. *Allocasuarina verticillata* (Drooping She-oak), Young Victorian native. DSH: 8cm. HxW (m): 2 x 1. Health: Poor. Structure: Poor. Arb. Rating: Low. Declining, epicormic shoots, suppressed.. NRZ (rad. m): 2. SRZ (rad. m): 1.5. NRZ Impact: **None** - NA. Permit: DDO10, PP_Undersize.

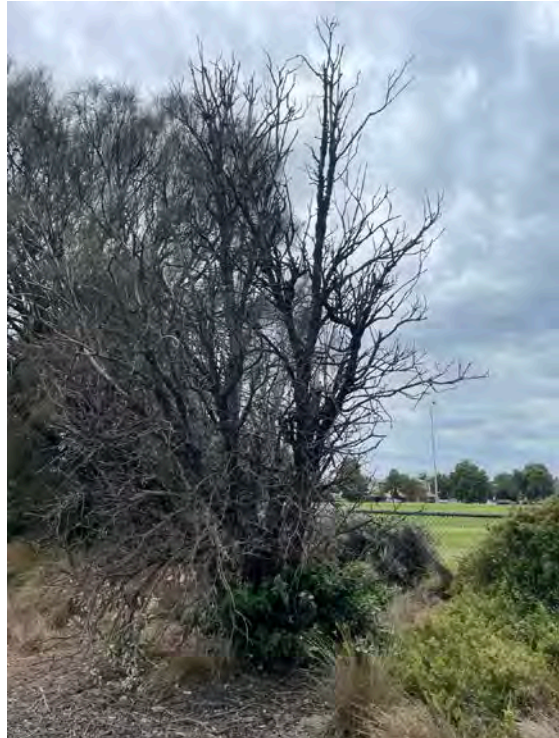
Tree ID:456. *Metrosideros excelsa* (Pohutukawa), Over-mature Exotic evergreen. DSH: 27,15,13,12cm. HxW (m): 5 x 4. Health: Poor. Structure: Very Poor. Arb. Rating: Very Low. Deadwood >50mm, decay, in irreversible decline, main leader dead. 7027.. NRZ (rad. m): 4.3. SRZ (rad. m): 2.3. NRZ Impact: **Within** - Crossover _splay - 100.0%. Permit: DDO10, PP_Undersize.

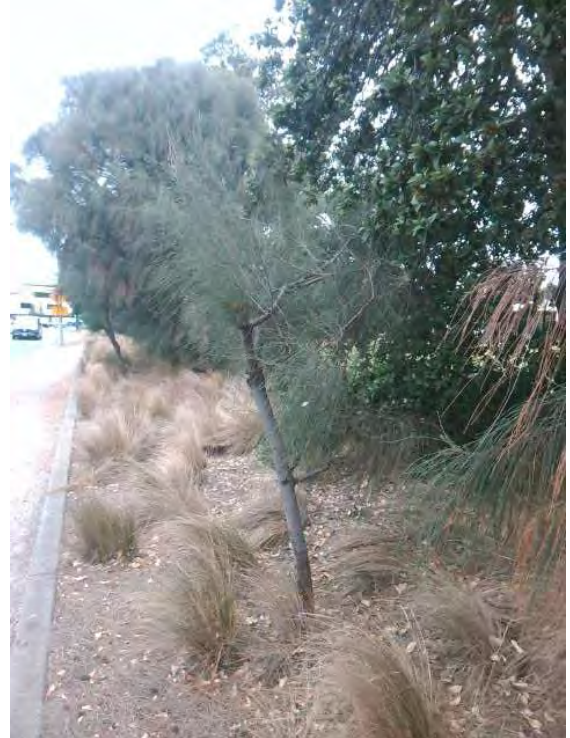
Tree ID:458. *Allocasuarina verticillata* (Drooping She-oak), Semi-mature Victorian native. DSH: 8cm. HxW (m): 2 x 2. Health: Fair. Structure: Fair to Poor. Arb. Rating: Low. Epicormic shoots, lost main leader.. NRZ (rad. m): 2. SRZ (rad. m): 1.5. NRZ Impact: **None** - NA. Permit: DDO10, PP_Undersize.
