South Melbourne Town Hall

Fire Services Investigation Report

Prepared for: City of Port Phillip Council

Project No: MEL2057
Date: 27 March 2020
Revision: 01

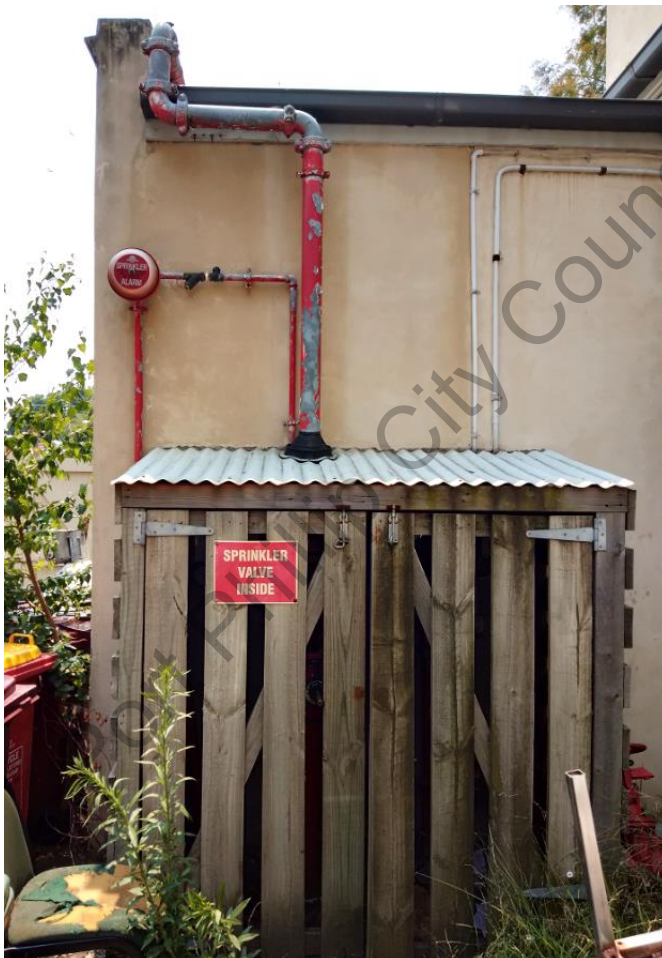
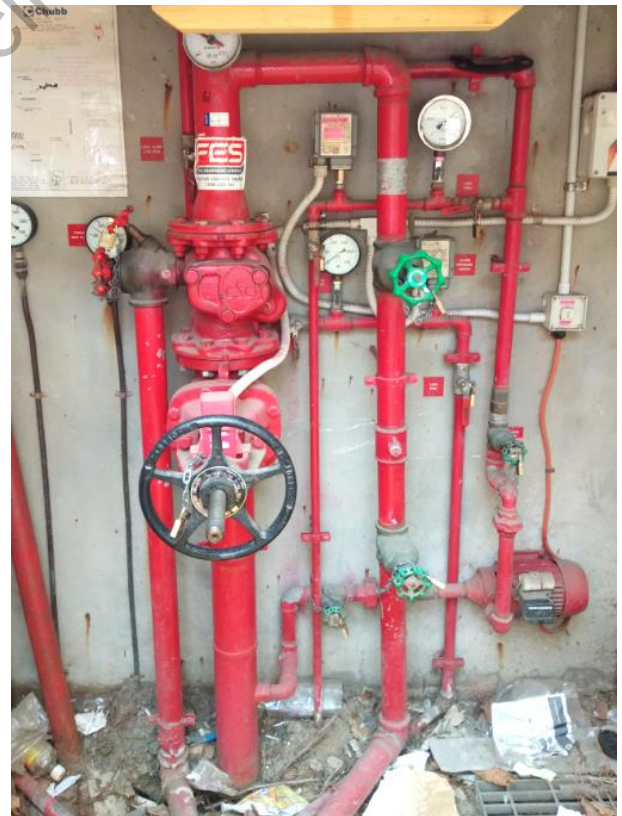
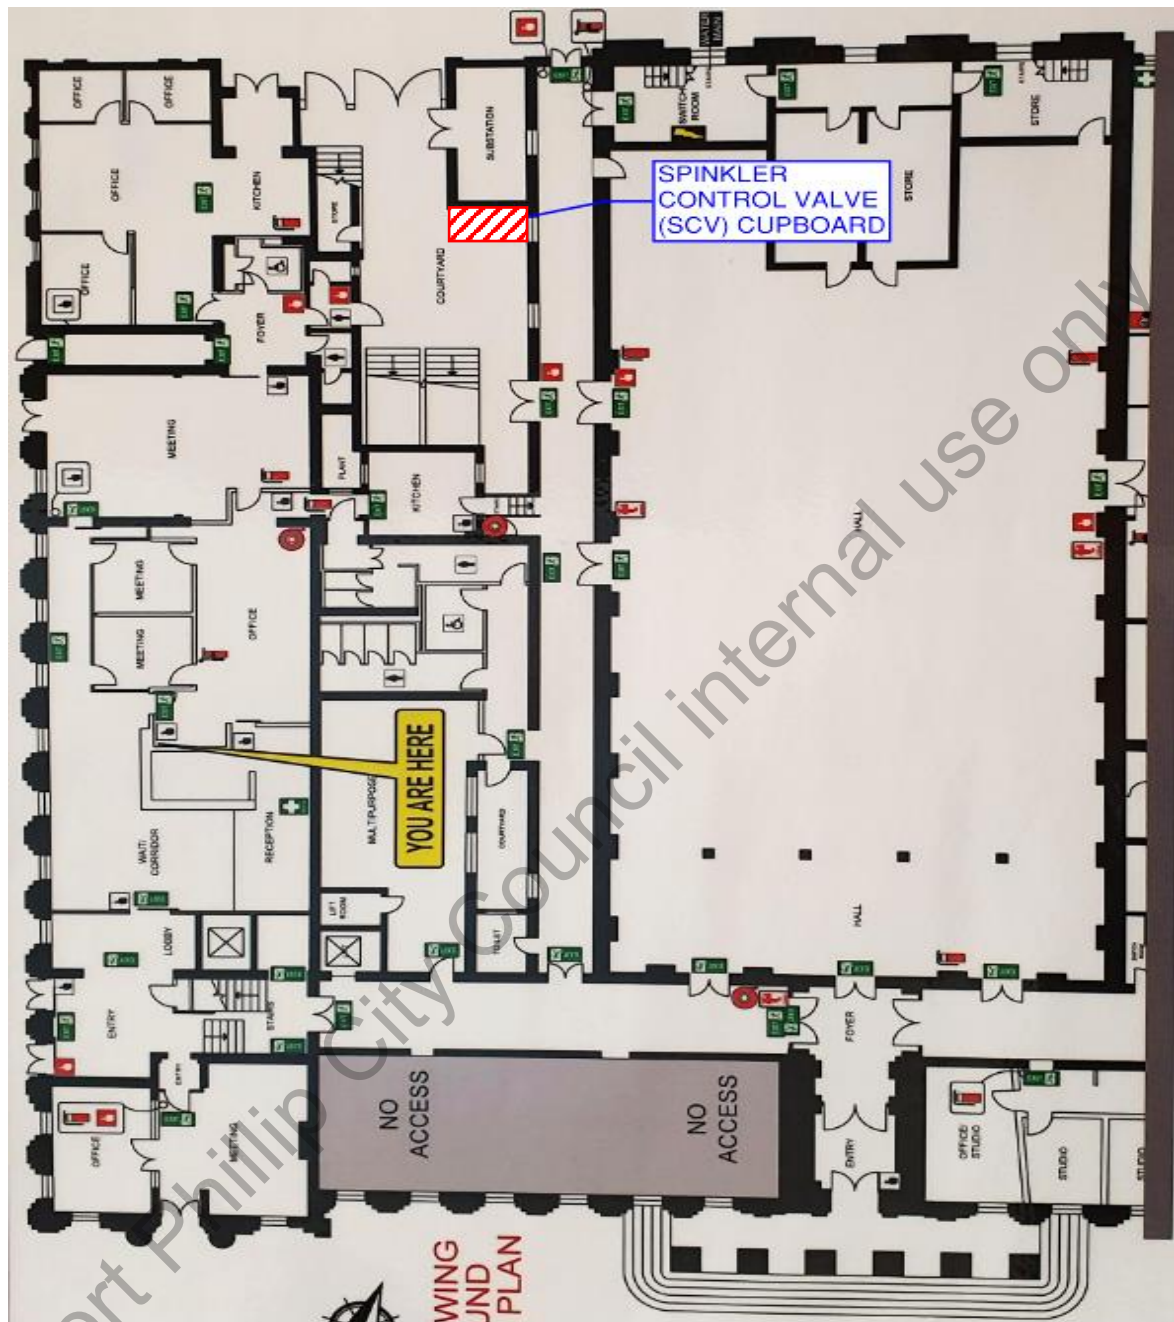
- There is 1x Sprinkler Control Valve (SCV) only serving the sprinklers system in the building
- It is noted this is not shown in all the Evacuation Diagrams, nor shown on the Block Plan at the FIP (Fire Indicator Panel)
- While sprinklers are generally installed in the building, they are not throughout the building – i.e. the main Hall is not sprinklers protected

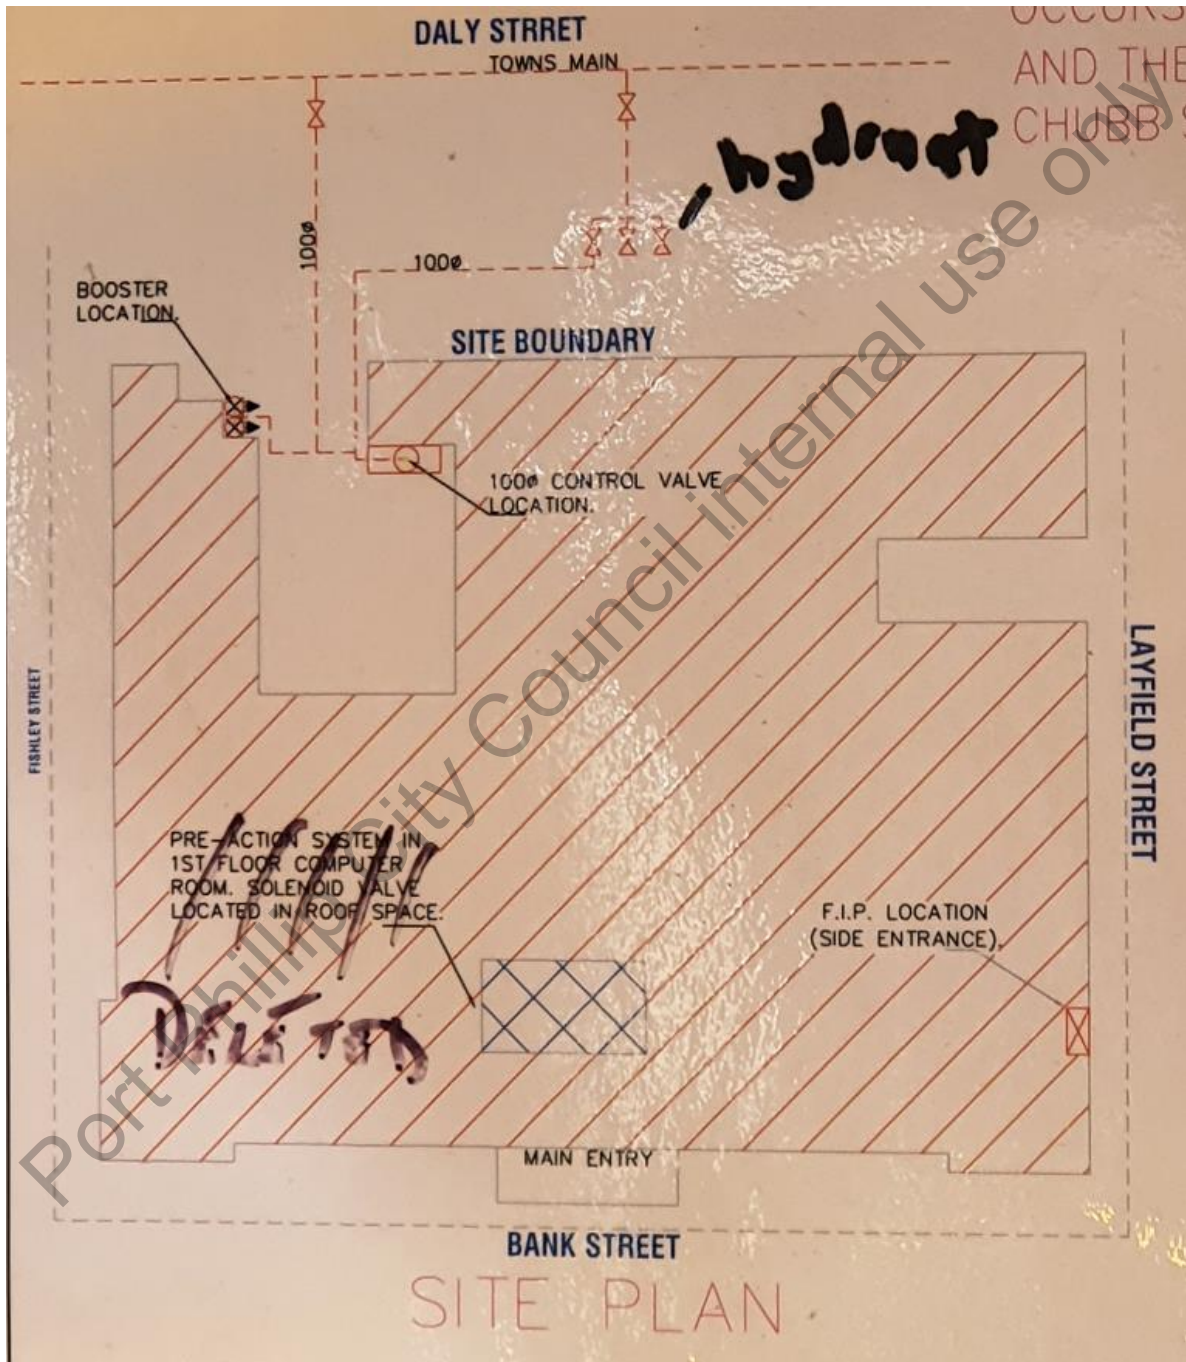
- The Block Plan in the SCV cupboard shows the sprinklers system is separate from the hydrant system, and it is being supported by the town main's water pressure and flow, without the use of on-site fire pump and tank

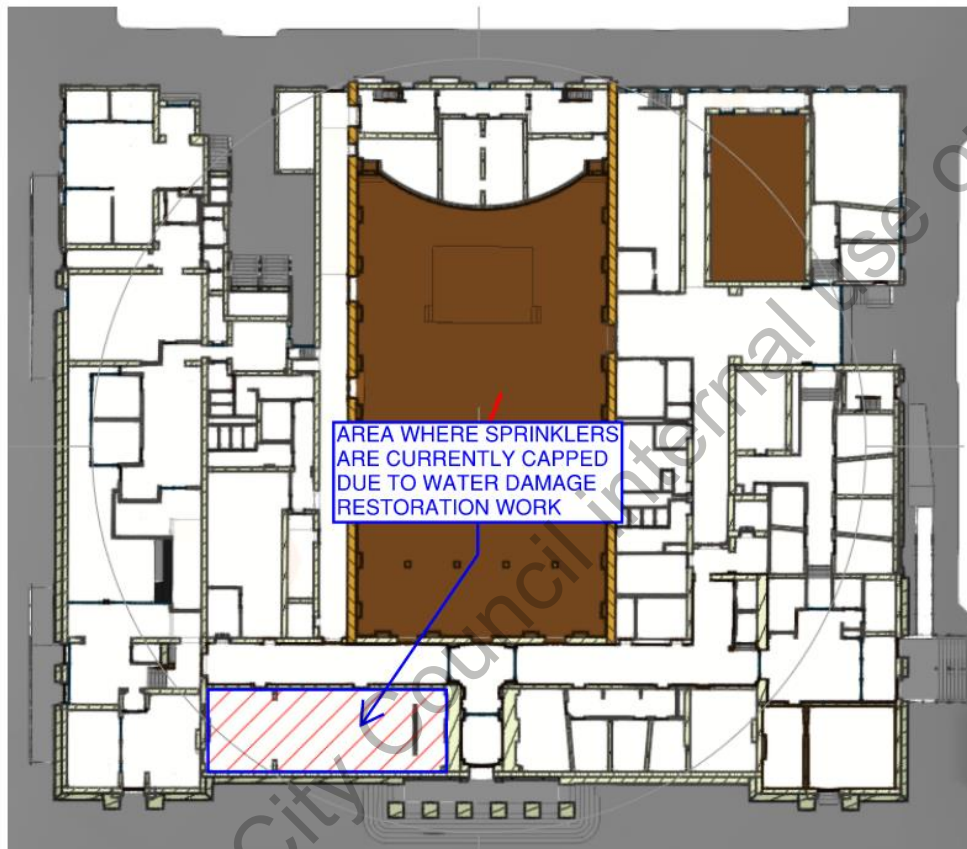
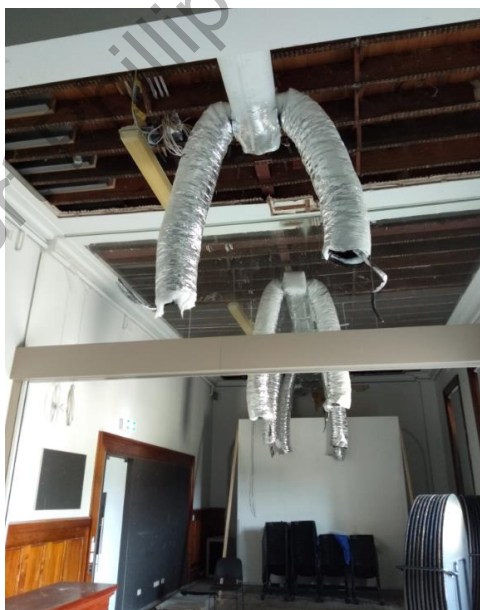
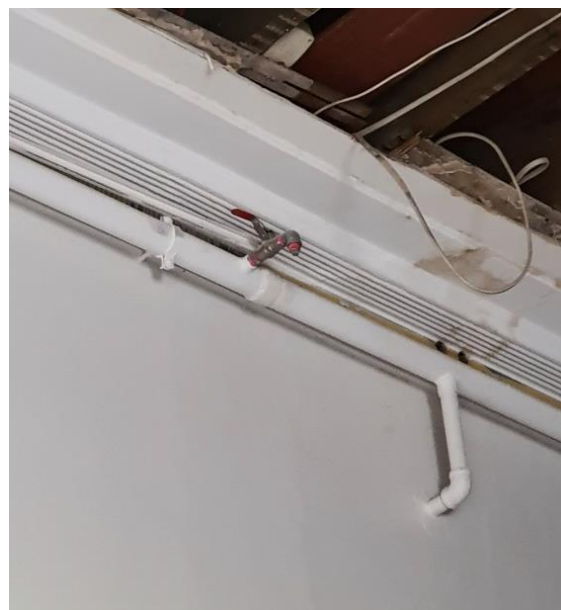
GROUND FLOOR

- There are some areas in the building where sprinklers are currently capped (disconnected) due to structural and water damage restoration work

- Replace all sprinkler heads due to existing “recalled” Omega heads; and other heads which are due for 25-year sample test (it is more cost effective to replace them)
- Re-instate sprinklers at structural and water damage areas

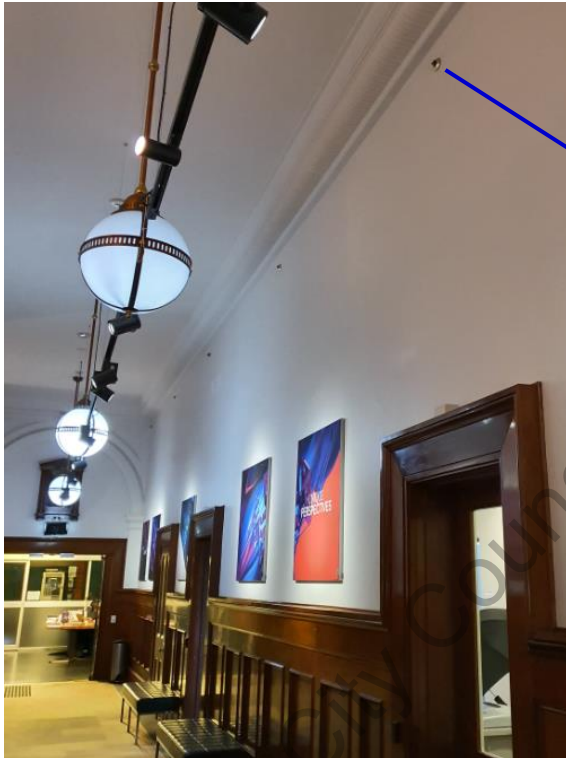
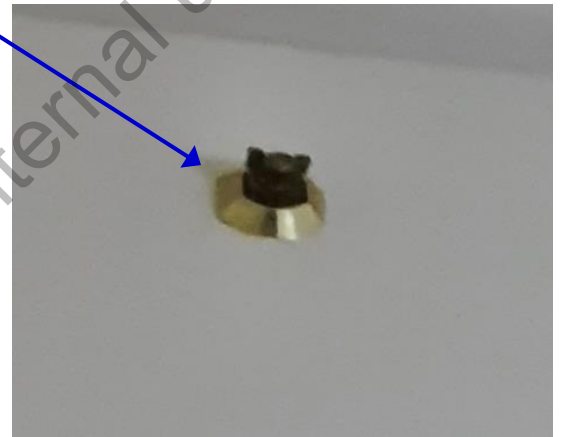
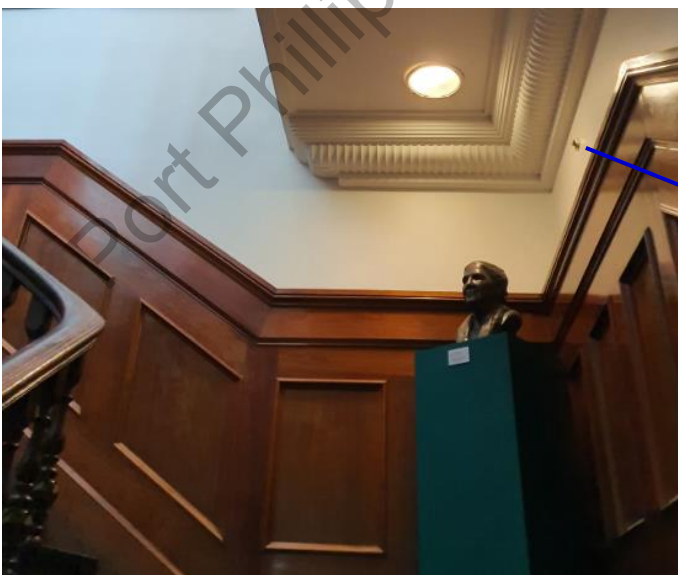
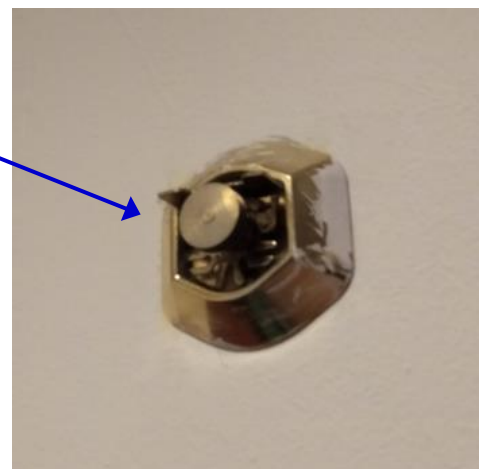
- The Block Plan in the SCV cupboard shows the sprinklers system was installed in Year 1993, which means the sprinkler heads are now due for 25 yearly sample tests as per AS1851
- Based on the documents we have reviewed, we noted Excel Fire Protection contractor and FES (Fire Equipment Services) contractor had identified the existing sprinkler heads are Omega heads (recalled approx. 20 years ago) and thus would require immediate replacement

- The existing Omega sprinkler heads which have been recalled shall be replaced immediately
- The existing sprinkler heads which have been due for a 25 yearly test shall be replaced immediately. It is more cost effective to replace these sprinklers than the test due to labour cost
- Confirm with Building Surveyor if the structural & water damage restoration building work would trigger >50% volume and hence would trigger the need of upgrading existing fire services to meet the latest compliance requirements of current Standards

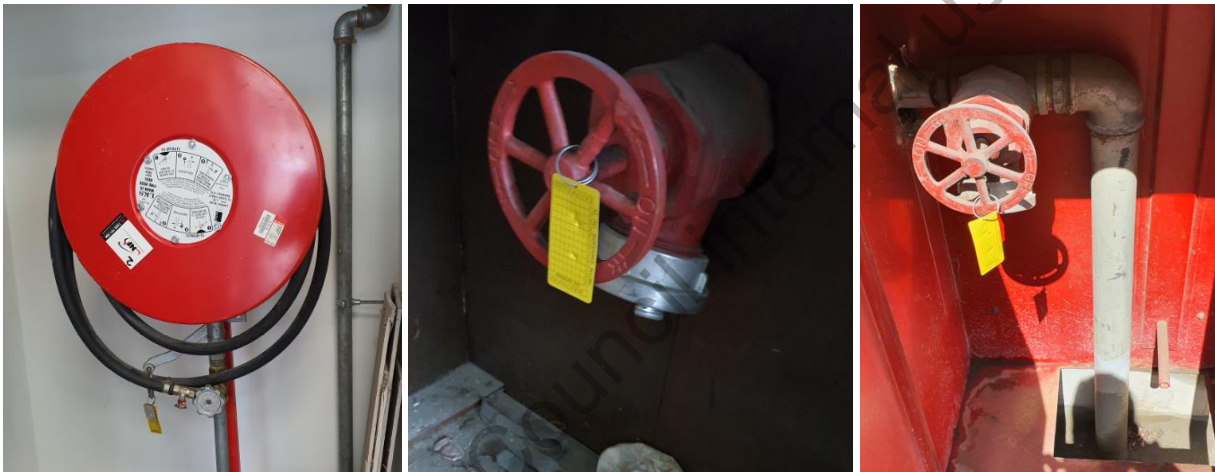
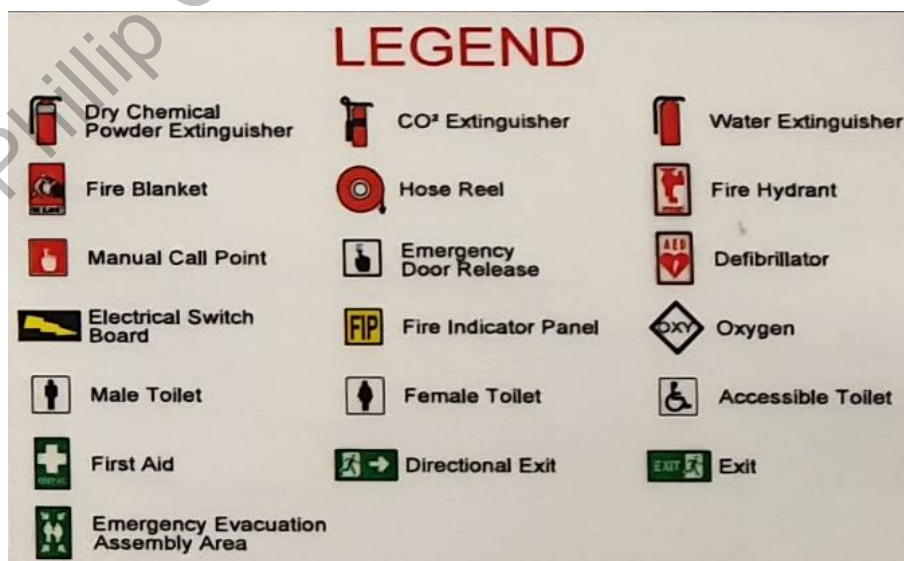
- Hydrants and hose reels are generally distributed throughout the building
- The maintenance records we have received and reviewed have shown the existing hydrants and hose reels have been maintained regularly as per AS1851
- Booster assembly for the hydrant system is located facing Daly St

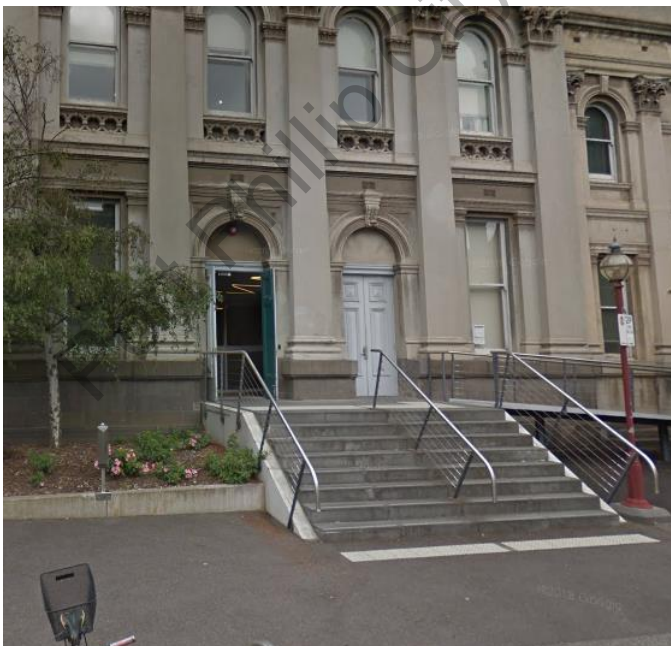
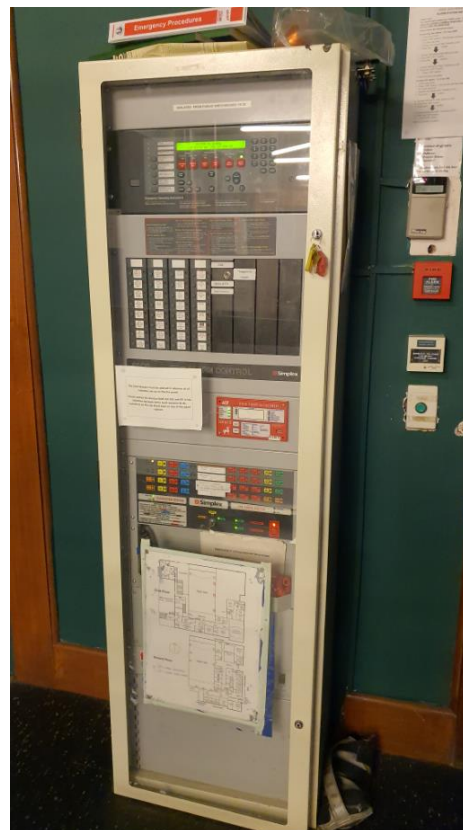
- The FIP + EWIS (Combo Panel) is currently located at the East entrance of the building, access from Layfield St
- Beam detectors only have been installed in the main Hall
- Smoke detectors have been installed at "ANAM" tenancy only but not throughout the building
- EWIS speakers have been installed at "ANAM" tenancy only but not throughout the building
- The maintenance records we have received and reviewed have shown the existing fire detection & alarm systems have been maintained regularly as per AS1851, but the document from "National Fire Solutions" have shown work carried out up until Year 2017 only. Verification required from the Building Maintenance Officer if other contractor(s) have been engaged

- Extend detection & alarm systems to serve the entire building
- Re-zone and commission of FIP
- Install WIP (Warden Intercom Phone) throughout or fire brigade phone jacking points

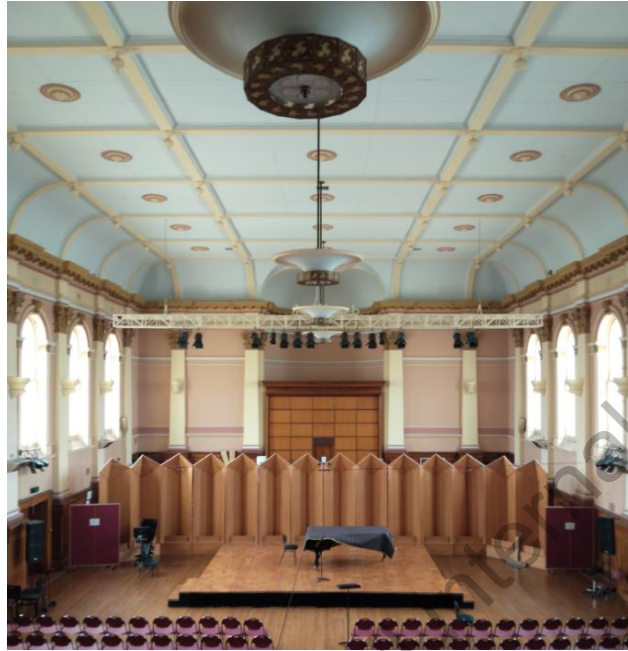
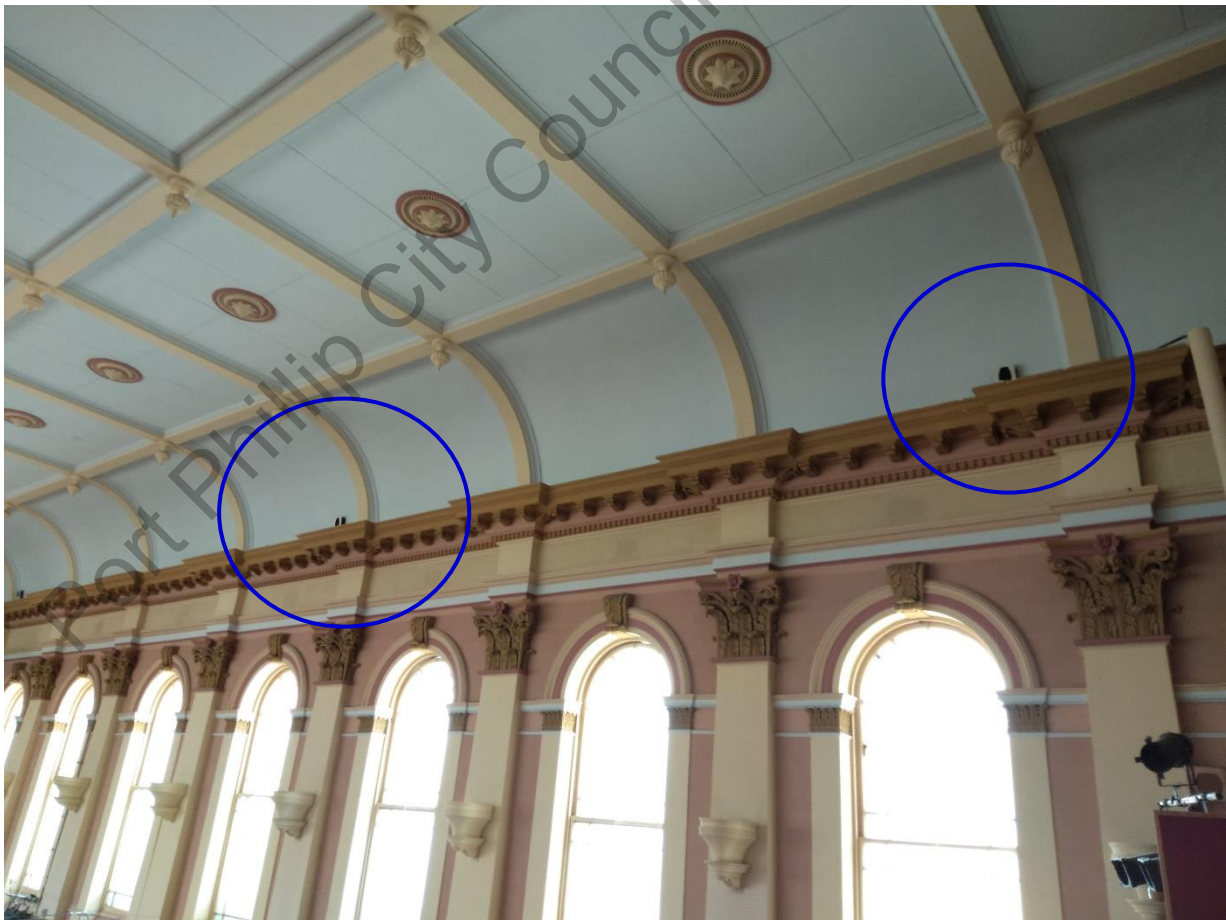
- Beam detectors only in the Main Hall area
