SOUTH MELBOURNE TOWN HALL ROOF STRUCTURE ASSESSMENT

Prepared for City of Port Phillip

December 2020

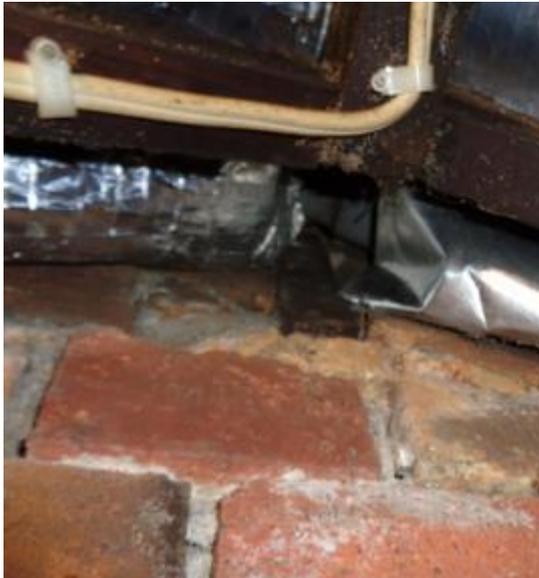
Figure 1: Ridge board cut at south gable

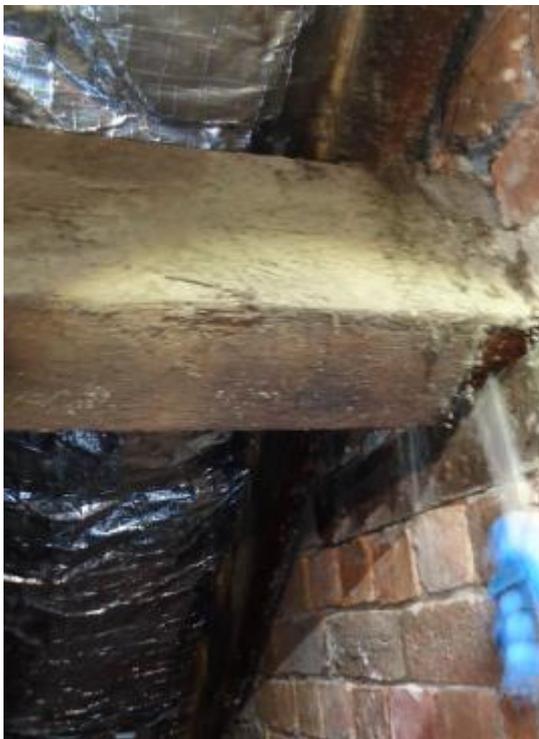
**Figure 3: Underpurlin with 70mm end bearing.
Pulled out of wall 40mm.**

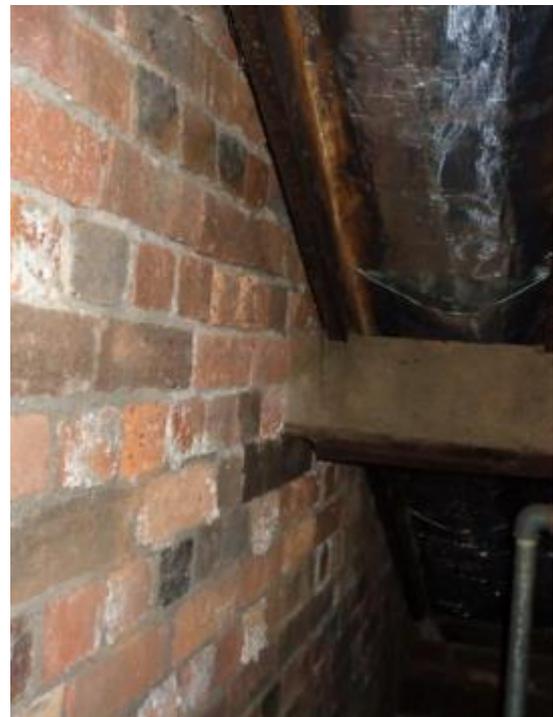
Figure 4: Underpurlin pulled out of wall

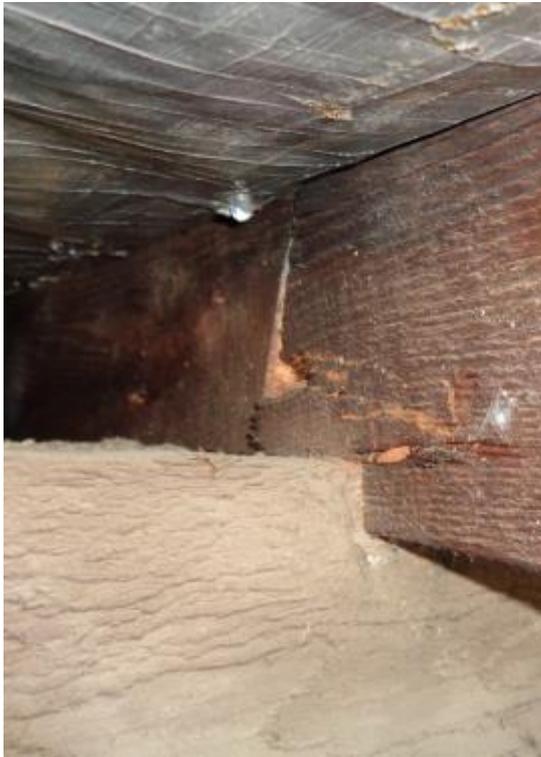
straightened. This has evidently been achieved by cutting the rafter over the underpurlin and providing a splicing cleat to the side of the rafter.

Figure 5: Rafter cut over the underpurlin

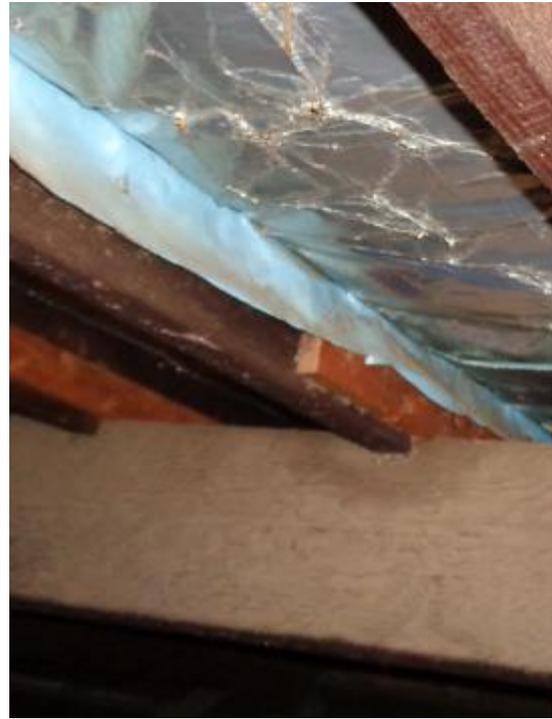
Figure 6: Splicing cleat to the side of the rafter

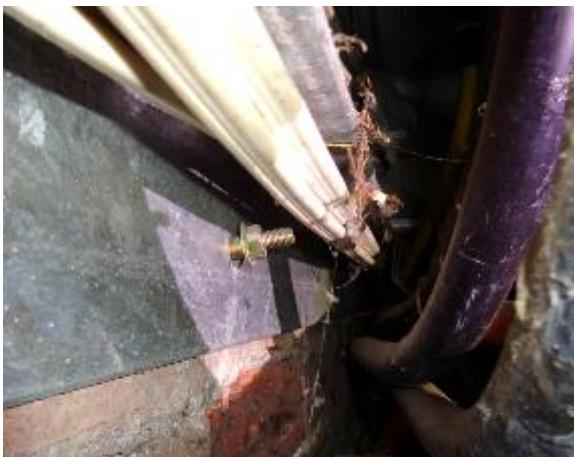
Figure 8: Loose raker anchor bolt

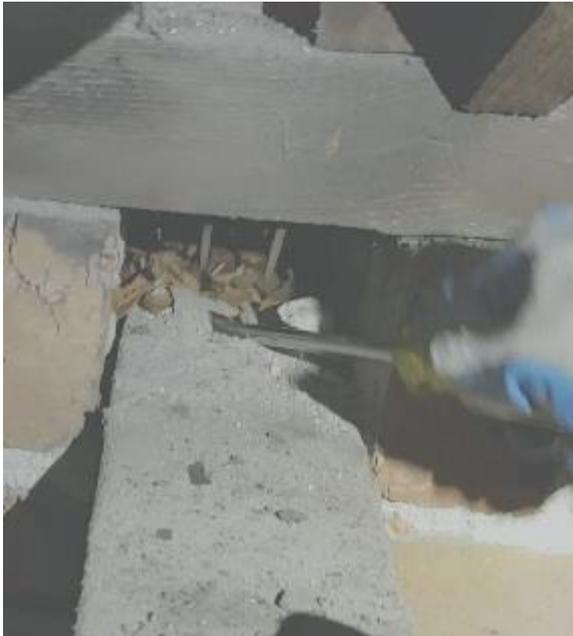
Roof truss RT36.1 (“Mayor’s Room”) had considerable rot in the bottom chord where built into the wall. At first the timber back in under the wall plate appeared in good condition and probing the timber around the brick wall line indicated the timber was solid. However, when probing the timber under the wall plate, the blade of the screwdriver went straight through the top of the timber. The timber in the probed area fell apart. It was impossible to inspect the soffit of the truss or the bearing plate as there was a ceiling joist up against the wall preventing inspection or probing of the truss. As the truss has dropped around 65mm, it is assumed that the bearing plate has rotted away. This truss was back propped down the floor below after these observations. All props should remain in place until the trusses are reinforced.

Figure 14: Extensive rot in the end of RT36.1

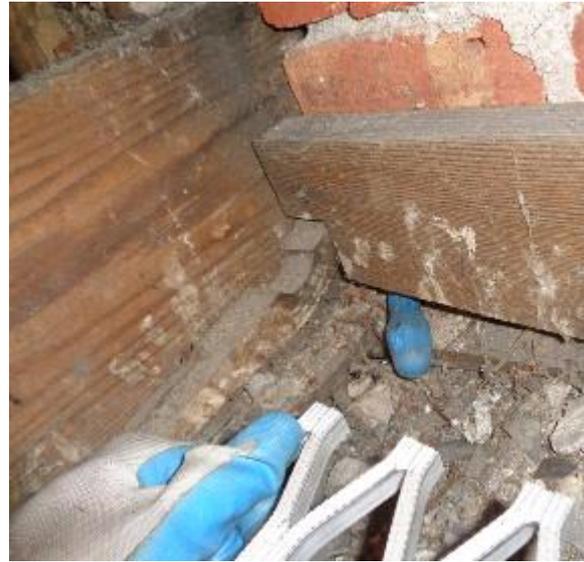
Under RT36.2 the bearing/wall plate has rotted away and the truss has dropped some 70mm. Probing around the truss with a screw driver indicated that there is also some rot in the soffit and at the end of the bottom chord. The extent of rot was not as significant as RT36.1 and was not back propped. However, this truss could present an issue in the near future if it is not repaired and made good.

Figure 15: Some Rot under RT36.2

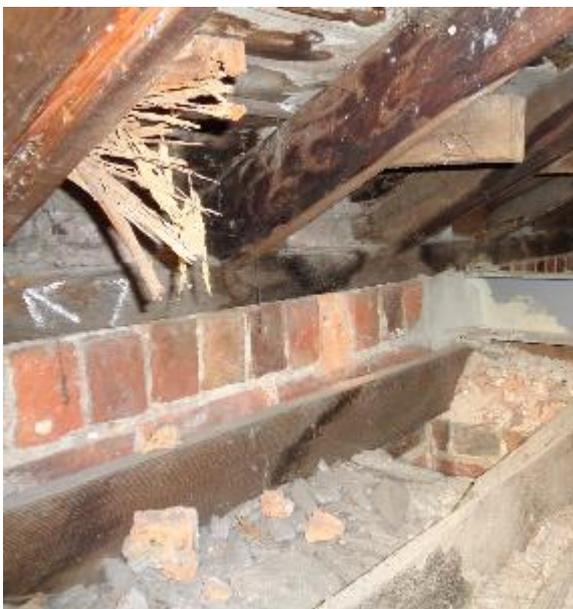
There was also some local termite damage to one of the gutter board cleats. The damage didn't appear to have spread, and local replacement of termite damaged timber at the same time as other repairs would likely be a suitable means of remediation.

Figure 16: Some termite damage between RT36.2 and RT36.3

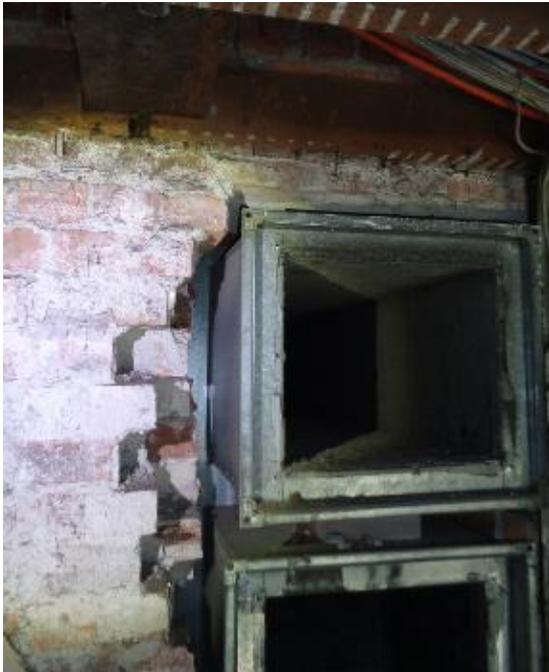
A hole has been knocked through the wall under the north end of roof truss RT2.3. This hole has been broken through the wall and not made good and no lintel installed. The edge of the brickwork should be rebuilt tying the skins of brickwork together and a lintel installed.

Figure 17: AC Ducts at north end of RT2.3

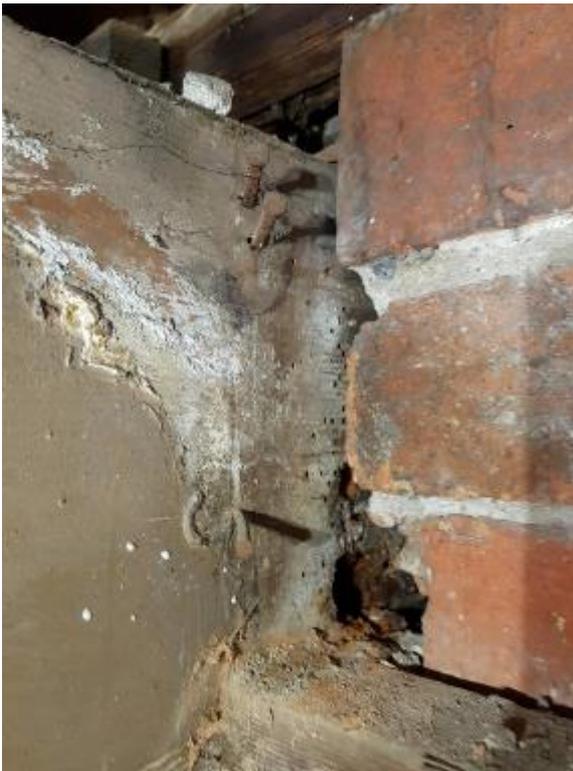
Figure 21: Truss RT8.6 Rot/borer damage

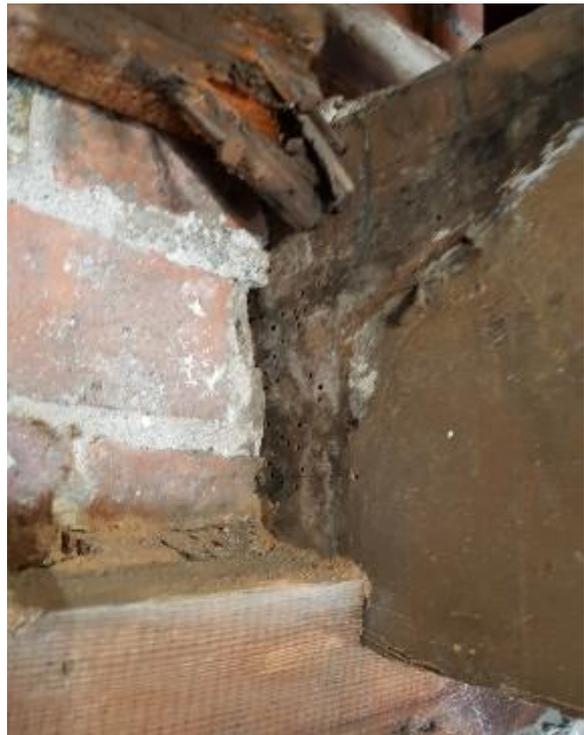
Figure 22: Truss RT8.6 Rot/borer damage

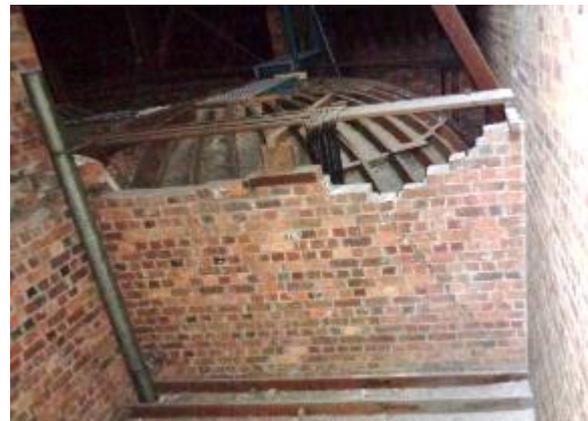
Figure 24: Cracked Buttress wall

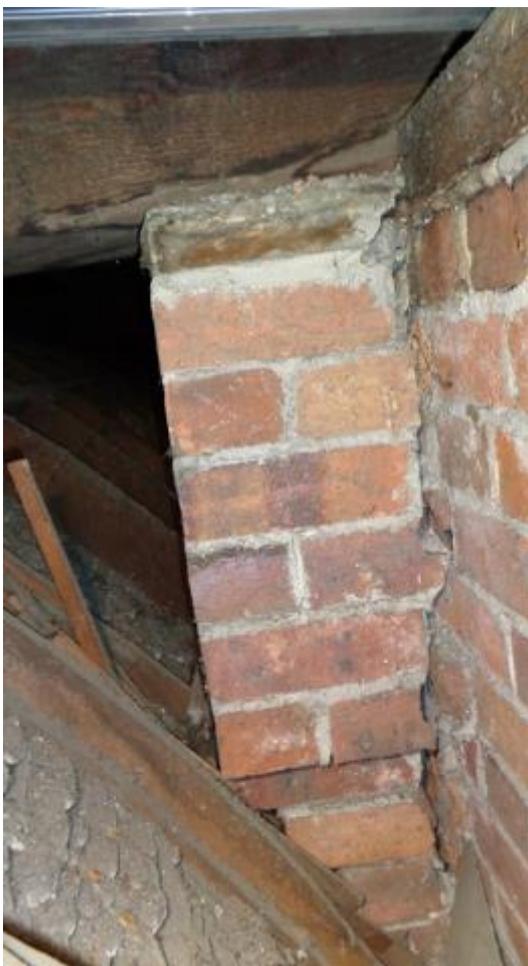
All of the brick corbels inspected had fractured vertically at the junction with the wall. Some had some minor cracking and others had come away completely and are likely only in-place because they are wedged between the wall, ceiling joists and truss. One of the corbels has been completely removed and replaced with a timber strut (at truss RT38.9). As a minimum, the loose corbels would need to be removed to address the potential for one to come loose and fall through the ceiling.

Figure 25: RT38.3 East- Corbel broken away from wall and wedged between ceiling, wall and truss.

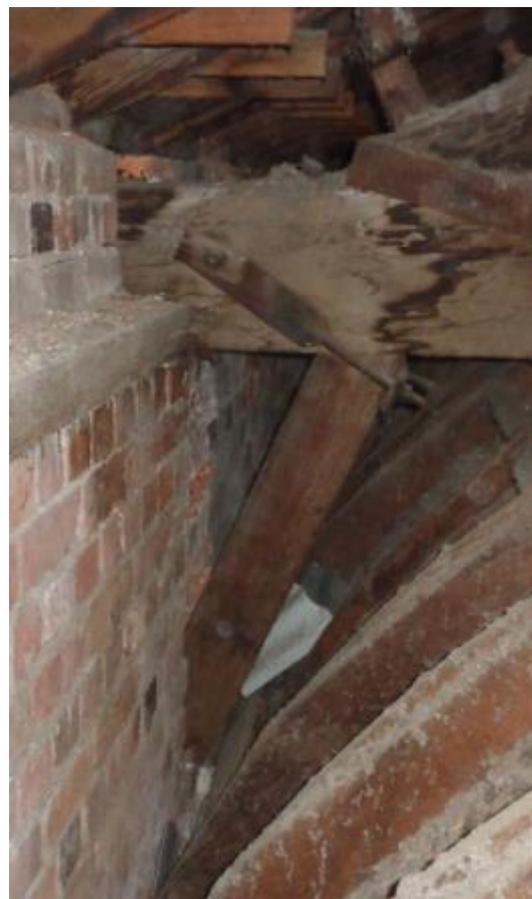
Figure 26: RT38.9 East – Corbel removed and replaced with a timber strut.

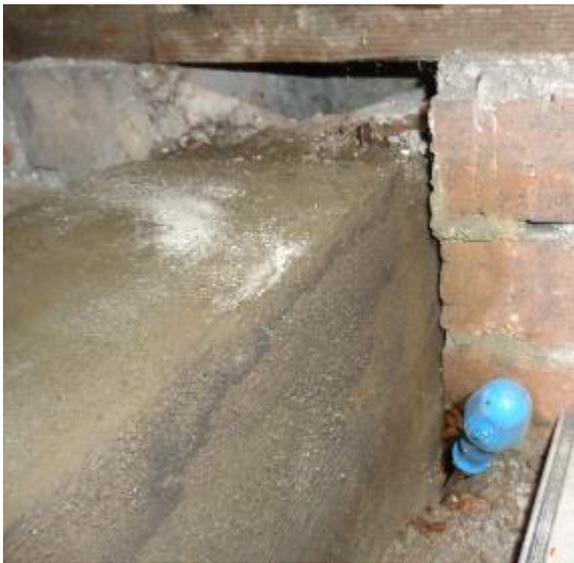
There was rot in five of the seven truss bottom chords inspected along with the bearing/eaves tie plate. This varied from the soffit of the truss being soft when probed with a screwdriver, to complete loss of the bearing/eaves tie plate. The degree of rot in the timber has led to increasing damage to the brick corbel as the truss has imparted more load onto the corbel. As noted above, the corbel at RT38.9 has failed completely and been replaced with a timber strut.

Figure 27: Truss RT38.2 – Rot in the bearing plate and soffit of bottom chord

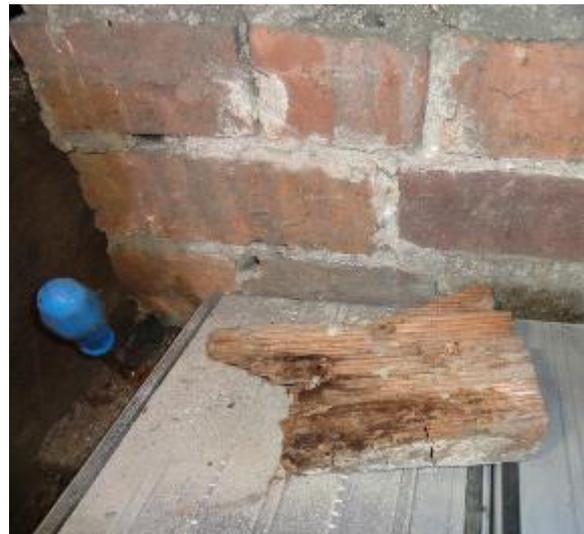
Figure 28: Piece of timber has come loose from the top of the bottom chord under the wall plate.

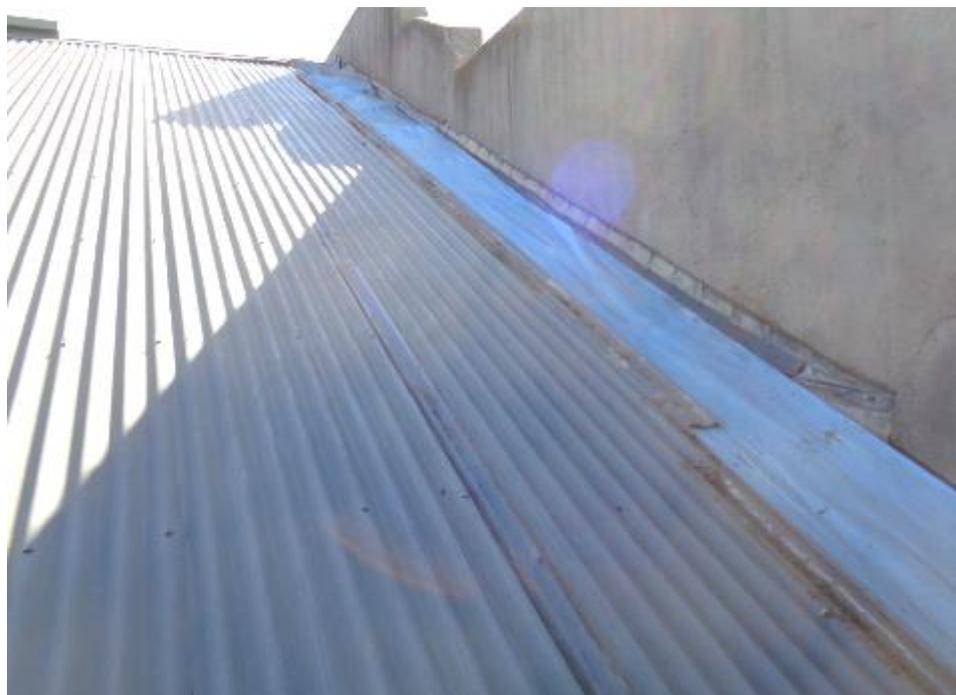
As it can be seen from the below photograph, of the internal spans on the main hall, the fixing spacing varies from every third rib to every fourth rib and fifth rib. This is clearly not in accordance with the NCC.

Figure 31: Example of roof sheeting over main hall showing spacing between fixings

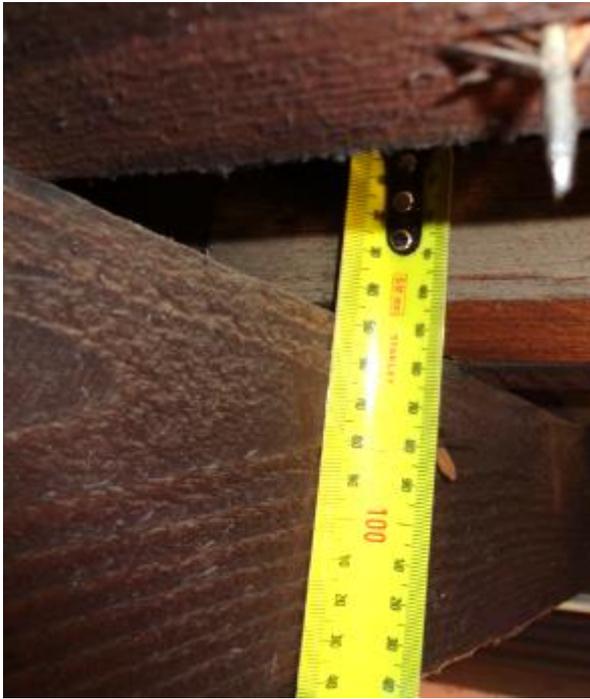
The nails were measured to be 90mm long by approximately 3.75mm diameter. In our opinion, these nails have sufficient capacity as a general fixing but do not have sufficient capacity near the ridge and eaves where local pressure factors could increase the uplift pressure by 30%.

Figure 32: Example of batten nails

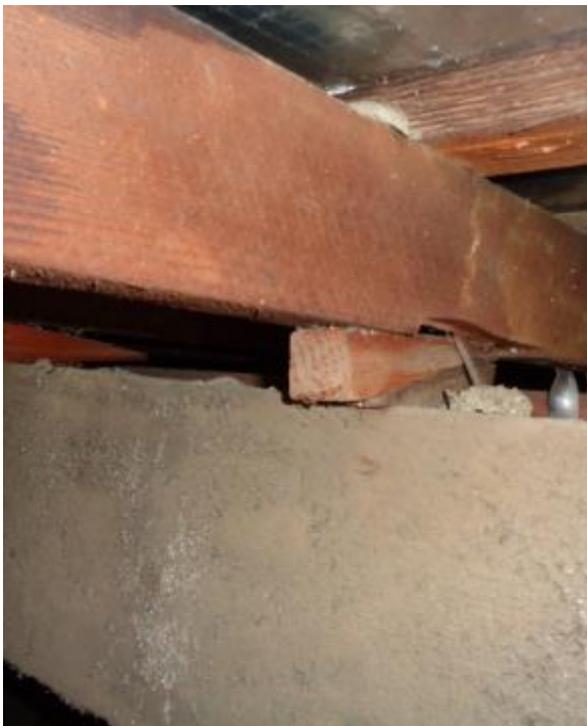
Figure 36: Rafter in Main Hall not tied down

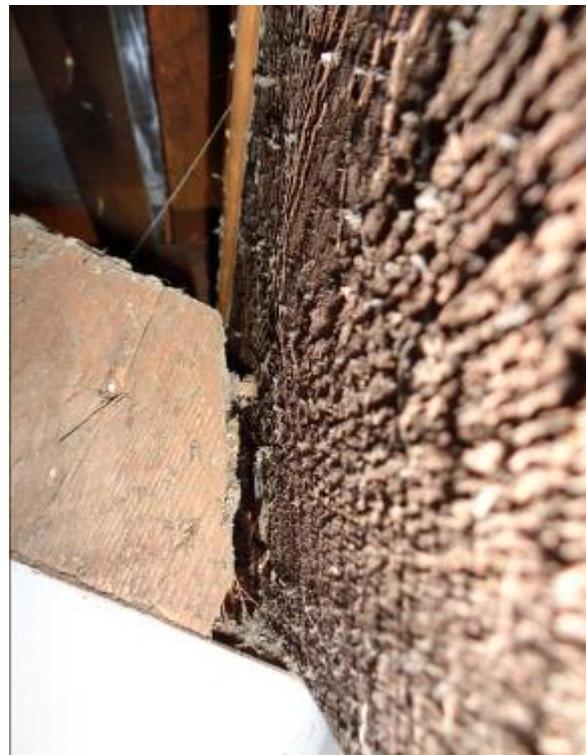
Figure 38: Skewed nails between queen post and underpurlin

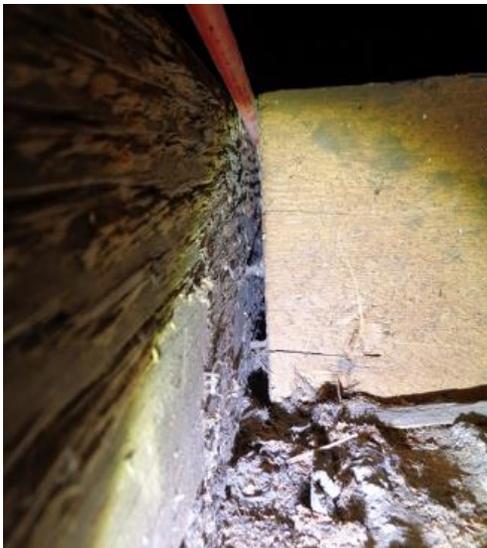
In the main hall, the ends of the ceiling joists appear to have been attached to the side of the roof trusses with two skew nails. For a typical tight joint, it is expected each nail would have a working load capacity of 50kg. So, for a joint relying on two nails, capacity could be 100kg, which would be inadequate to support the force imposed by a person. With a gap between the ceiling joist and the truss, the capacity of the joint would be substantially less than this. However, it may be possible that there could be a timber bearing plate nailed to the side of the truss bottom chord that the ceiling joists sit on, and the skew nails only serve to hold the ceiling joist in place. This would need to be confirmed during remedial works in order to ensure the connections are adequate.

Figure 42: Two skewed nails

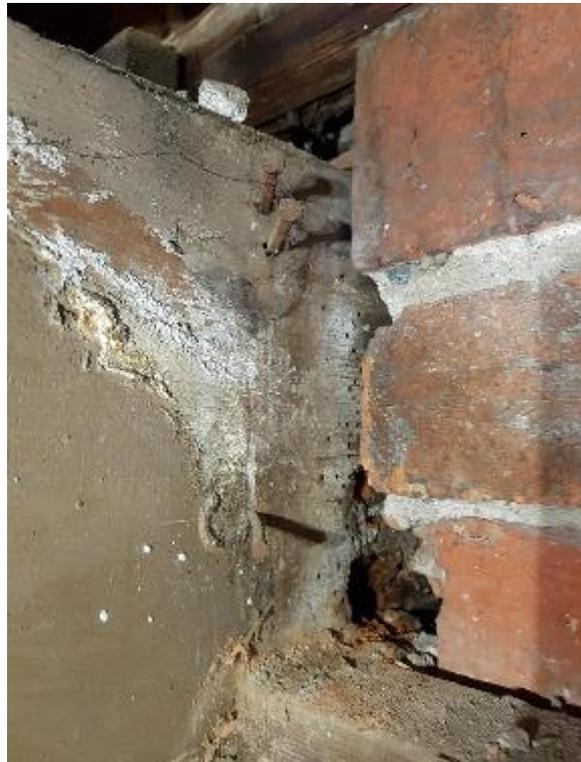
Figure 47: Rot in the end of RT8.6

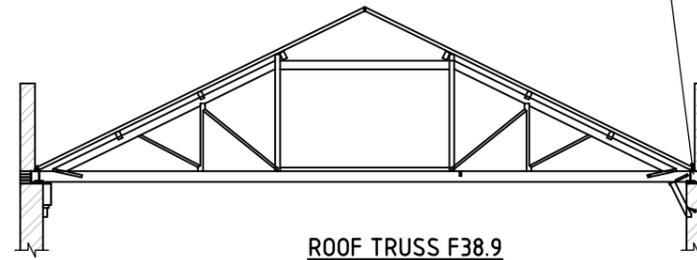
ROOF TRUSS F38.9

BRICK CORBEL PREVIOUSLY BROKEN AWAY FROM WALL AND A TIMBER PROP ADDED IN ITS' PLACE. JUDGING BY THE TYPE OF CONSTRUCTION THIS WAS MOST LIKELY DONE PRE 1940.

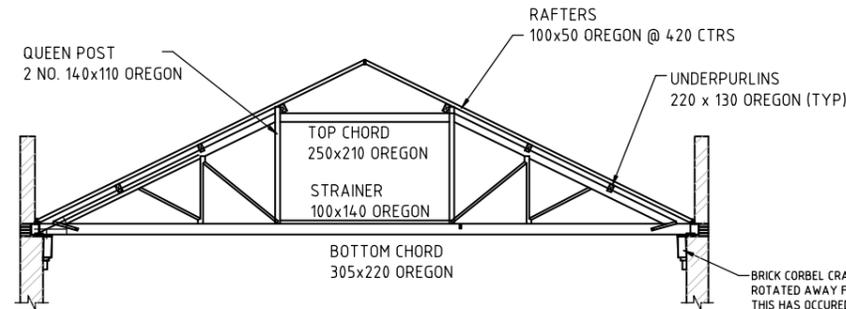
ROOF TRUSSES
F38.1 TO F38.8
AND F38.10

BRICK CORBEL CRACKED AND ROTATED AWAY FROM WALL. THIS HAS OCCURED ON BOTH SIDE OF THE BUILDING.
