South Melbourne Town Hall

Electrical Services Inspection Report

Rev No: P3

Project No: 2019-028

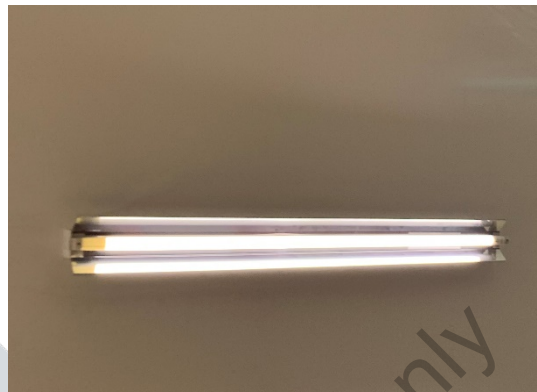
Fluorescent Batten

The majority of the existing light fittings in this building appear to be of old types.

To bring the general lighting in the building to standard compliance, lighting upgrade is required – Replacing the existing lighting systems with new systems consisting of modern-looking highly efficient LED fittings and programmable lighting control technologies. This can be done in a few stages with the least efficient lights being replaced first, such as the fluorescent lights and metal halides, retrofit light fittings and then other fittings.

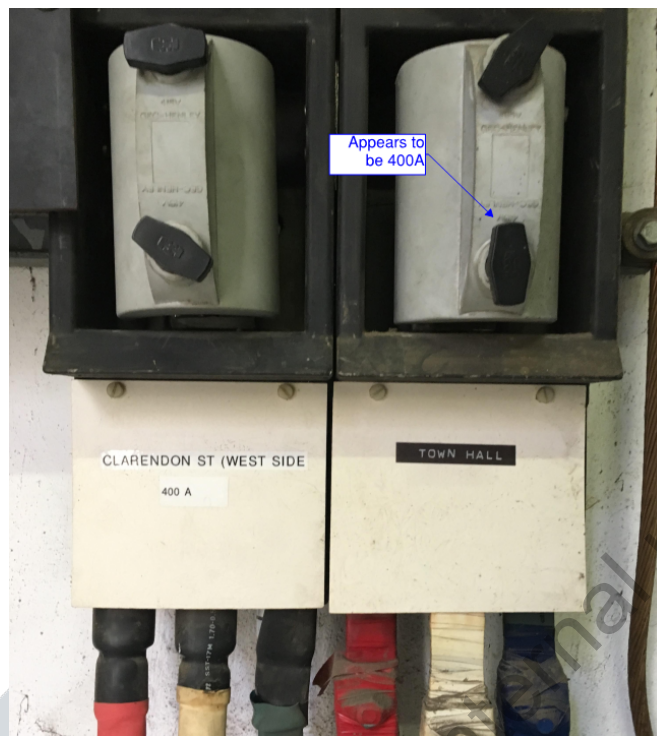
LV Feeder for the Town Hall

According to information provided by the power authority (CitiPower), the capacity of the indoor substation is 1,000 kVA (1,390 A). This transformer is NOT dedicated to this building. CitiPower have no records showing the agreed supply capacity to this building. However, as per the information provided by CitiPower, the rating of the LV feeder (fuse switch) for this building is 400 A (see below figure).

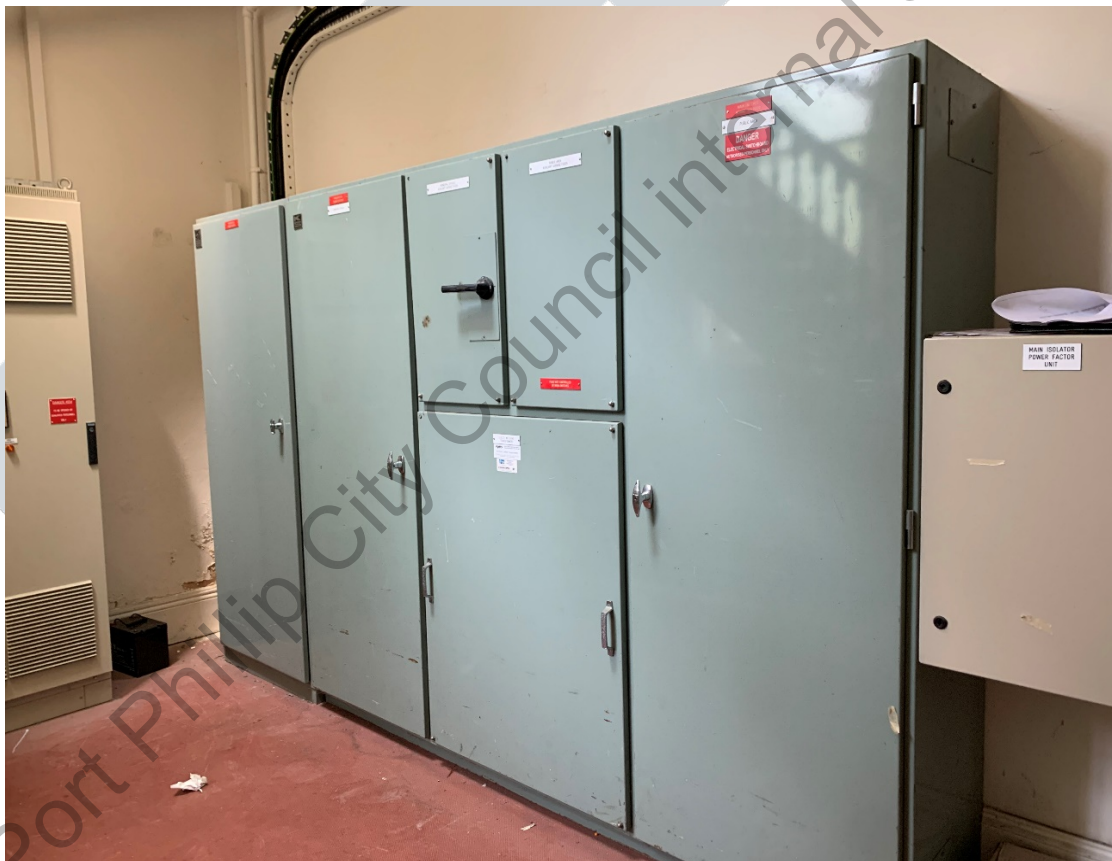
Existing Main Switchboard

The existing main switchboard is old but appears to be in a good condition. The current rating is possibly 800A – 1,000A. The construction of the board appears to be Form 3a which is not deemed to be sufficiently provided with internal separation to reduce the probability of the initiation of an internal arcing fault as per the latest AS/NZS 3000 requirements. Compliance with AS/NZS 3000 is not retrospective until alterations or additions are carried out to the switchboard. However, extra safety precautions shall be taken when working on the switchboard.

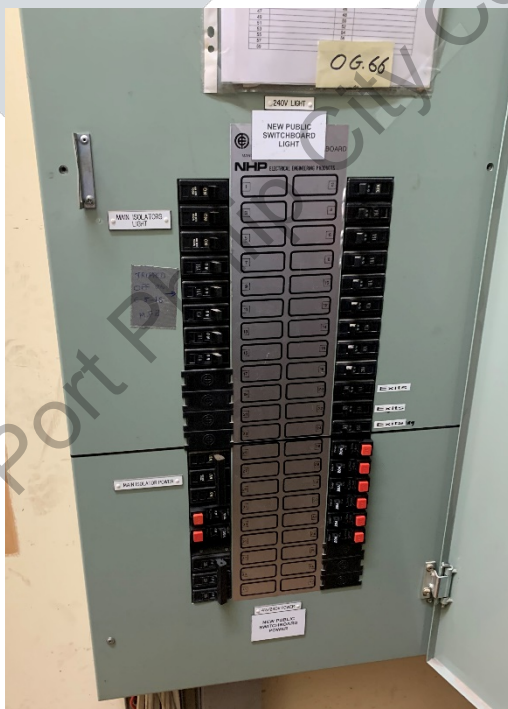
East Wing GF – Public L&P DB

- Most DBs are old and some are in poor conditions
- Majority of lighting and power sub-circuits in the DBs are not provided with RCD protection as per AS/NZS 3000 requirements.
- No time clock control for boiling water unit control as per BCA requirements.
- No external lighting controls as per BCA requirements.
- No energy monitoring for lighting, power, mechanical and lift services as per BCA requirements.
- Where located in a passage to a required exit, which is the case for most DBs, the DB or the cupboard is not smoke sealed as per BCA and AS/NZS 3000 requirements.
- Breakers in the DBs are mostly old-style circuit breakers.
- Majority of the DBs have no spare poles.
- Labelling of most DBs is not clear and no circuit schedules provided.

To facilitate future restoration works and any future refurbishment works, it is necessary to bring the non-compliant switchboards to Code and Standard requirements:

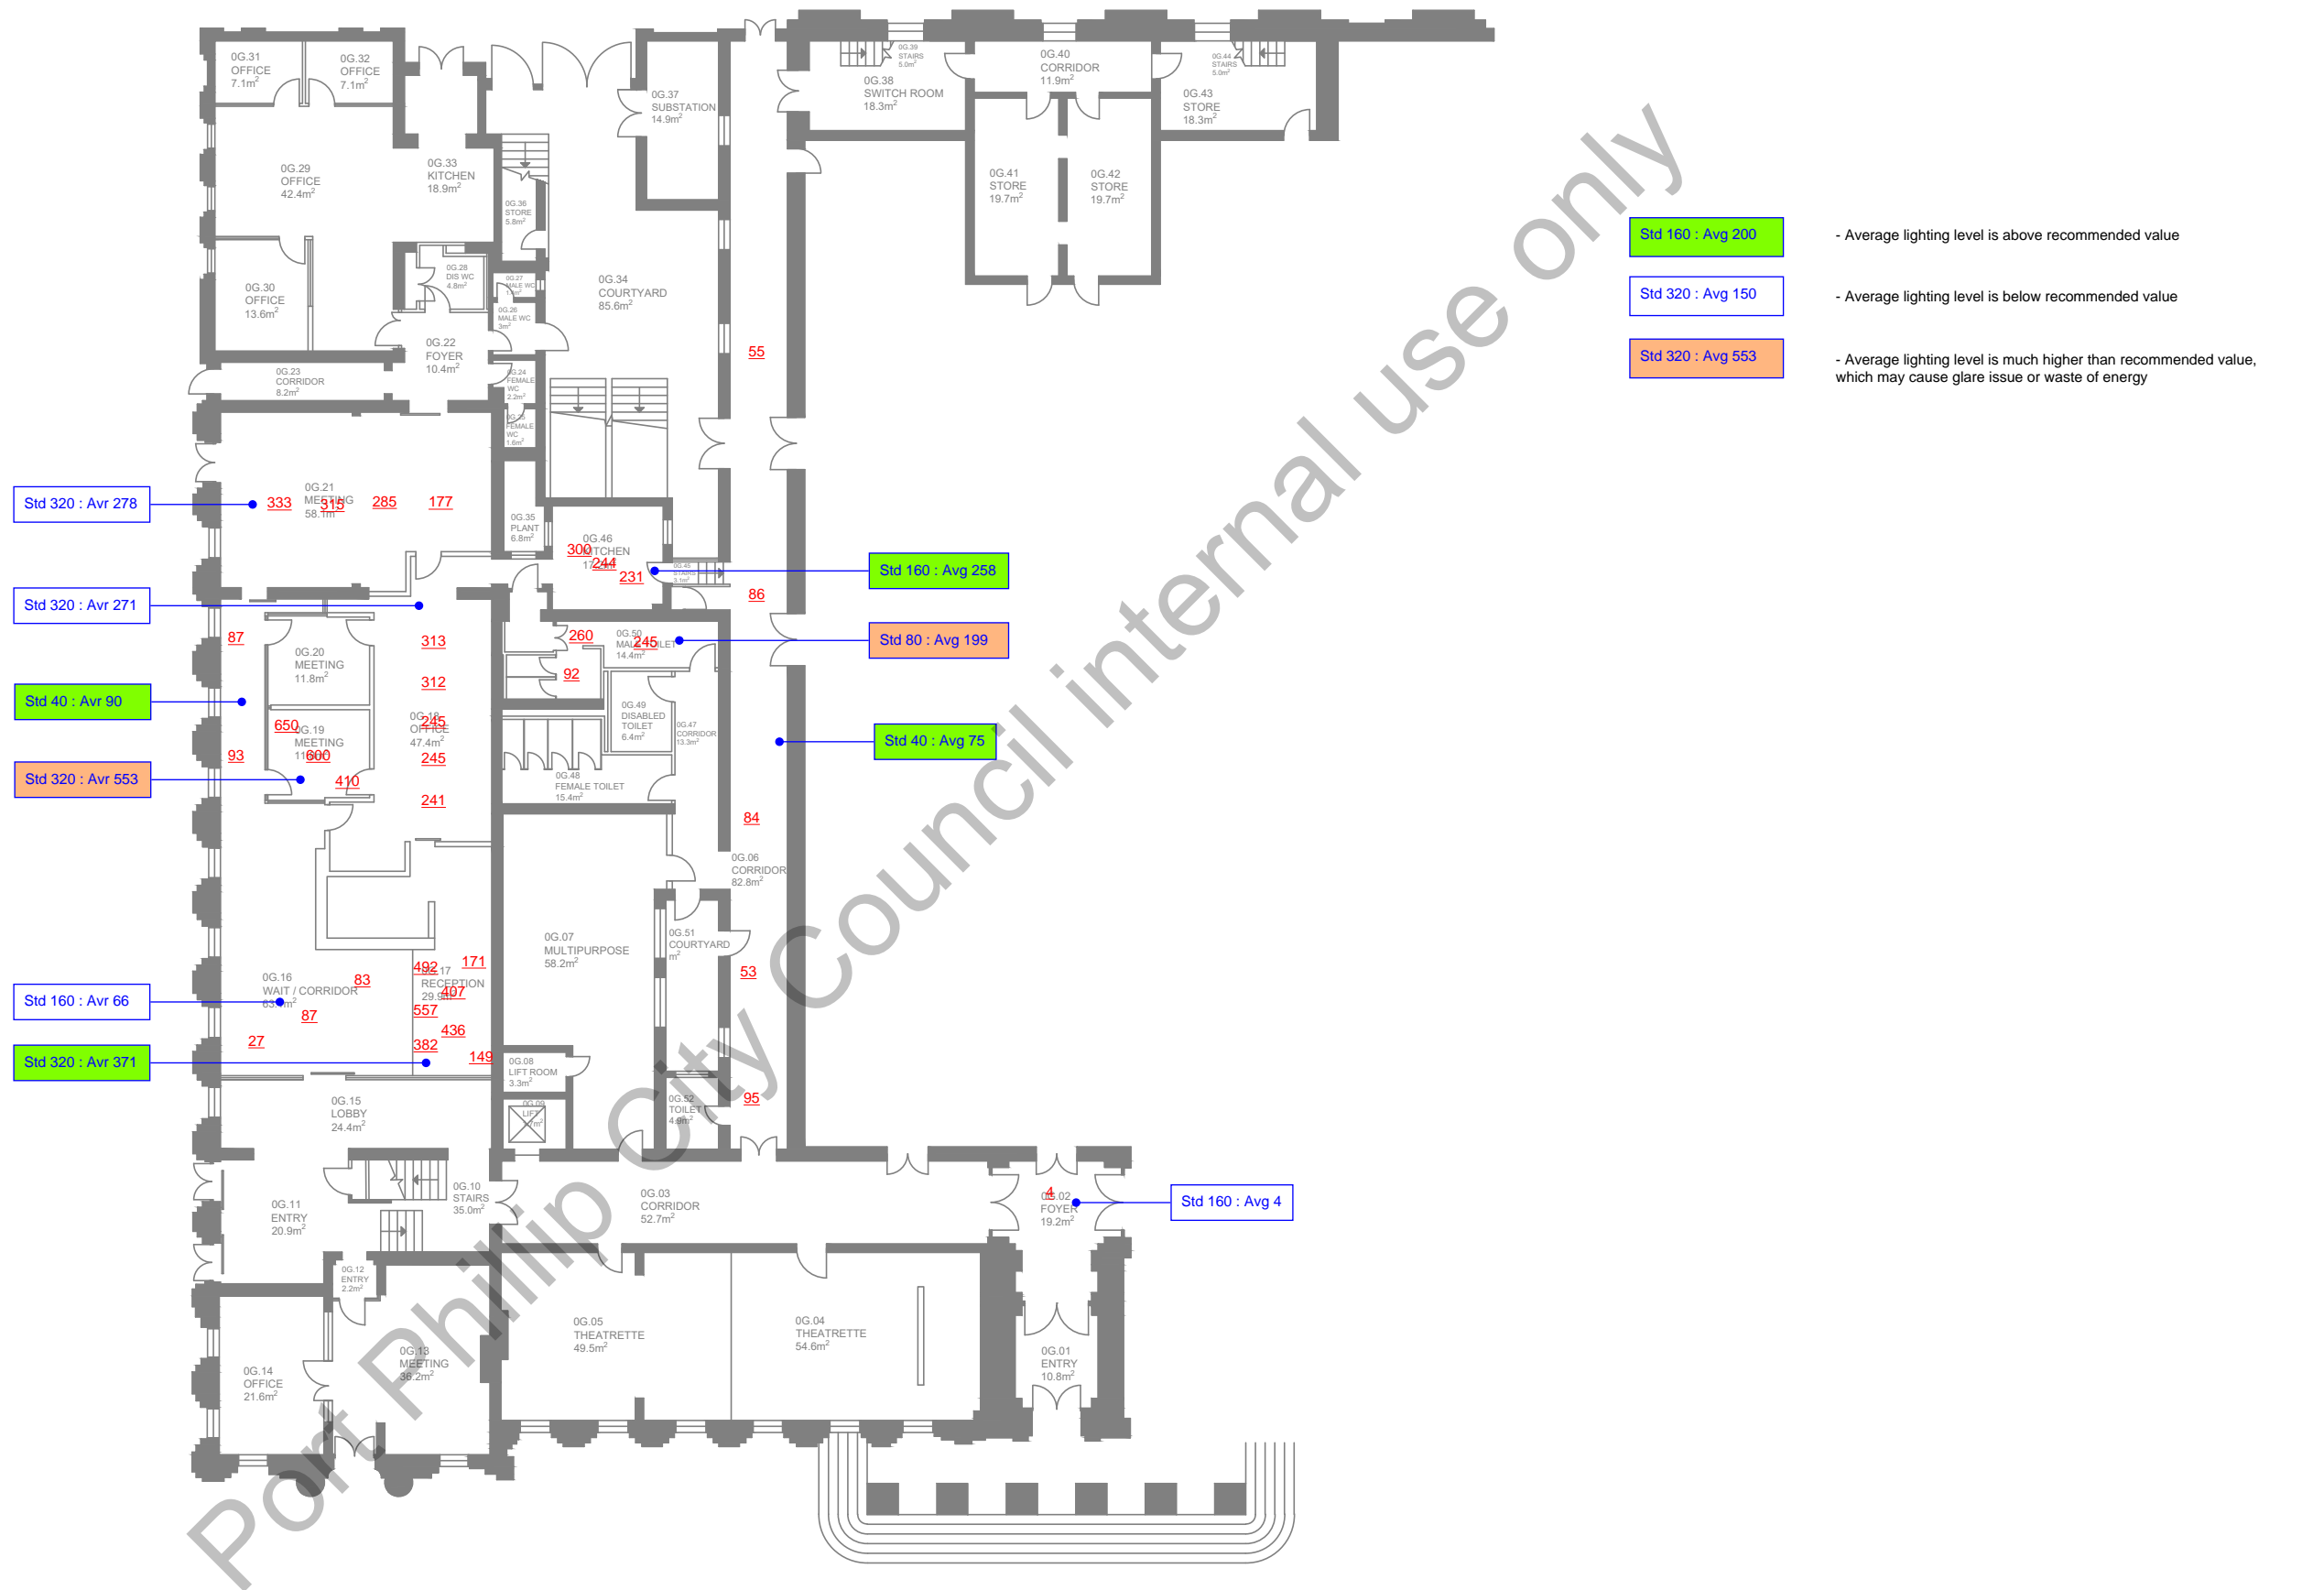
WEST WING - GROUND FLOOR

- Some areas' lighting levels are well below the recommended levels

- In some areas, although the average lighting level is above the recommended level, the uniformity is not good enough
- In some areas the lighting levels are excessive being a few times more than the recommended values.

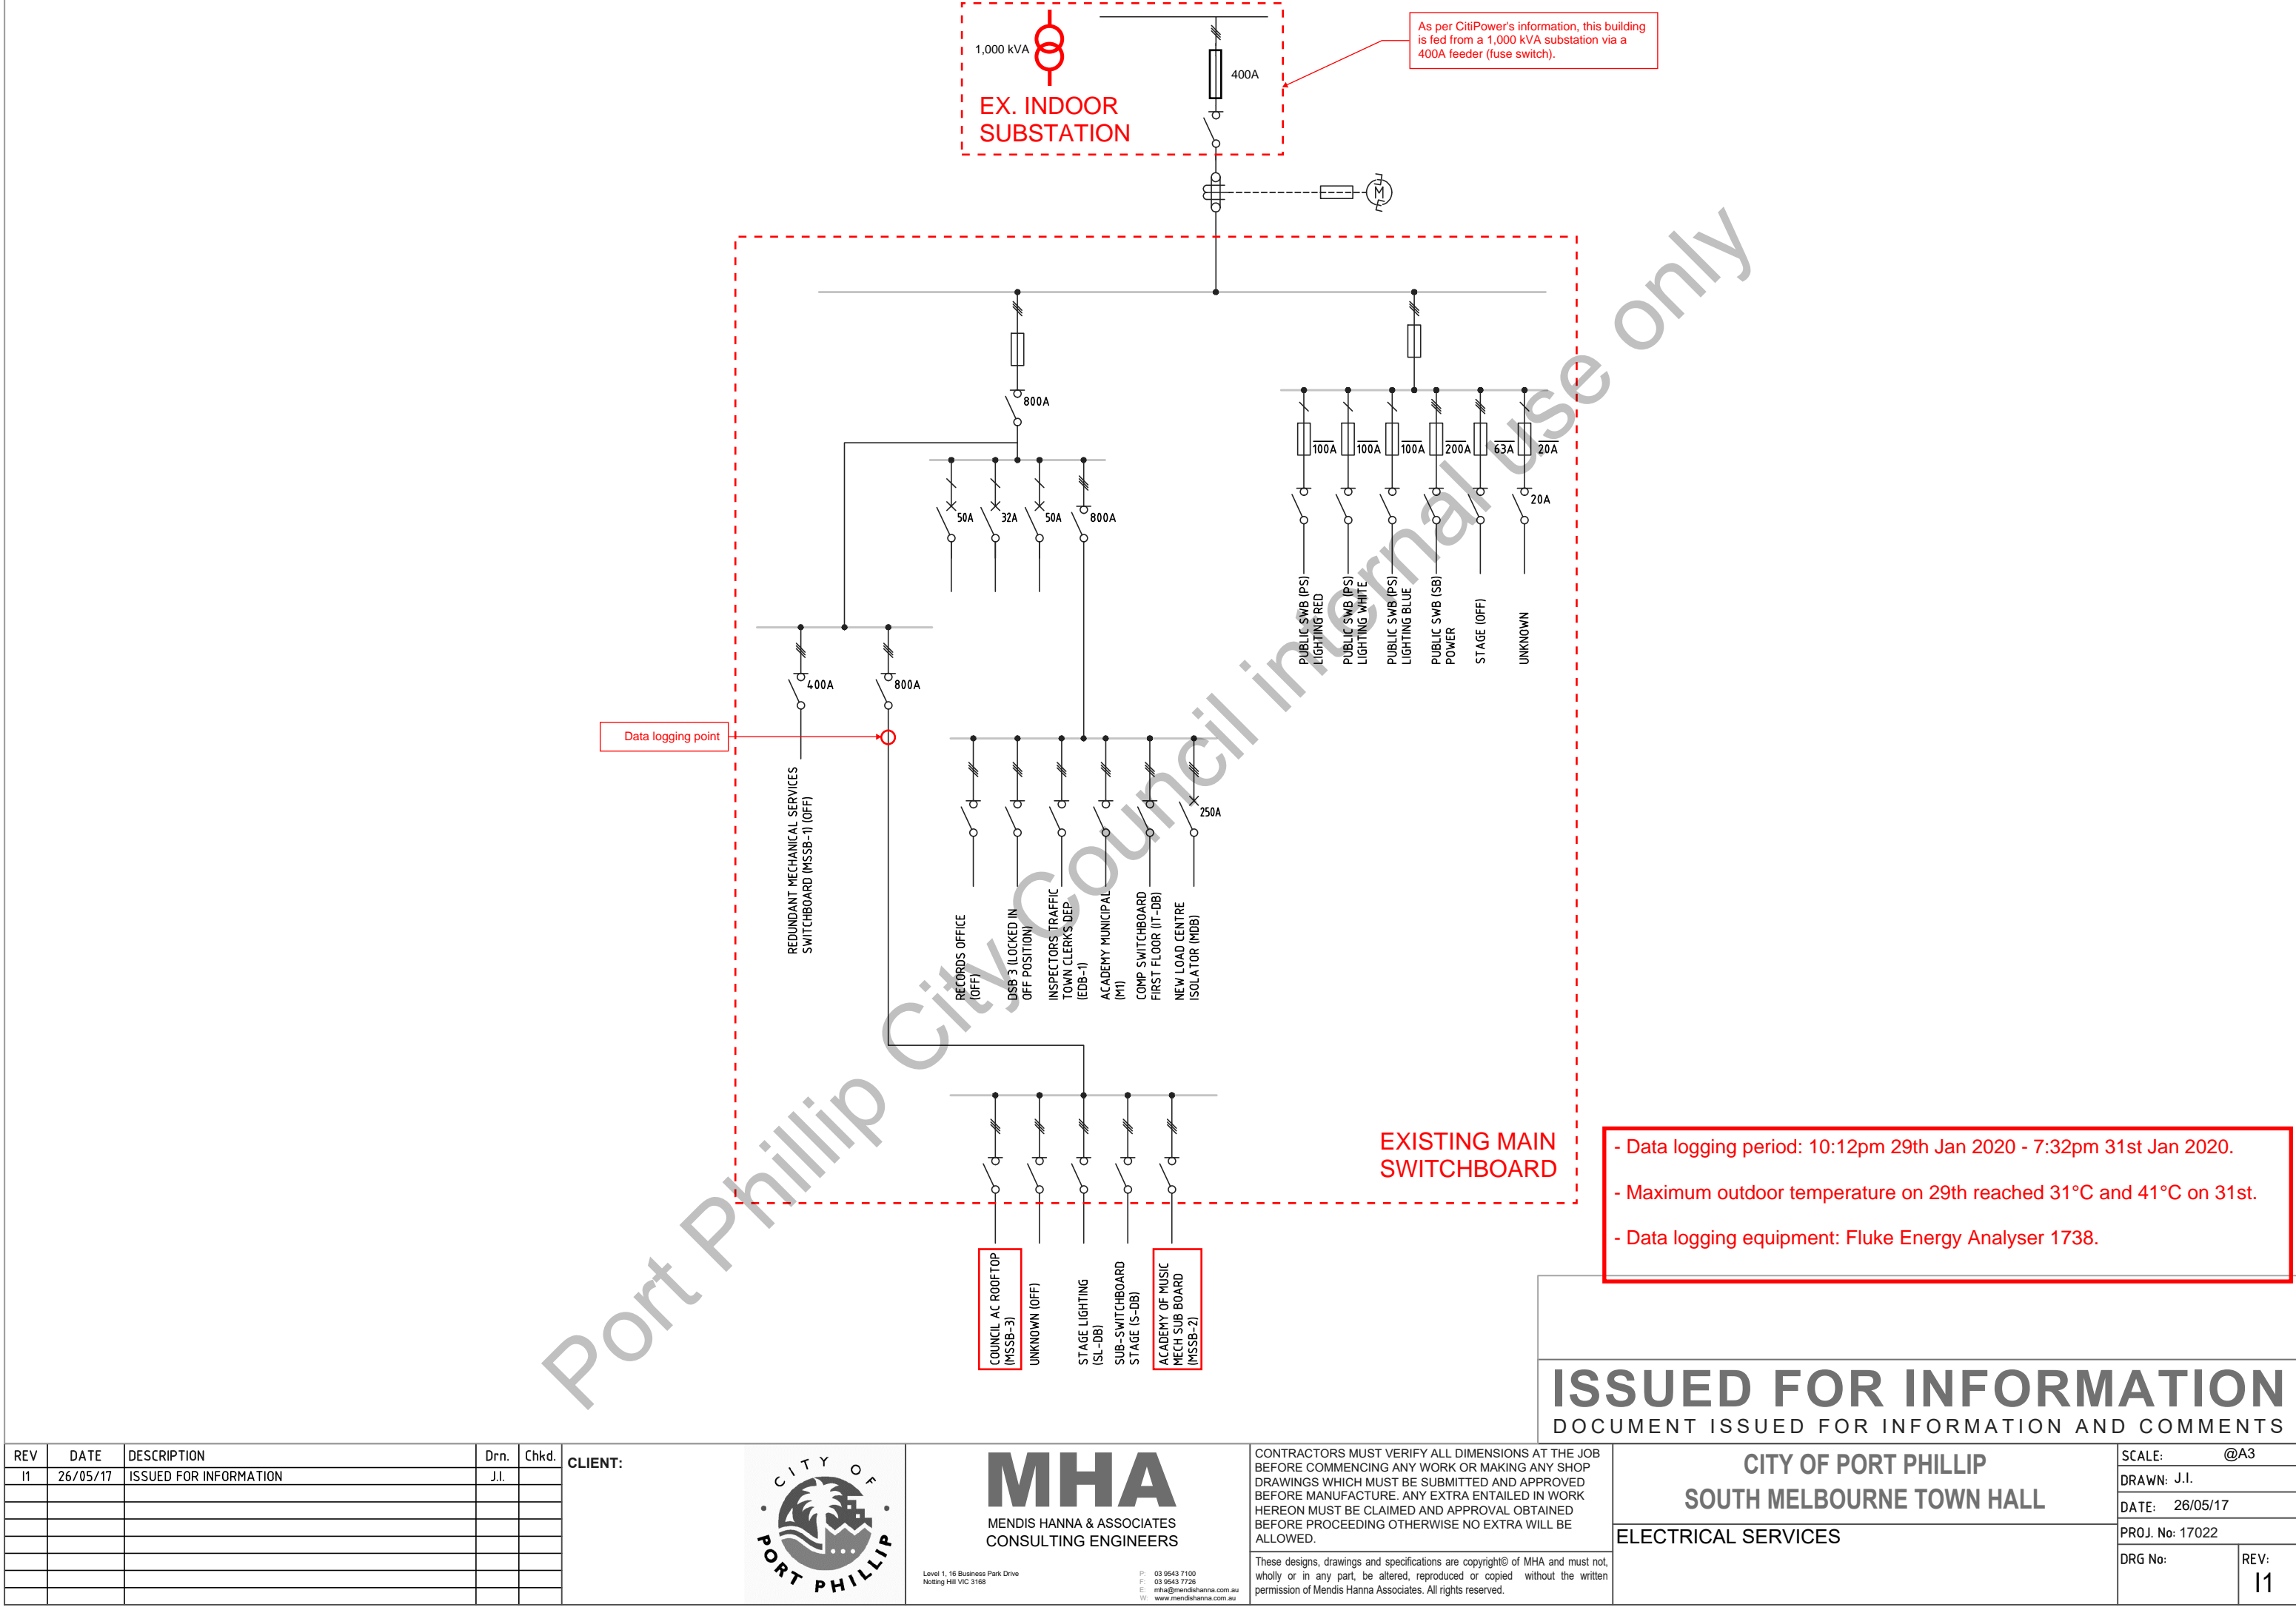
Recorded maximum current is 290.7A on Phase C. It is very likely that this was a recorded spike triggered by starting of the mechanical equipment in the morning (around 7:00 am). The average maximum is 71.4A on Phase C which has included the low base load at night-time.

Based on the recorded load profile, the maximum demand at the selected measuring point and during the logging period is in the order of 90A ~ 130A on Phase C. Refer to Appendix C for more detailed information.
