# ASSESSMENT OF TOWN HALL CLOCK TOWER

South Melbourne Town Hall

Prepared for City of Port Phillip

Report Title: Assessment of Town Hall Clock Tower  
Client: City of Port Phillip

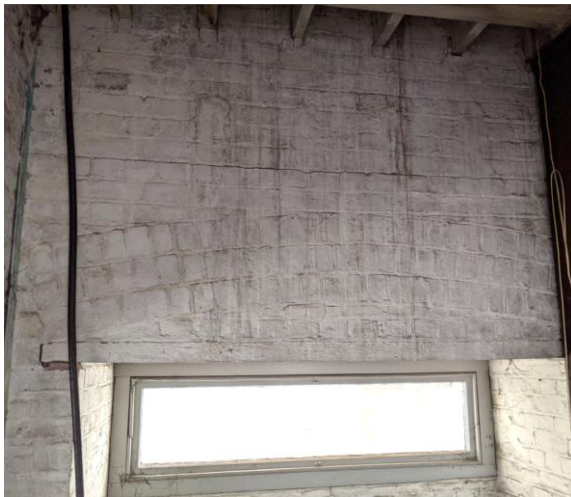
From the access stair, a horizontal crack was noted on all four faces of the tower at approximately 7 brick courses below the soffit of the floor joists at level 3. Plotting this location on the Veris drawings (Appendix A) indicates that the crack location closely corresponds with a change in wall thickness.

**Figure 1: Horizontal crack around full perimeter of tower.**

#	Item	Recommended Action	Relative Priority
1	Crack at Level 2 Staircase	Consider undertaking structural assessment of the stability of the tower above this level.	Low to Medium
2	Loose Brickwork around Level 4 Clock Attachments	Re-point the brickwork around the fixings for the clock face.	Medium
3	Floor of Level 5 Bell Level	Repair the cut floor joist, e.g. by lapping a length of timber beside the cut joist.	High
4	Bell Clapper Support on Level 5	Remove, inspect and make good the pivot pin support bushings for the bell clapper pivot pin. This may involve dismantling and removing the clapper assembly for inspection and repair at an engineering workshop.	High
5	Flagpole and Braces on Level 6	Replace the rotted timber bracing the flagpole.	High
6	Level 6 – Corroded Steel at Brick Dome	Investigate the cause and extent of corrosion in the steel plate around the top of the brick dome and develop a repair strategy.	High

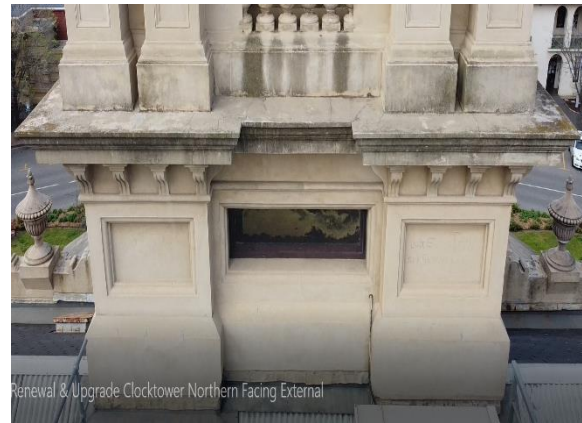
**Figure 2: Note crack location in relation to window and change in wall section.**

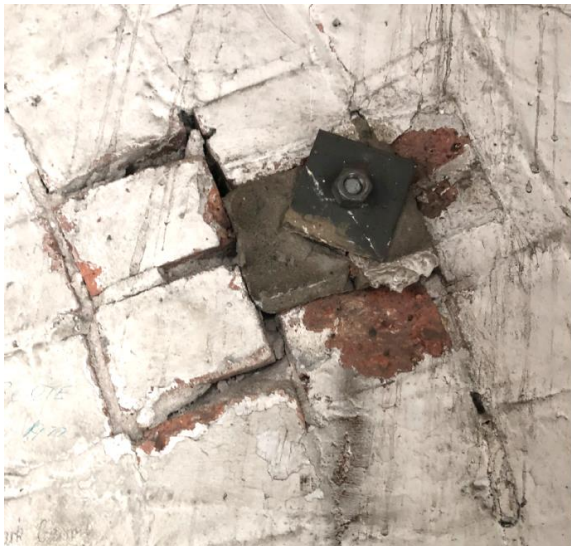
It appears that the clock face has been re-attached to the brick walls with through bolts. The brickwork around the bolts has come loose. The brickwork at the attachment points on the east side was in the worst condition.

Figure 3: Clock Face Fixing

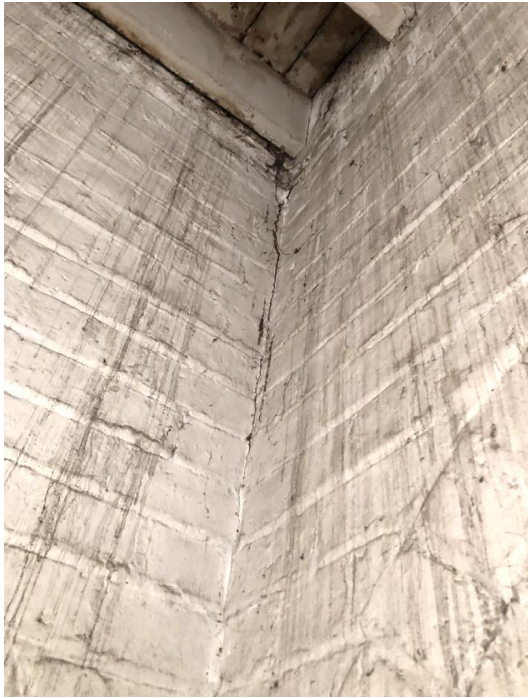
There is some general cracking in the brick walls at this level, particularly vertical cracking down from the Bell Level floor in the corners.

**Figure 6: Vertical Crack in the corner**

7	General	Monitor the limited cracking in the masonry. Monitor the timber including in the flagpole. Address general corrosion and wear of the steel components (bolted joints, fixings, mechanical parts) by removing the corrosion, cleaning, and applying and maintaining suitable protective products, lubricants and/or coatings.	Low/Ongoing

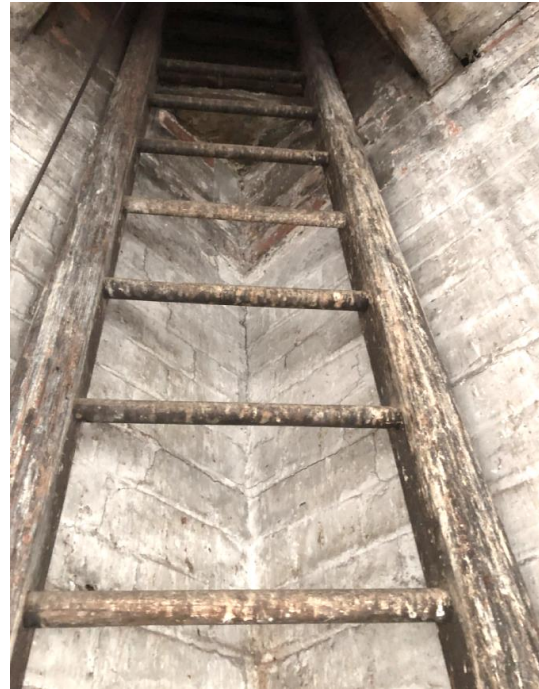
**Figure 7: Vertical crack in the corner behind the access ladder and a diagonal crack on the left side behind the ladder.**

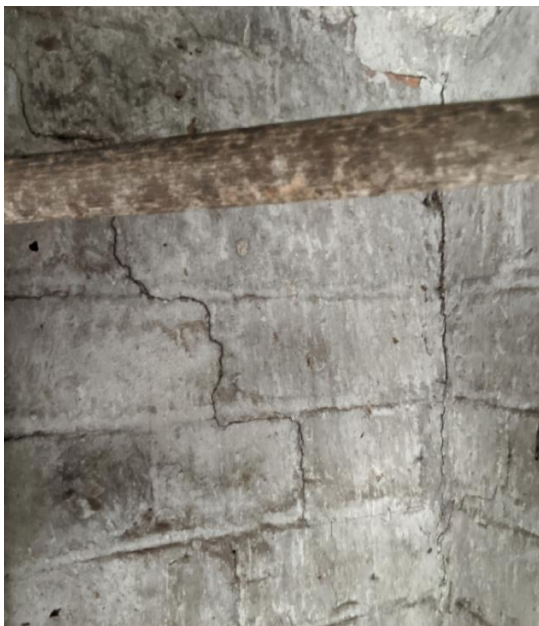
**Figure 8: Diagonal crack behind the ladder.**

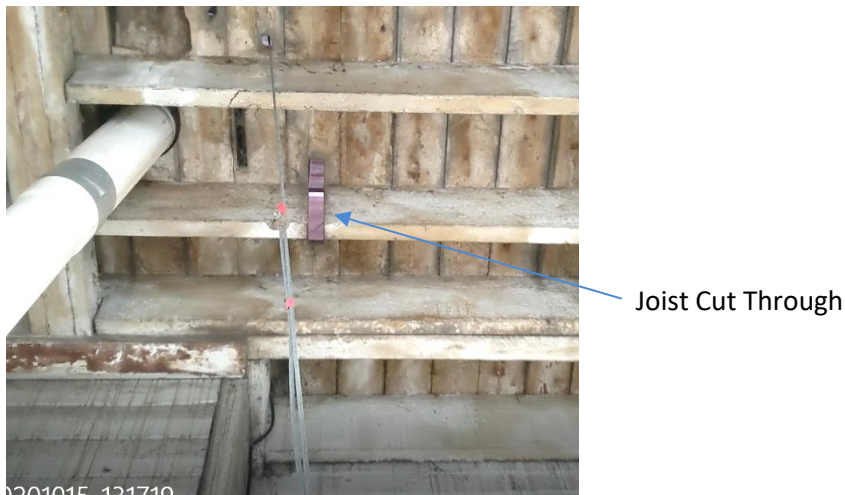
One of the floor joists has been cut through and there are some cuts through the flooring itself. Some of the mortar caps around the ends of the joists are loose but in general the floor is solid.

Figure 9: Floor joist cut through

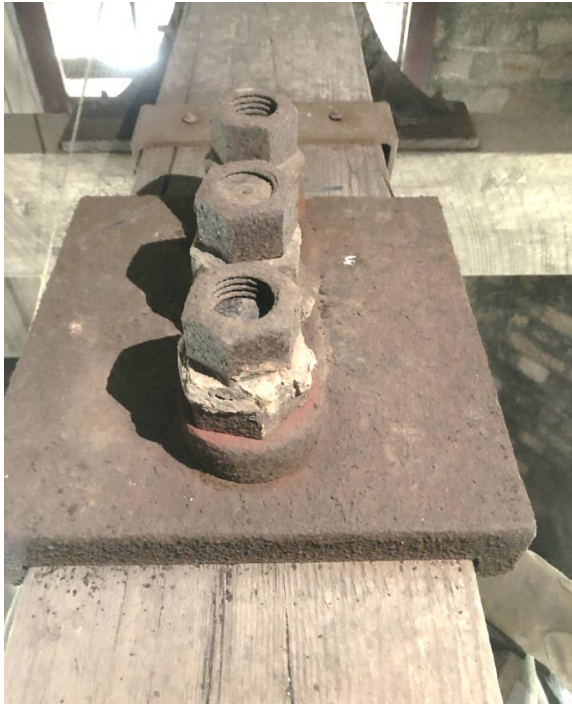
The bell itself appears to be supported by two large bolts which pass through the support beam. There is a large bearing plate on top of the beam spreading the load across the top of the beam and centralizing the support point.

**Figure 10: Bell support spreader plate**

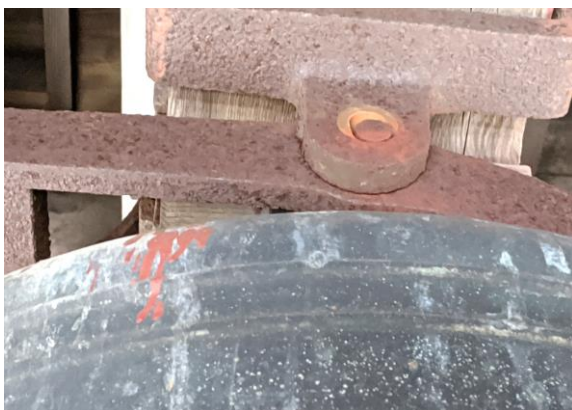
Where the pivot pin runs through the support bracket, the bush that houses the pin has become ovalized on the west side and has cracked on the east side. The pin has slid towards the ovalized opening such that only a short section of the pin is supported on the east side. The bell clapper has become offset and no longer striking the bell square on. At some point in time, the bracket supporting the bell clapper has been strengthened by the addition of a bracket over the beam welded to the support bracket.

**Figure 11: Bell Clapper pivot pin ovalized**

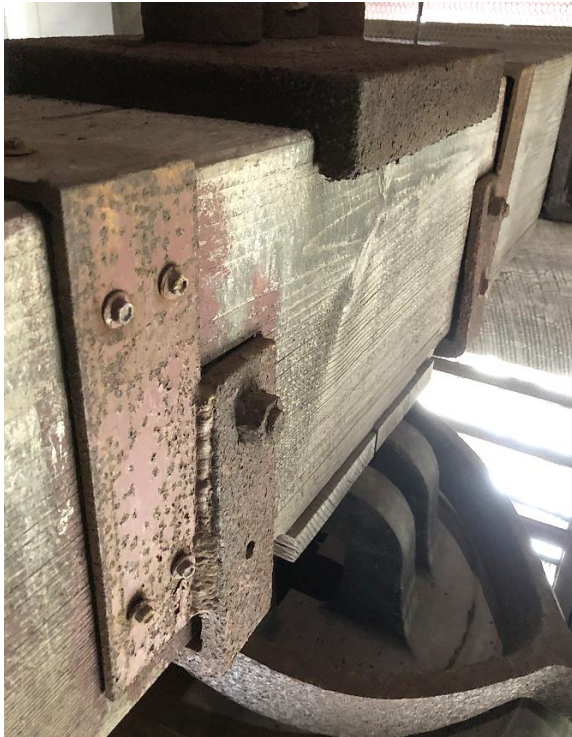
Figure 13: Bell Clapper support reinforcing.

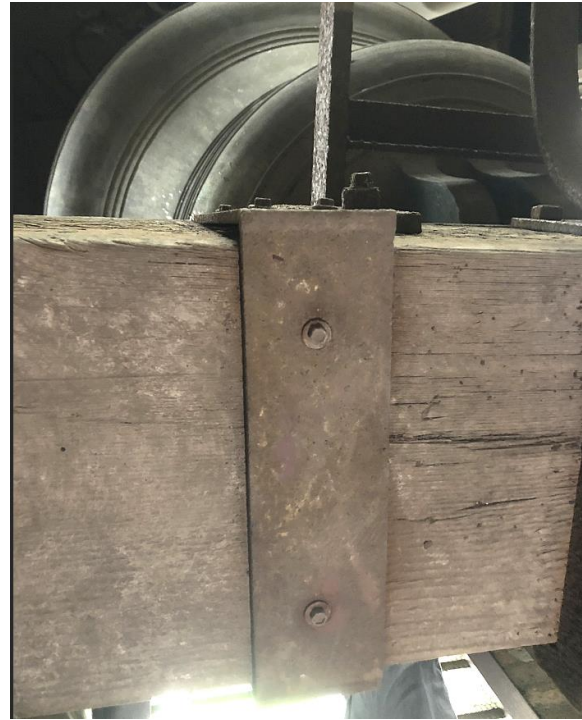
Figure 14: Bell Clapper support reinforcing top view.

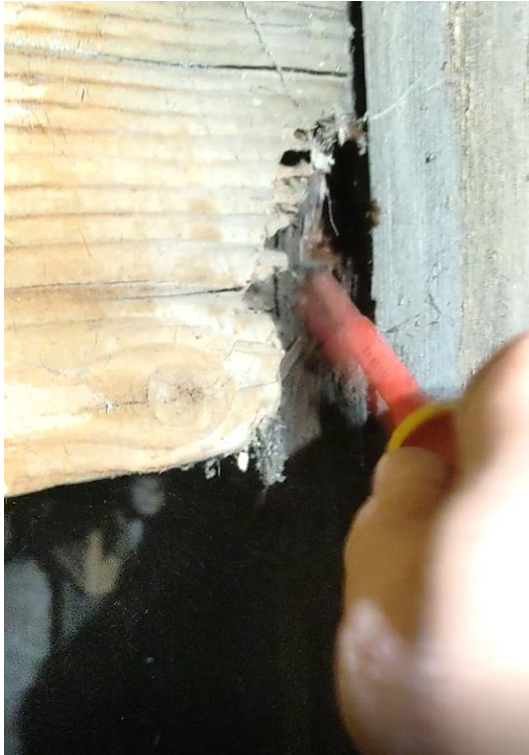
The function of the mid-height horizontal brace is to tie and stiffen the diagonal braces by tying them back to the flagpole. One of the braces has rotted through where bolted to the flagpole. Presumably, water has been running down the flagpole and collecting at this location leading to rot in the timber.

**Figure 15:** Rot in one of the horizontal braces where it is bolted to the side of the flagpole.

5	Flagpole and Braces on Level 6	One horizontal brace will need to be replaced to address the rot in the timber. The corrosion of the bolted connections does not appear severe but may be addressed as a preventative measure before further metal loss occurs.
6	Level 6 – Corroded Steel at Brick Dome	It is possible that the expansion of the steel plate at the top of the brick dome, resulting from its corrosion, has lifted the brickwork producing the crack observed from outside.  It is likely the expansion will continue until the corrosion is arrested.  To understand the extent of the corrosion, some pockets of bricks would need to be removed above the plate. This would be a difficult task due to the restricted space between the flagpole and the brickwork.

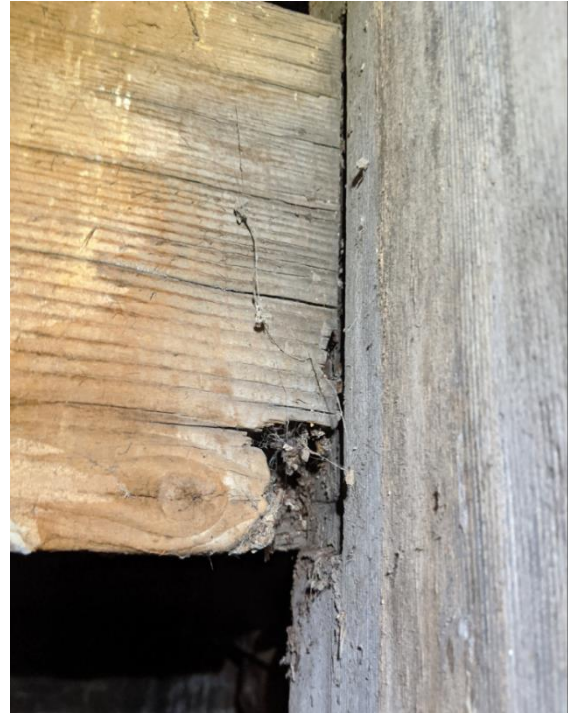
**Figure 16:** Rot in one of the horizontal braces

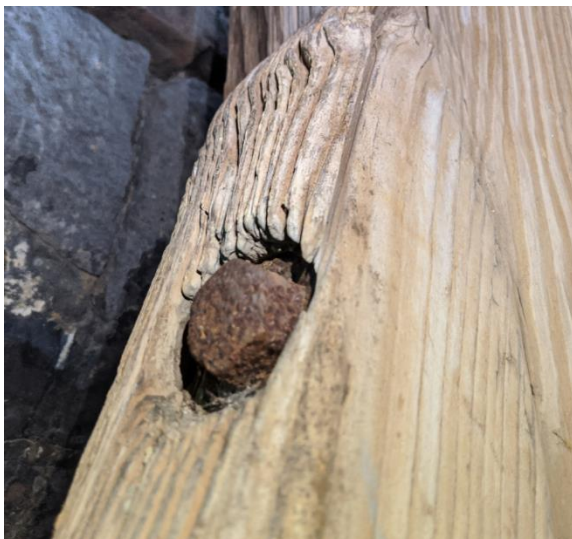
**Figure 17:** Bolt head pulled into the timber brace

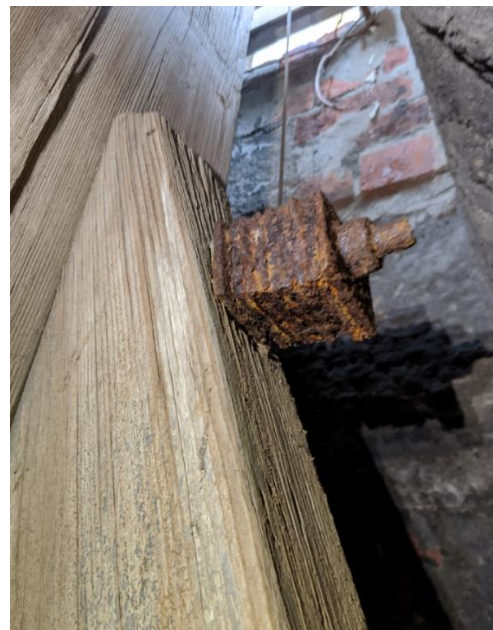
**Figure 18:** Corroded washers

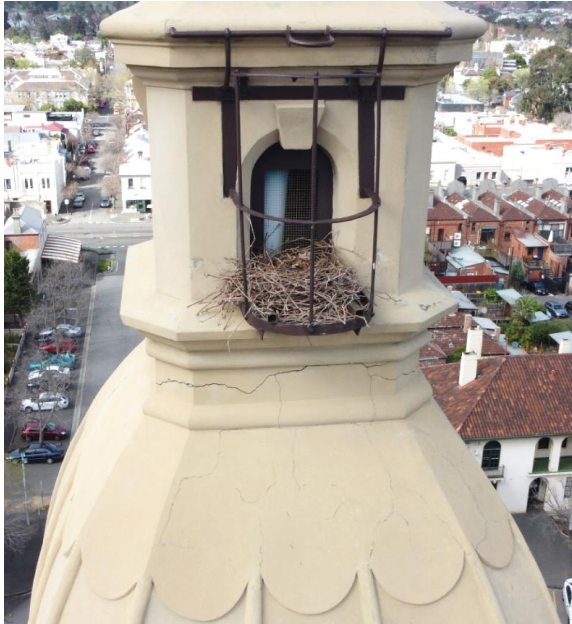
The top of the brick dome is capped with stone and the bricks laid to makeup the very top of the bell tower to which the crow's nest is attached. From inside the tower there is a crack above the stonework and below the brickwork. This appears to correspond with the crack observed in the drone footage provided by CPP. There is a steel plate on top of the stonework which has corroded.

**Figure 19: Crack at the top of the dome around the perimeter of the Bell Tower. North Elevation**

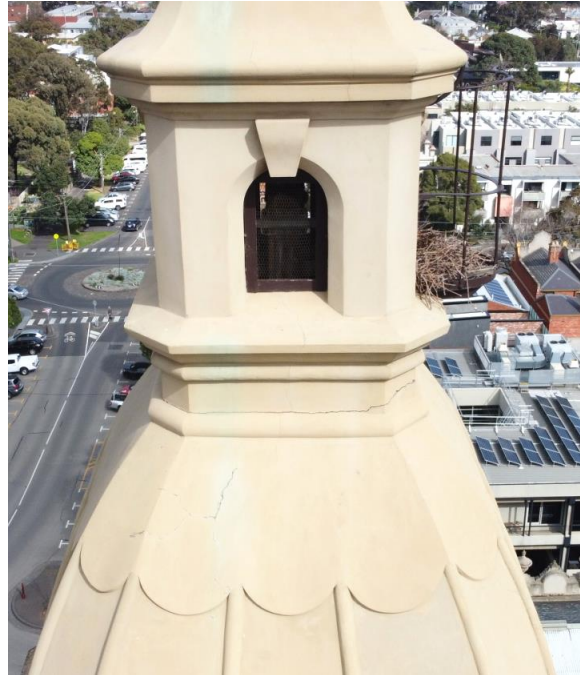
**Figure 20: East Elevation**

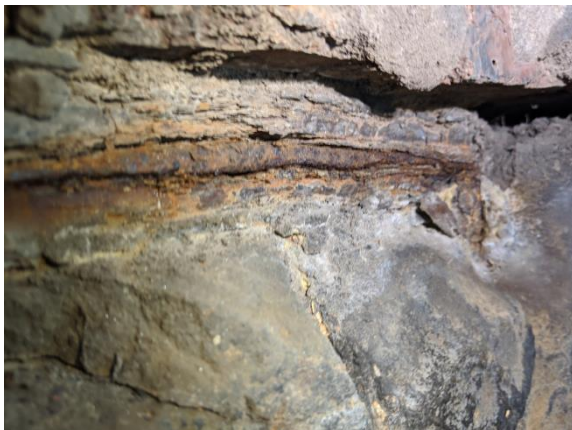
**Figure 21: Corroded steel plate between stone capping and brickwork**
