# Coles Car Park Alfred St. Tree Retention Survey

**Prepared for:** Jacob Vittorio,  
C/O City of Port Philip  
St Kilda Town Hall  
99a Carlisle Street,  
St Kilda, Victoria 3182

**Prepared by:** John Petrie  
Dip Arboriculture

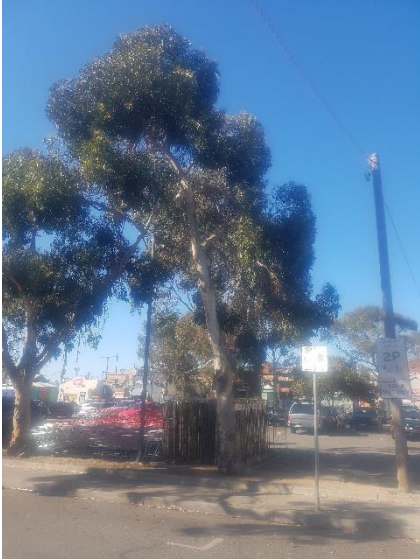
<b>No.</b>	1

<b>Botanical Name</b>	<i>Eucalyptus globulus</i>			
<b>Common Name</b>	Southern Blue Gum			
<b>DBH (cm)</b>	43	<b>Origin</b>		Native
<b>DARB (cm)</b>	56	<b>Health</b>		Fair
<b>Height / width</b>	9 x 9	<b>Structure</b>		Fair
<b>Tree A/Z</b>	A2	<b>ULE</b>		Medium
<b>TPZ (m)</b>	5.2			
<b>SRZ</b>	2.6	<b>Comments</b>		Deadwood in canopy, located beside storm water drain tree shows good response to pruning.
<b>10% of TPZ area (m<sup>2</sup>)</b>	3.5

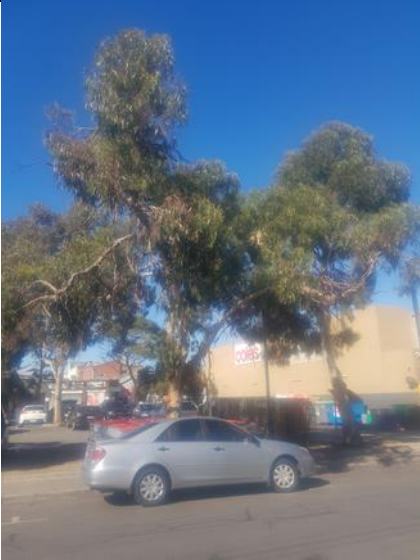
<b>No.</b>	2

<b>Botanical Name</b>	<i>Eucalyptus globulus</i>			
<b>Common Name</b>	Southern Blue Gum			
<b>DBH (cm)</b>	43	<b>Origin</b>		Native
<b>DARB (cm)</b>	54	<b>Health</b>		Fair
<b>Height / width</b>	9 x 10	<b>Structure</b>		Poor
<b>Tree A/Z</b>	Z5	<b>ULE</b>		Medium
<b>TPZ (m)</b>	5.2			
<b>SRZ</b>	2.6	<b>Comments</b>		Large scar on leader co-dominant branches
<b>10% of TPZ area (m<sup>2</sup>)</b>	3.5

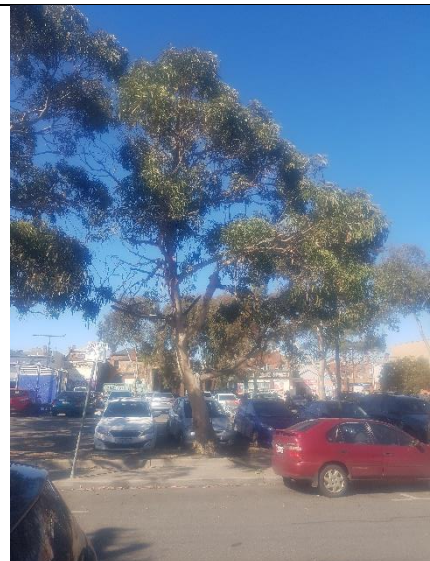
**No.** 4

**Comments** Deadwood, canopy thinning

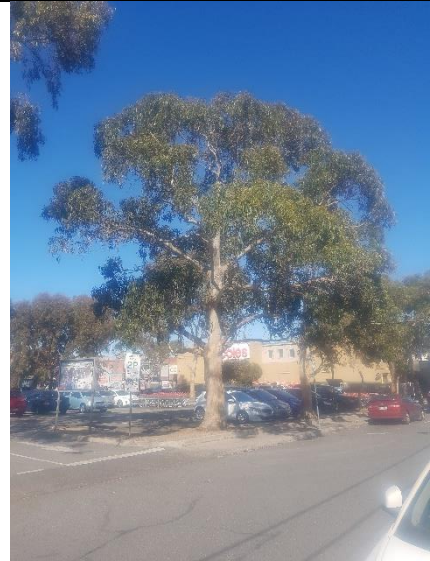
**No.** 5

**Comments** Sparse canopy. Deadwood

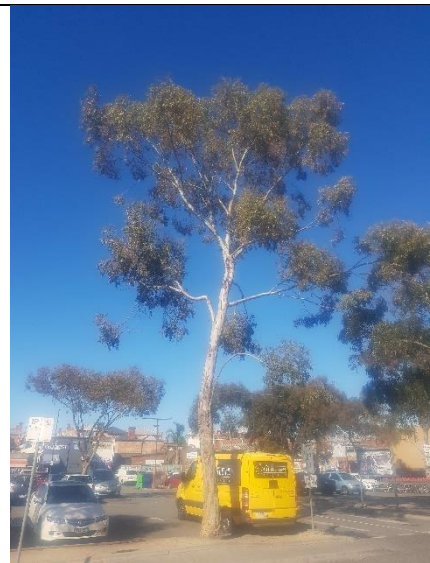
**No.** 6

**Comments** History of branch failure, Large tare-out on N.E. side

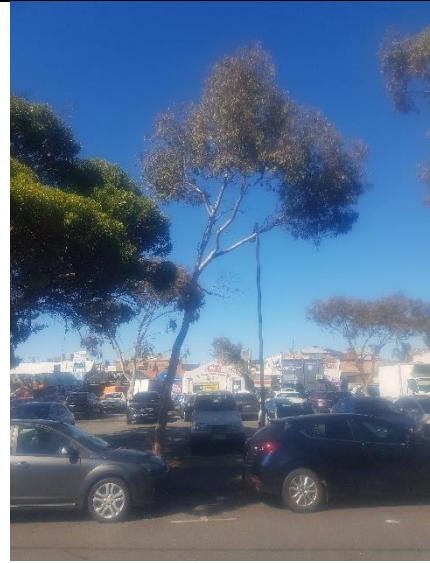
**No.** 7

**Comments** Deadwood.

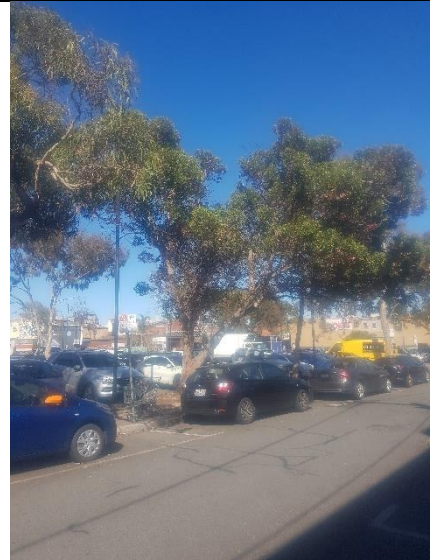
**No.** 8

**Comments** Deadwood. Old brick pit at base of tree

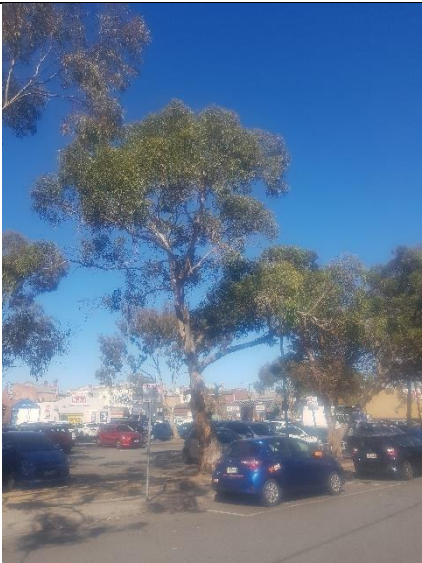
<b>No.</b>	9

<b>Botanical Name</b>	<i>Eucalyptus globulus</i>			
<b>Common Name</b>	Southern Blue Gum			
<b>DBH (cm)</b>	61	<b>Origin</b>		Native
<b>DARB (cm)</b>	71	<b>Health</b>		Fair
<b>Height / width</b>	10 x 12	<b>Structure</b>		Poor
<b>Tree A/Z</b>	25	<b>ULE</b>		Medium
<b>TPZ (m)</b>	7.3	<b>Comments</b>		Deadwood, girdling root, Large wound on center leader
<b>SRZ</b>	2.9			
<b>10% of TPZ area (m<sup>2</sup>)</b>	5

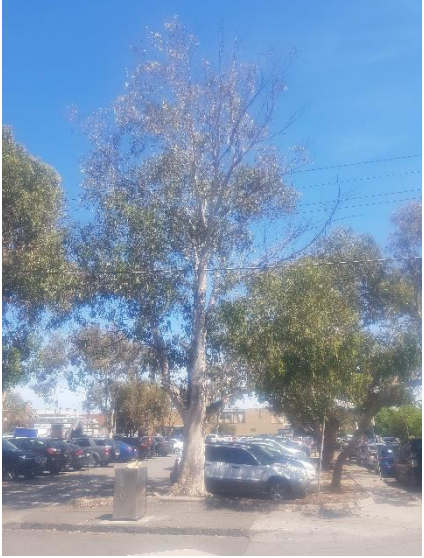
<b>No.</b>	11

<b>Botanical Name</b>	<i>Eucalyptus globulus</i>			
<b>Common Name</b>	Southern Blue Gum			
<b>DBH (cm)</b>	62	<b>Origin</b>		Native
<b>DARB (cm)</b>	74	<b>Health</b>		Poor
<b>Height / width</b>	12 x 10	<b>Structure</b>		Fair
<b>Tree A/Z</b>	A2	<b>ULE</b>		Medium
<b>TPZ (m)</b>	7.4			
<b>SRZ</b>	2.9	<b>Comments</b>		Deadwood, canopy thinning History of failure
<b>10% of TPZ area (m<sup>2</sup>)</b>	5.1

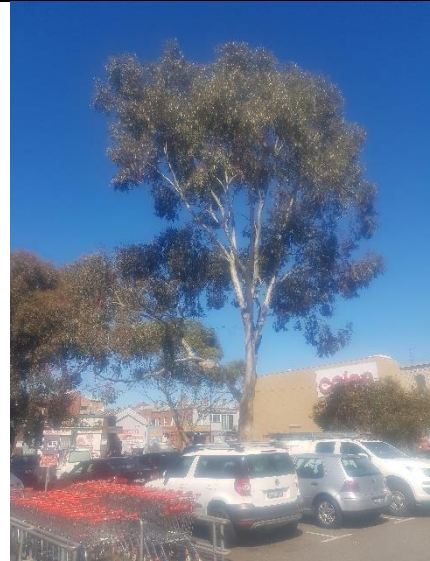
**No.** 13

**Comments** co-dominant branches

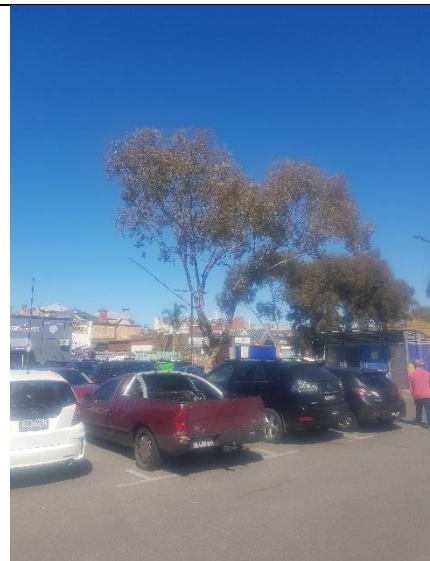
**No.** 14

**Comments** Sparse canopy deadwood

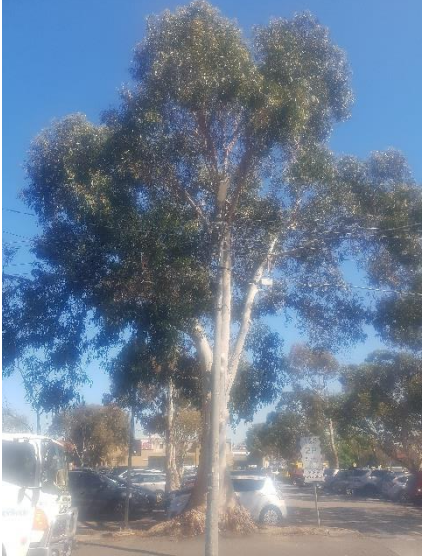
<b>No.</b>	17

<b>Botanical Name</b>	<i>Eucalyptus globulus</i>			
<b>Common Name</b>	Southern Blue Gum			
<b>DBH (cm)</b>	89	<b>Origin</b>		Native
<b>DARB (cm)</b>	108	<b>Health</b>		Fair
<b>Height / width</b>	12 x 11	<b>Structure</b>		Fair
<b>Tree A/Z</b>	A2	<b>ULE</b>		Long
<b>TPZ (m)</b>	10.7			
<b>SRZ</b>	3.4	<b>Comments</b>		Deadwood.
<b>10% of TPZ area (m<sup>2</sup>)</b>	7.3

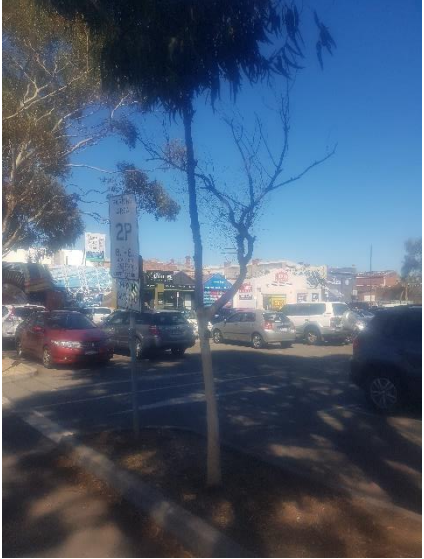
<b>No.</b>	18

<b>Botanical Name</b>				
<b>Common Name</b>	Dead			
<b>DBH (cm)</b>		<b>Origin</b>		
<b>DARB (cm)</b>		<b>Health</b>		Dead
<b>Height / width</b>	5 x 2	<b>Structure</b>		Poor
<b>Tree A/Z</b>	Z4	<b>ULE</b>		Remove
<b>TPZ (m)</b>				
<b>SRZ</b>	1.5	<b>Comments</b>		Dead. No hollows. Remove tree.
<b>10% of TPZ area (m<sup>2</sup>)</b>

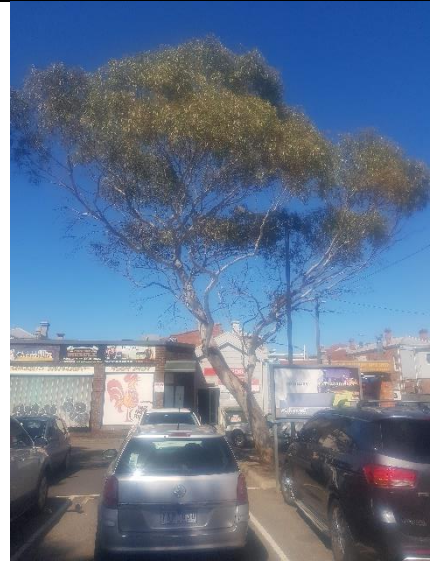
**No.** 19

**Comments** Deadwood, large exposed roots with some damage

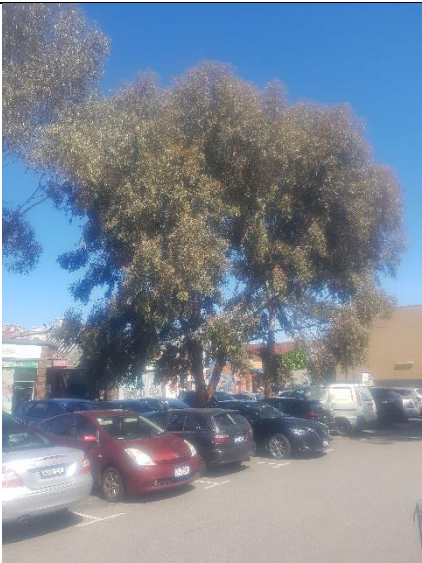
<b>No.</b>	21		
<b>Botanical Name</b>	<i>Eucalyptus melliodora</i>		
<b>Common Name</b>	Yellow Box		
<b>DBH (cm)</b>	43	<b>Origin</b>	Indigenous
<b>DARB (cm)</b>	47	<b>Health</b>	Fair
<b>Height / width</b>	10 x 10	<b>Structure</b>	Fair
<b>Tree A/Z</b>	Z1	<b>ULE</b>	Long
<b>TPZ (m)</b>	5.2		
<b>SRZ</b>	2.4	<b>Comments</b>	Small deadwood in canopy
<b>10% of TPZ area (m<sup>2</sup>)</b>	3.5

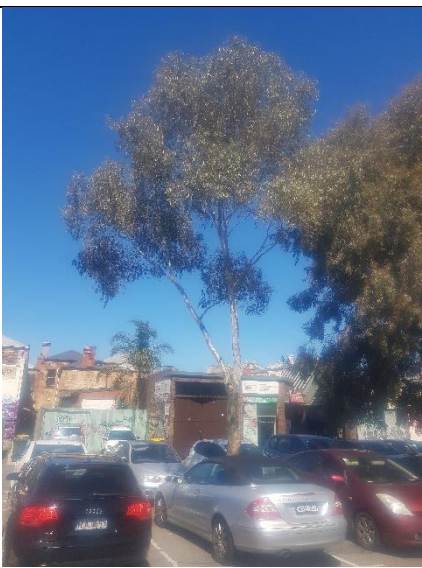
<b>No.</b>	22		
<b>Botanical Name</b>	<i>Eucalyptus leucoxylon</i>		
<b>Common Name</b>	Yellow Gum		
<b>DBH (cm)</b>	32	<b>Origin</b>	Native
<b>DARB (cm)</b>	36	<b>Health</b>	Fair
<b>Height / width</b>	10 x 9	<b>Structure</b>	Fair
<b>Tree A/Z</b>	Z5	<b>ULE</b>	Long
<b>TPZ (m)</b>	3.8		
<b>SRZ</b>	2.2	<b>Comments</b>	Co-dominant union in crown with compression fork, prune
<b>10% of TPZ area (m<sup>2</sup>)</b>	2.6

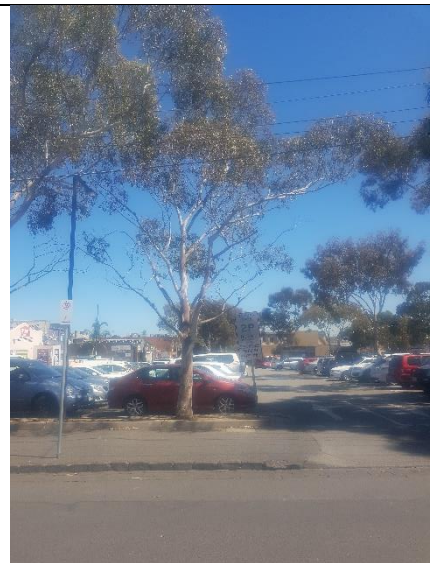
**No.** 24

**Comments** Deadwood.

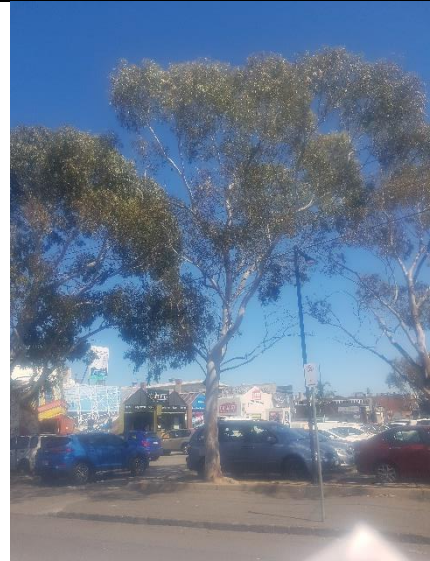
**No.** 25

**Comments** Deadwood.
