ARBORICULTURAL INSPECTION REPORT

BALACLAVA RETAIL RENEWAL AREA

NOVEMBER 2018

Arboricultural Inspection Report Balaclava Retail Renewal Area (39-47 Camden Street , Balaclava)

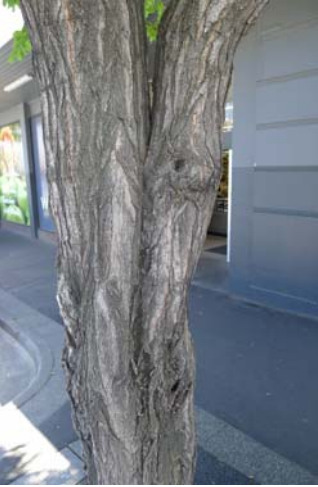
Photo 1 from south-east: Tree 1 bifurcation defect of stem

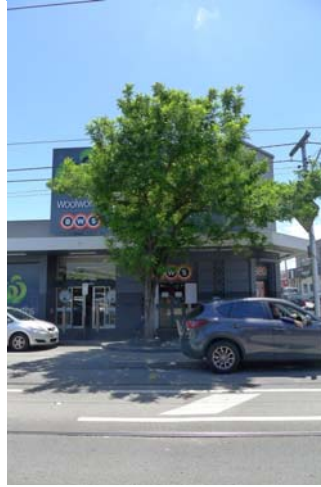
Photo 2 from south: Tree 1

| Tree # | SPECIES / COMMON NAME | AGE | DBH ¹ | HEIGHT x Width | HEALTH | STRUCTURE | DEFECTS ² | WORKS / ACTIONS | PRIORITY ³ | TPZ ⁴ | RETENTION VALUE | ORIGIN | COMMENTS |
|---|--|---|---|---|---|---|--|--|---|---|---|---|---|
| 1 | <i>Robinia pseudoacacia</i> Locust | Mature | 36cm | 7m x 6m | Good | Poor | Bifurcation defect of stem | Landscape treatment of planting area to reduce trip hazard | Medium | 4.32m | Low | Exotic (weedy) | Structural roots heaving pavement and causing a moderate to high risk trip hazard See Appendix 1 Photos 1, 2 & 3 |

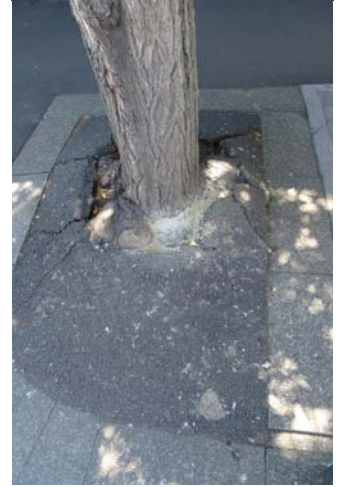
Note has been made regarding infrastructure interference developing from the structural roots (e.g. tree 1) of trees or trunk growth (e.g. tree 11).

Photo 3 from south: Tree 1 upheaval of hard surfaces around tree

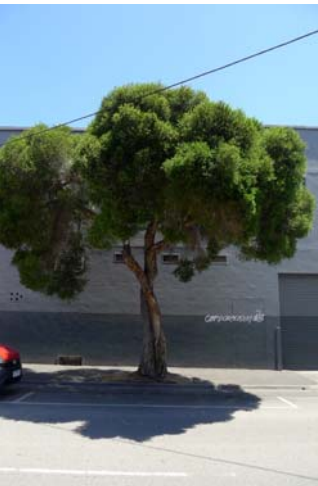
Photo 4 from east: Tree 2

| Tree # | SPECIES / COMMON NAME | AGE | DBH ¹ | HEIGHT x Width | HEALTH | STRUCTURE | DEFECTS ² | WORKS / ACTIONS | PRIORITY ³ | TPZ ⁴ | RETENTION VALUE | ORIGIN | COMMENTS |
|---|--|---|---|---|---|---|--|--|---|---|---|---|---|
| 2 | <i>Melaleuca armillaris</i> Bracelet Honey-myrtle | Mature | 35cm | 9m x 9m | Good | Poor | Bifurcation defects of stem, Vehicle impact wounds @ 2m roadside | Weight reduce canopy | Low | 4.2m | Medium | Vic Native | 2.2m wide footpath - 1.1 passable-slight tripping hazard. Poor species selection for narrow planting space. Stems naturally recline into vehicle or pedestrian space causing a hazard and requiring constant maintenance See Appendix 1 Photos 4, 5 & 6 (Multi-DBH (cm): 29 19) |

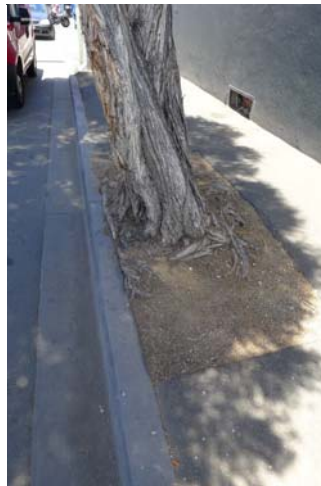
Photo 5 from north-east: Tree 2 narrow planting space

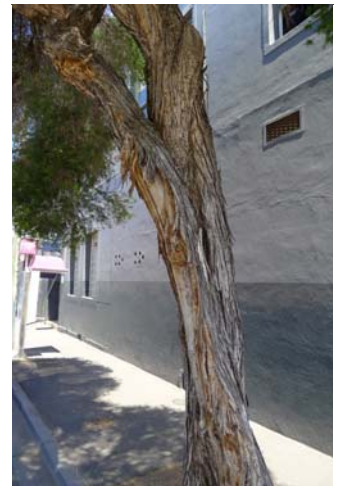
Photo 6 from north-east: Tree 2 vehicle impact damage to stem

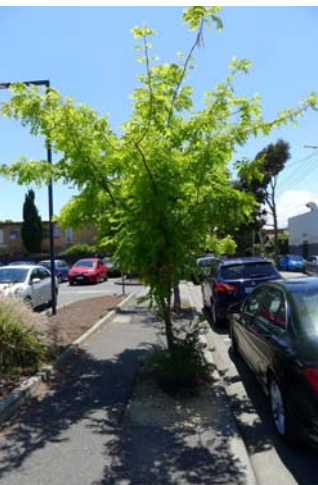
Photo 7 from south: Tree 3

| Tree # | SPECIES / COMMON NAME | AGE | DBH ¹ | HEIGHT x Width | HEALTH | STRUCTURE | DEFECTS ² | WORKS / ACTIONS | PRIORITY ³ | TPZ ⁴ | RETENTION VALUE | ORIGIN | COMMENTS |
|---|--|---|---|---|---|---|--|--|---|---|---|---|---|
| 3 | <i>Robinia pseudoacacia</i> Locust | Semimature | 7cm | 3m x 3m | Good | Poor | Bifurcation defects of stem | Clearance prune - pedestrians | Low | 2m | Medium | Exotic (weedy) | Poor stock, suckering at base See Appendix 1 Photo 7 (Multi-DBH (cm): 6,3) |

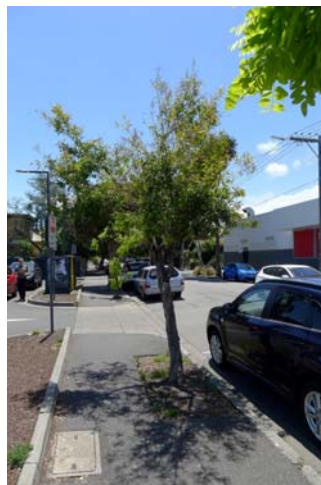
Photo 8 from south: Tree 4

| Tree # | SPECIES / COMMON NAME | AGE | DBH ¹ | HEIGHT x Width | HEALTH | STRUCTURE | DEFECTS ² | WORKS / ACTIONS | PRIORITY ³ | TPZ ⁴ | RETENTION VALUE | ORIGIN | COMMENTS |
|---|--|---|---|---|---|---|--|--|---|---|---|---|---|
| 4 | <i>Callistemon salignus</i> Willow Bottlebrush | Mature | 19cm | 4m x 3m | Fair | Poor | Broken stems/branches (possible vehicle impact or vandalism) | No works required | N/A | 2.28m | Low | Aus Native | See Appendix 1 Photos 8 & 9 |

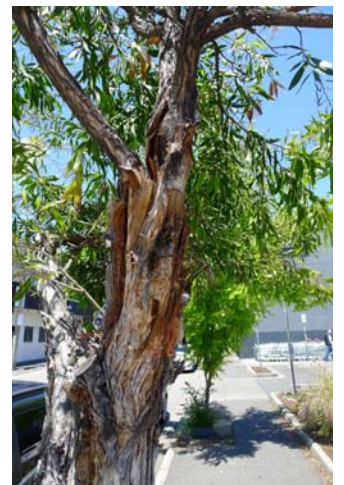
Photo 9 from north: Tree 4 broken stems

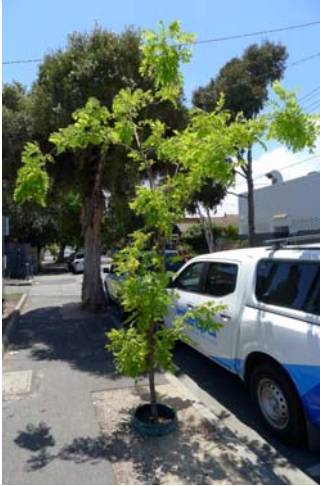
Photo 10 from south: Tree 5

| Tree # | SPECIES / COMMON NAME | AGE | DBH ¹ | HEIGHT x Width | HEALTH | STRUCTURE | DEFECTS ² | WORKS / ACTIONS | PRIORITY ³ | TPZ ⁴ | RETENTION VALUE | ORIGIN | COMMENTS |
|---|--|---|---|---|---|---|--|--|---|---|---|---|---|
| 5 | <i>Robinia pseudoacacia</i> Locust | Young | 4cm | 3m x 1m | Good | Poor | Broken branches | Formative prune | Low | 2m | Low | Exotic (weedy) | Poor stock. Thorns on stems - possibly rootstock has overgrown scion. Thorns become a hazard for pedestrians in future See Appendix 1 Photo 10 |

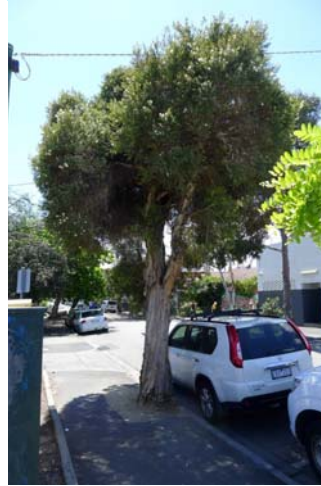
Photo 11 from south: Tree 6

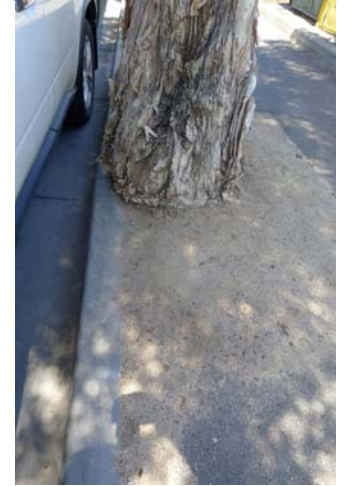
Photo 12 from north: Tree 6 stem has filled out planting space

| Tree # | SPECIES / COMMON NAME | AGE | DBH ¹ | HEIGHT x Width | HEALTH | STRUCTURE | DEFECTS ² | WORKS / ACTIONS | PRIORITY ³ | TPZ ⁴ | RETENTION VALUE | ORIGIN | COMMENTS |
|---|--|---|---|---|---|---|--|--|---|---|---|---|---|
| 6 | <i>Melaleuca linariifolia</i> Snow-in-Summer | Mature | 43cm | 7m x 7m | Fair | Fair | Minor or none noticed | No works required | N/A | 5.16m | Medium | Aus Native | Base of tree beginning to crack kerb. Stem has filled out planting space and will damage kerb in future See Appendix 1 Photos 11 & 12 |

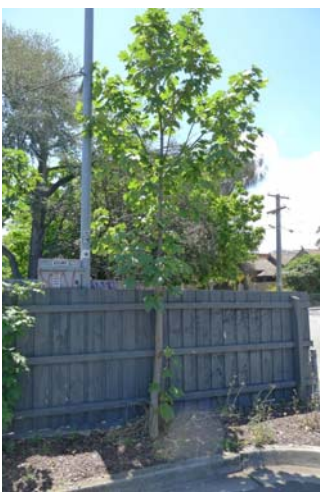
Photo 13 from south: Tree 7

| Tree # | SPECIES / COMMON NAME | AGE | DBH ¹ | HEIGHT x Width | HEALTH | STRUCTURE | DEFECTS ² | WORKS / ACTIONS | PRIORITY ³ | TPZ ⁴ | RETENTION VALUE | ORIGIN | COMMENTS |
|---|--|---|---|---|---|---|--|--|---|---|---|---|---|
| 7 | <i>Acer pseudoplatanus</i> Sycamore | Semimature | 7cm | 5m x 3m | Good | Good | Wounds in lower stem (stem failure wound) | No works required | N/A | 2m | Low | Exotic (weedy) | Weedy species possibly self-sown See Appendix 1 Photo 13 |

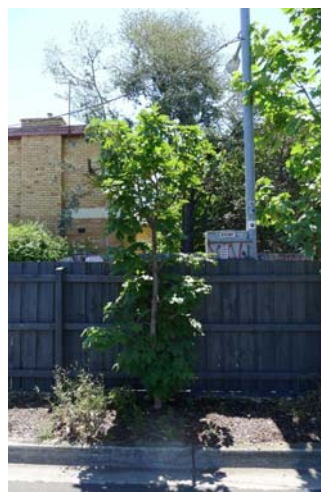
Photo 14 from south: Tree 8

| Tree # | SPECIES / COMMON NAME | AGE | DBH ¹ | HEIGHT x Width | HEALTH | STRUCTURE | DEFECTS ² | WORKS / ACTIONS | PRIORITY ³ | TPZ ⁴ | RETENTION VALUE | ORIGIN | COMMENTS |
|---|--|---|---|---|---|---|--|--|---|---|---|---|---|
| 8 | <i>Acer pseudoplatanus</i> Sycamore | Semimature | 5cm | 3m x 2m | Good | Good | Minor or none noticed | No works required | N/A | 2m | Low | Exotic (weedy) | Weedy species possibly self-sown See Appendix 1 Photo 14 |

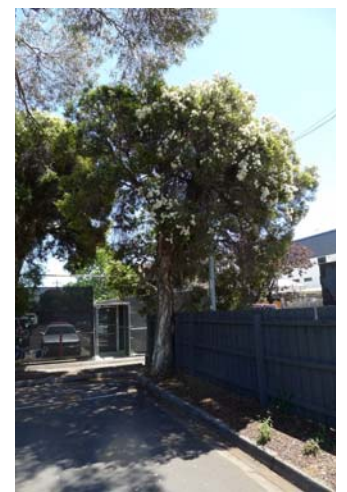
Photo 15 from southeast: Tree 9

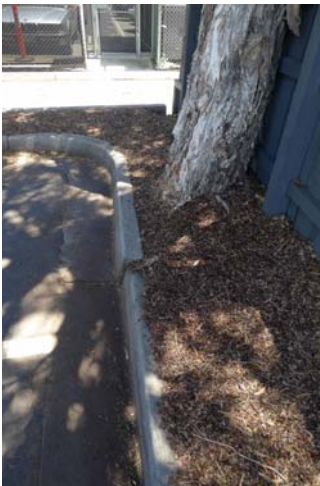
Photo 16 from southeast: Tree 9 kerb has moved due to structural root growth

| Tree # | SPECIES / COMMON NAME | AGE | DBH ¹ | HEIGHT x Width | HEALTH | STRUCTURE | DEFECTS ² | WORKS / ACTIONS | PRIORITY ³ | TPZ ⁴ | RETENTION VALUE | ORIGIN | COMMENTS |
|---|--|---|---|---|---|---|--|--|---|---|---|---|---|
| 9 | <i>Melaleuca linariifolia</i> Snow-in-Summer | Mature | 43cm | 9m x 8m | Good | Poor | Bifurcation of stem | Prune for clearance to street light | Medium | 5.16m | Medium | Aus Native | Approx. 1m wide planting strip, infrastructure damage occurring. See Appendix 1 Photos 15 & 16 |

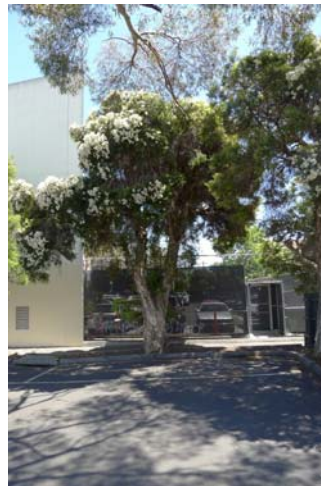
Photo 17 from east: Tree 10

| Tree # | SPECIES / COMMON NAME | AGE | DBH ¹ | HEIGHT x Width | HEALTH | STRUCTURE | DEFECTS ² | WORKS / ACTIONS | PRIORITY ³ | TPZ ⁴ | RETENTION VALUE | ORIGIN | COMMENTS |
|---|--|---|---|---|---|---|--|--|---|---|---|---|---|
| 10 | <i>Melaleuca linariifolia</i> Snow-in-Summer | Mature | 66cm | 9m x 9m | Good | Poor | Bifurcation defects of stem | No works required | N/A | 7.92m | Medium | Aus Native | Approx. 0.7m wide planting strip, infrastructure damage occurring See Appendix 1 Photo 17 |

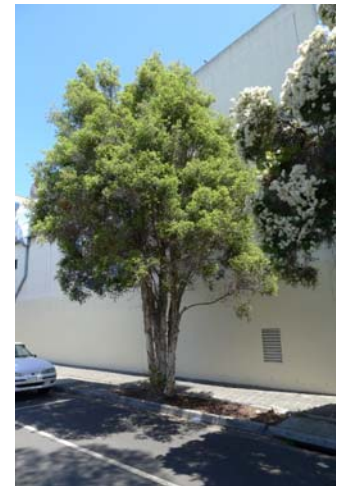
Photo 18 from north-east: Tree 11

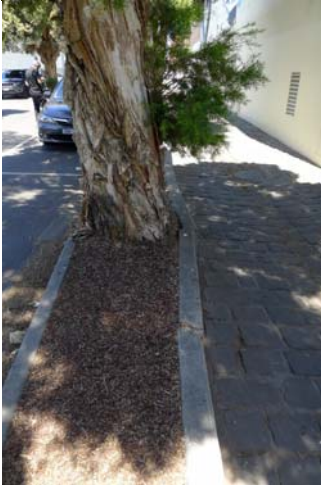
Photo 19 from north: Tree 11 stem has filled out planting space

| Tree # | SPECIES / COMMON NAME | AGE | DBH ¹ | HEIGHT x Width | HEALTH | STRUCTURE | DEFECTS ² | WORKS / ACTIONS | PRIORITY ³ | TPZ ⁴ | RETENTION VALUE | ORIGIN | COMMENTS |
|---|--|---|---|---|---|---|--|--|---|---|---|---|---|
| 11 | <i>Melaleuca styphelioides</i> Prickly-leaved Paperbark | Mature | 36cm | 8m x 6m | Fair | Fair | Bifurcation defects of stem | Weight reduce stems with bifurcations | Medium | 4.32m | Medium | Aus Native | Approx. 0.7m wide planting strip, infrastructure damage occurring. Stem has filled out planting space. See Appendix 1 Photos 18 & 19 (Multi-DBH (cm): 12,15,17,21,15) |

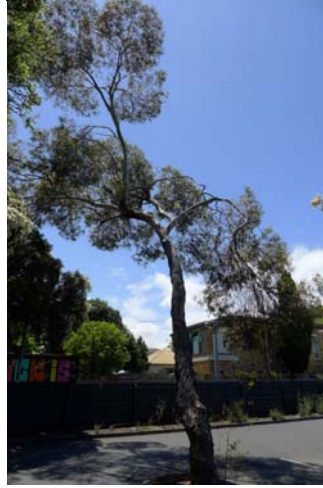
Photo 20 from south-west: Tree 12

| Tree # | SPECIES / COMMON NAME | AGE | DBH ¹ | HEIGHT x Width | HEALTH | STRUCTURE | DEFECTS ² | WORKS / ACTIONS | PRIORITY ³ | TPZ ⁴ | RETENTION VALUE | ORIGIN | COMMENTS |
|---|--|---|---|---|---|---|--|---|---|---|---|---|--|
| 12 | <i>Eucalyptus leucoxylon subsp. megalocarpa</i> Large-fruited South Australian Blue Gum | Mature | 44cm | 10-14m x 7m | Fair | Poor | History of branch failure, general poor form causing tree to be prone to branch failure, crossing branches | No works required | N/A | 5.28m | Medium | Aus Native | infrastructure damage occurring See Appendix 1 Photo 20 |

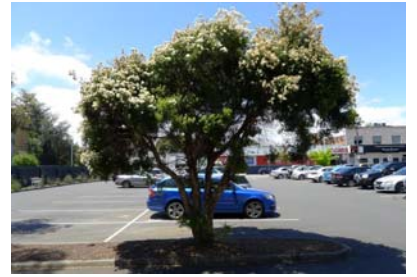
Photo 21 from west: Tree 13

| Tree # | SPECIES / COMMON NAME | AGE | DBH ¹ | HEIGHT x Width | HEALTH | STRUCTURE | DEFECTS ² | WORKS / ACTIONS | PRIORITY ³ | TPZ ⁴ | RETENTION VALUE | ORIGIN | COMMENTS |
|---|--|---|---|---|---|---|--|---|---|---|---|---|--|
| 13 | <i>Melaleuca linariifolia</i> Snow-in-Summer | Mature | 29cm | 4m x 4m | Fair | Poor | Bifurcations of stem | No works required | N/A | 3.48m | Medium | Aus Native | Multi-stemmed form not ideal for confined position See Appendix 1 Photo 21 (Multi-DBH (cm): 11,19,13,13) |

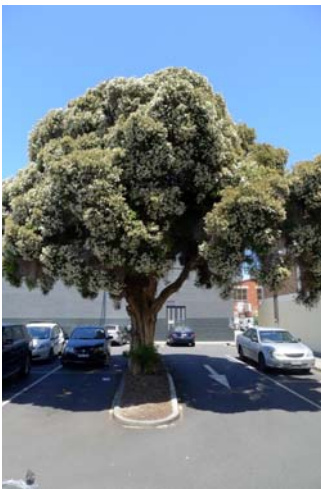
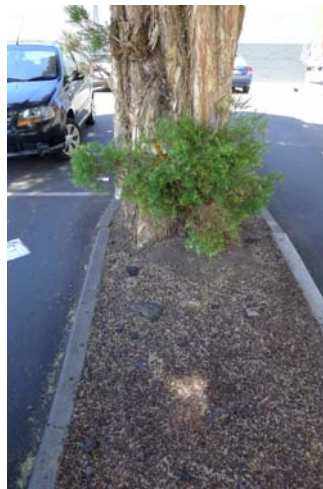
The large Melaleuca (tree 14) would be worth retaining if space can be allowed for in designs for the area. The tree however is fairly central to the car park and its retention may preclude reasonable development of the space.

Photo 22 from north: Tree 14

Photo 23 from north: Tree 14

| Tree # | SPECIES / COMMON NAME | AGE | DBH ¹ | HEIGHT x Width | HEALTH | STRUCTURE | DEFECTS ² | WORKS / ACTIONS | PRIORITY ³ | TPZ ⁴ | RETENTION VALUE | ORIGIN | COMMENTS |
|---|--|---|---|---|---|---|--|---|---|---|---|---|--|
| 14 | <i>Melaleuca linariifolia</i> Snow-in-Summer | Mature | 65cm | 10-14m x 13m | Good | Poor | Bifurcation defects of stem | Weight reduce stems with bifurcations | Medium | 7.8m | High | Aus Native | Approx. 1m wide planting strip, infrastructure damage occurring. Stem has filled out planting space and will continue damaging kerb in future. Largest and most likely oldest tree in the car park. See Appendix 1 Photos 22 & 23 |
