BUILDING ASSESSMENT AND DEVELOPMENT OF REMEDIAL STRATEGIES FOR SOUTH MELBOURNE TOWN HALL

Prepared for City of Port Phillip

April, 2020

Report Title: Building Assessment and Development of Remedial Strategies for South Melbourne Town Hall

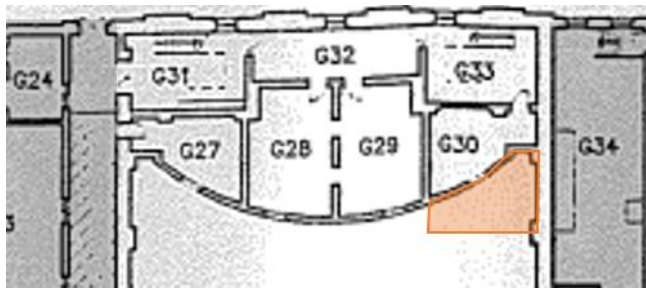
Figure 3 – Highlighted area of floor plan with subfloor deterioration.

Inspection of this area found the floor to be springy and to shift when loaded. Refer to the discussion on the dampness in rooms G27 to G33 in Section under the heading of “Walls” (Section 3.4.4).

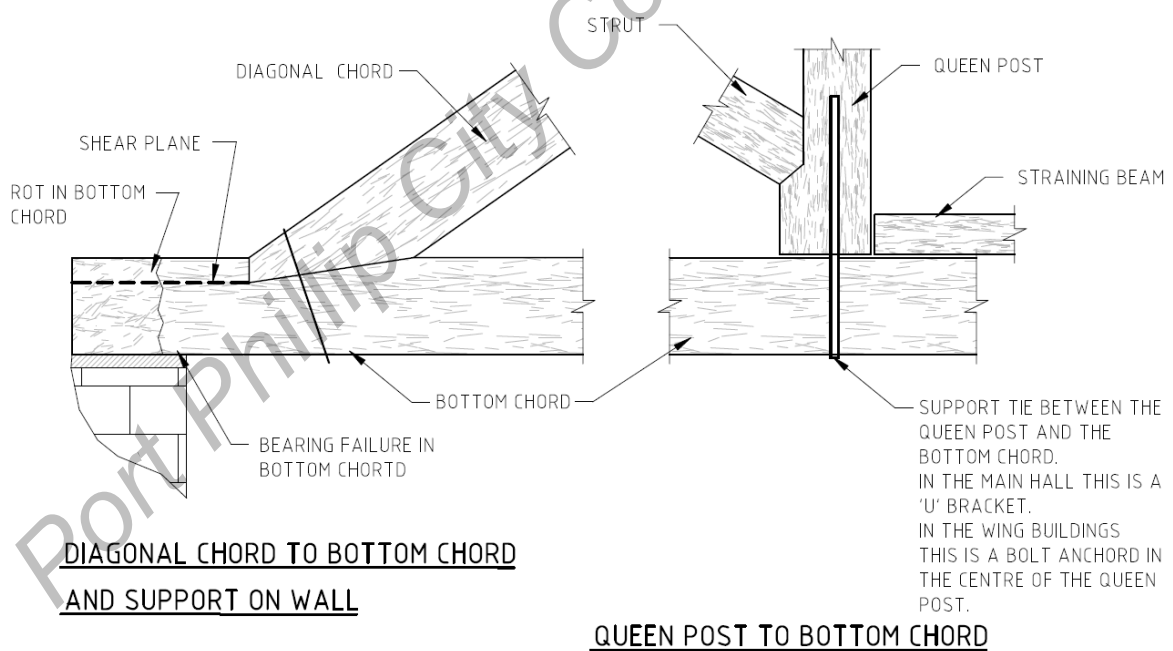
Figure 15. Bottom chord connection detail

With all trusses the connection of primary concern is where the diagonal meets the bottom chord as this is the most highly stressed connection and most susceptible to water damage from leaking gutters. Refer to the report of the trusses in the South Wing where it was possible to access this connection.

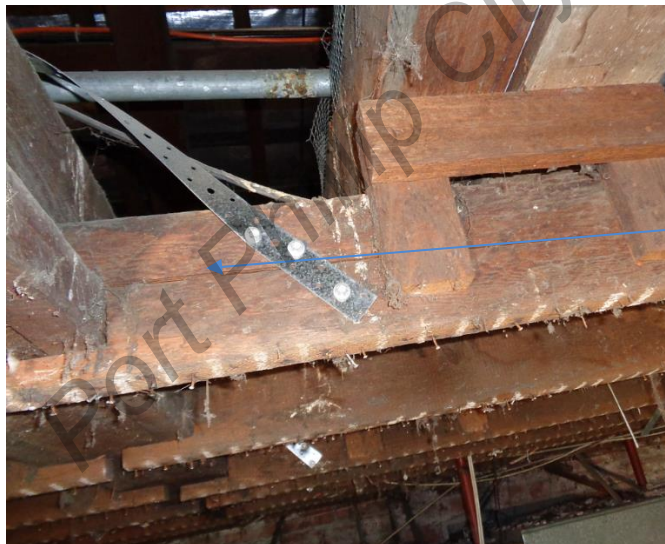
Figure 17. Notch in ceiling joist

The notch in the end of the ceiling joist reduces the shear capacity of the joist at the support. This has led to cracks in many of the ceiling joists.

A similar detail has been provided in the east and west wings.
