Bryce  
Raworth  
CONSERVATION | HERITAGE

# Schedule of Conservation Works

146 – 150 Bridport Street,  
Albert Park

VCAT P357/2023  
28 August 2024

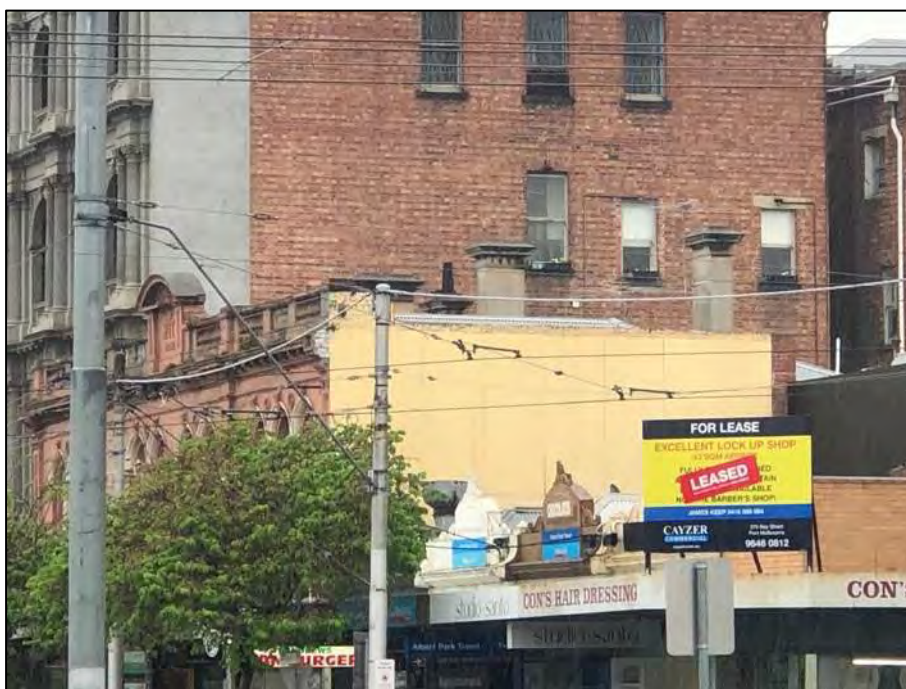
Figure 4 Original chimneys are visible in oblique views from the east.

- 8.1 Retained chimneys to be protected throughout the works and stabilised as required.
- 8.2 As required, repair and render chimneys, using the techniques outlined above for walls.
- 8.3 Fit new metal rain caps and flashing to existing chimneys to prevent water ingress.

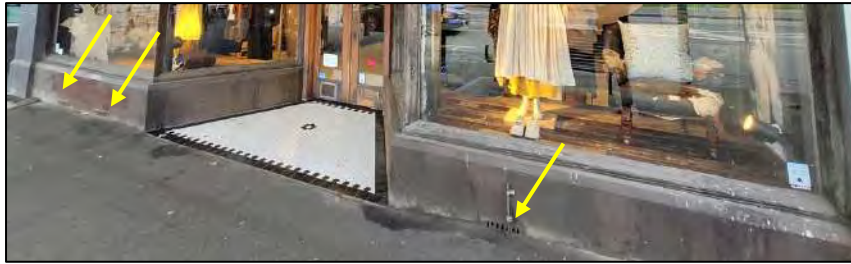
Figure 11 Half buried air vents.

- 2.5 Remove airconditioning unit.
- 2.6 Salvage and retain all cast iron air vents (refer section 5), and ensure provision is made for airflow.
- 2.7 Existing shop front to number 150 to be removed – refer to section 4 for details.

- 5.6 Repair and reinstate salvaged and restored cast iron vents to their original location. Repaint with a primer and two coat exterior enamel paint system to architect's specification.

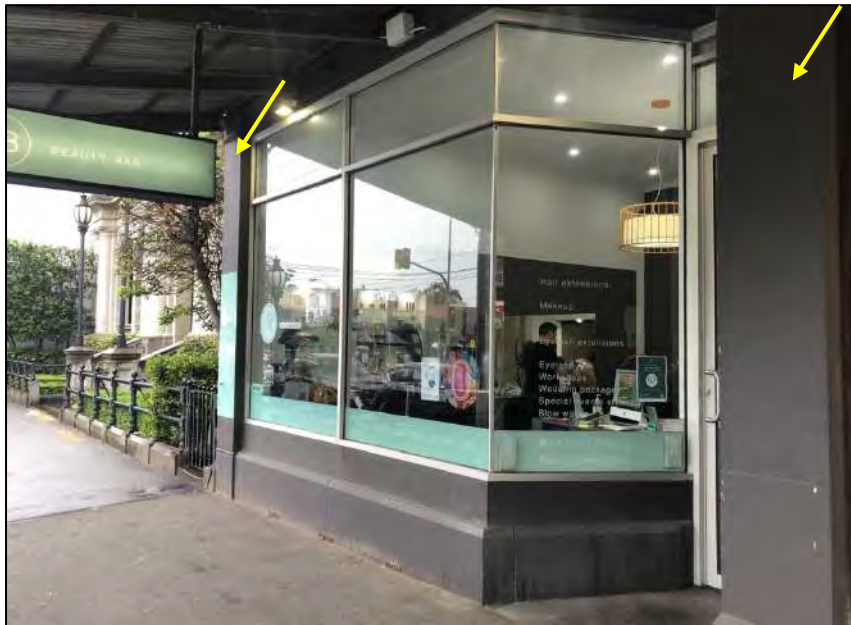
Figure 12 Existing shopfront to number 150. Granite to the pillar's to be retained, shop front to be demolished.

- 4.17 Demolish all elements of the existing shop front including shopfront frames, glazing, doors, signage and plinth.
- 4.18 Carefully demolish the infill slab to the ingo in order to investigate whether the original tiling to the floor of the ingo is still extant below. If tiles are extant restore as per the tiling to the shopfronts outlined below. If no tiles are extant replace with new concrete slab and finish to match the proposed finish for the apartment entry.
- 4.19 The granite pillars to either side are to be retained and restored.
- 4.20 New shopfront to ground floor as shown on the architect's drawings.

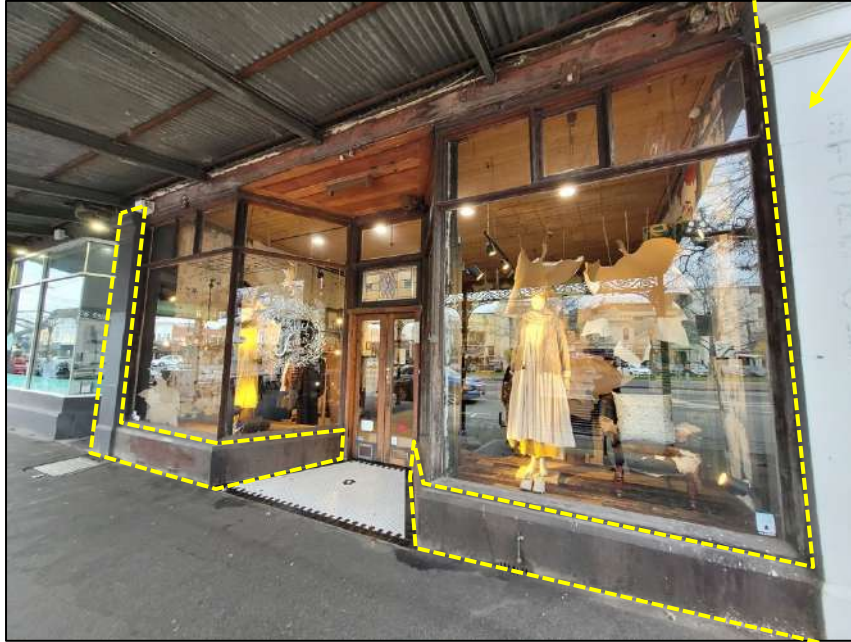
Figure 13 Existing shopfront to number 149 with the granite overpainted. Paint is to be removed and the granite restored.

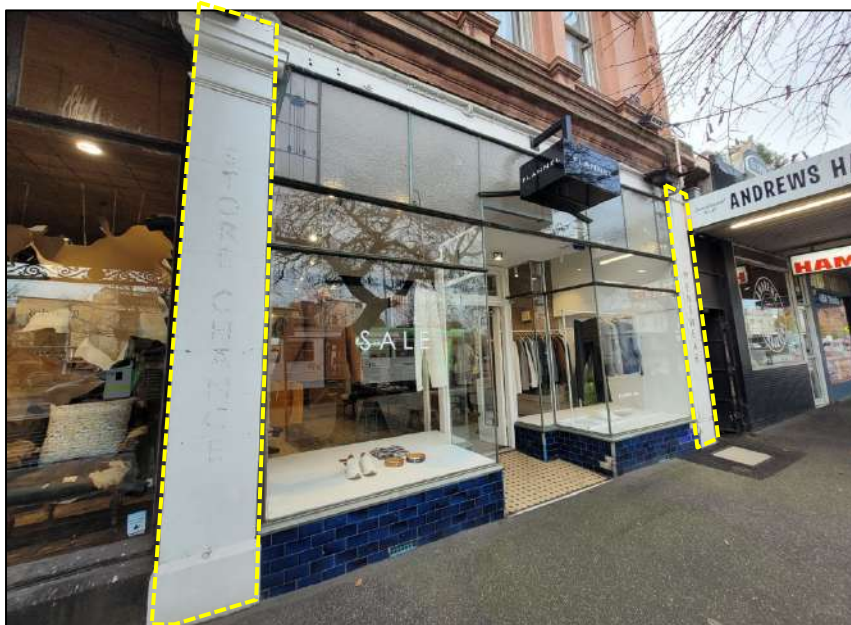
Figure 14 Existing granite pillars to number 146 that have been overpainted. Paint is to be removed and the granite restored.

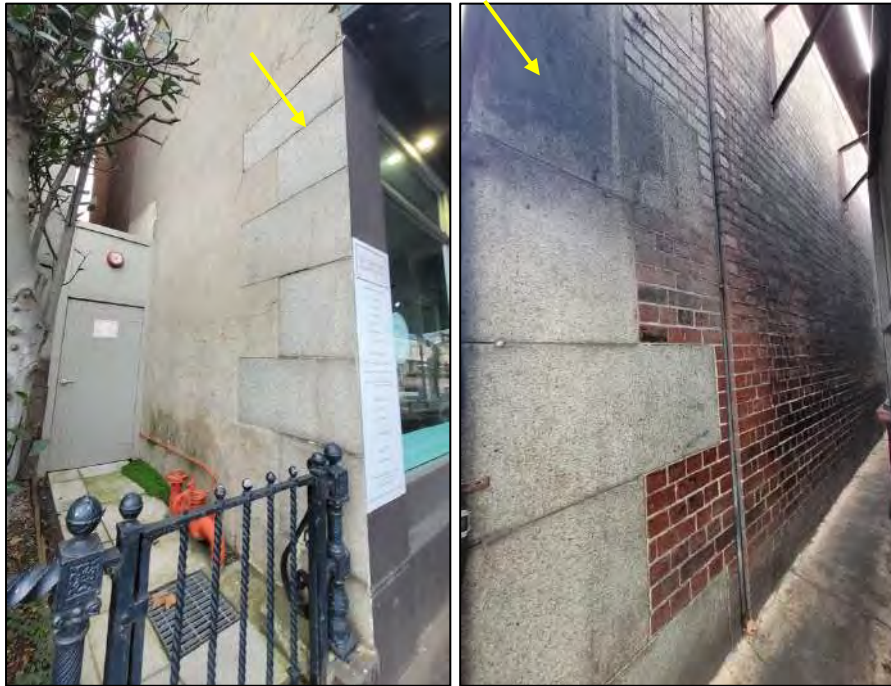
Figure 15 The existing granite to both side elevations, to be cleaned and mortar renewed.

- 3.14 Rake out and repoint (to match the original pointing and strike) all brickwork and granite to gain a consistent presentation. Degraded/loose mortar is to be raked out to a minimum depth of 20mm. New mortar is to be coloured to match existing. New mortar is to be coloured to match existing.

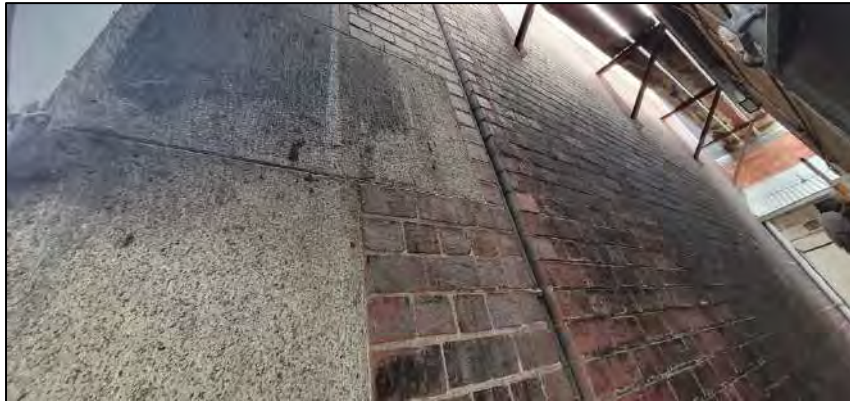
Figure 16 Detail view of the existing brickwork to the side elevation.

- 3.11 Repair the brickwork to the retained side elevation including associated damage and fabric losses (holes etc) using traditional repair techniques and compatible, low strength mortars. Where bricks are missing or damaged or penetrations for services have been introduced the bricks are to be replaced using bricks salvaged from the demolished parts of each respective building provided they are in sound condition and are an exact match. If required, holes in bricks are to be filled using a soft (hydrated) lime mortar mix coloured to match the existing brickwork using brick dust.

- 3.12 Replace heavily decayed bricks to match existing from the salvaged portions of bricks.
- 3.13 As an option, investigate potential for removal of part render finish to the west elevation, with reinstatement of a brick face.

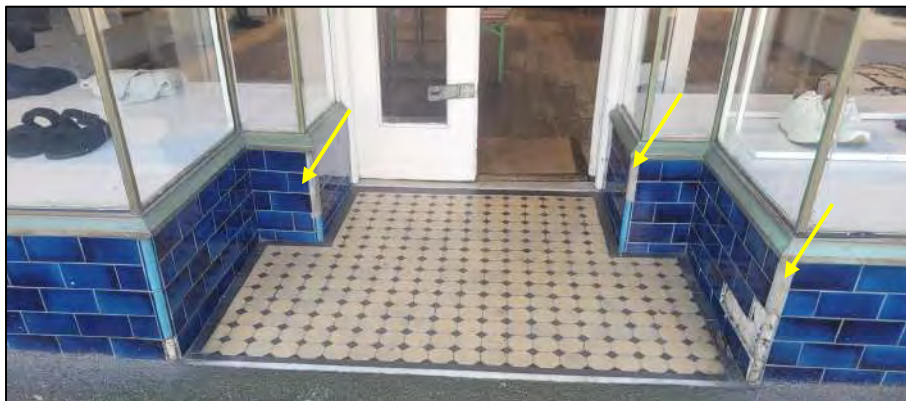
Figure 17 Detail view of the tiles to shopfront plinth and the shop ingo floor to be retained and restored.

- 4.21 Ensure tiles are protected throughout construction as outlined above.
- 4.22 Gently clean the tiles to remove surface deposits, glue remnants from signage, grime etc using PH neutral detergent. Wire, wool or other hard abrasive cleaning pads are not to be used. Small tests should be undertaken in discreet sections of the façade to the heritage consultant's approval to establish the efficacy of the tile cleaning methods and their safety for use.
- 4.23 Areas of localised damage and missing tiles are to be replaced with sourced second hand or reproduction tiles.
- 4.24 Tiles are to be inspected by a specialist tiling contractor to ensure any loose or degraded grouting is appropriately replaced and that the tiles are appropriately secured.

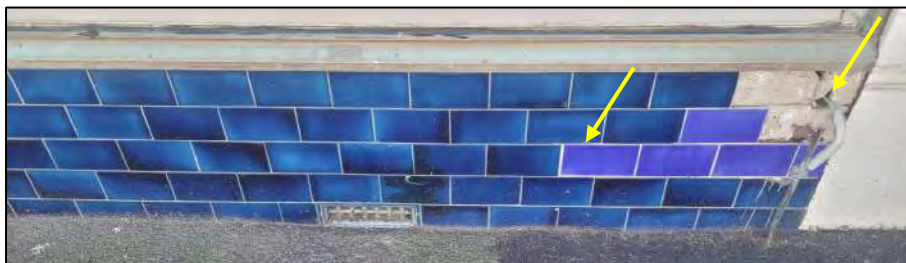
Figure 18 Detail view of the tiles to the shop plinth to be retained and restored including replacement of the non-matching tiles.

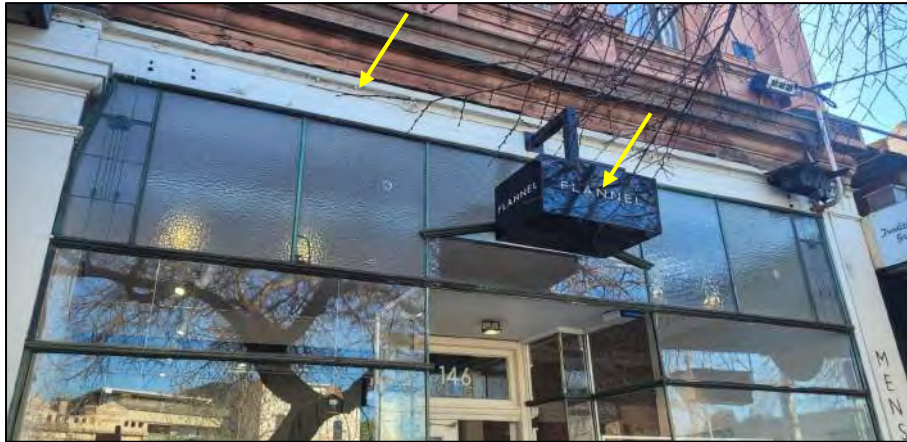
Figure 19 Detail view of the metal verandah bracket to be retained and non-original sign to be demolished.

- 4.11 Demolish the following:
- Non-original sign.
  - Non-original light fittings and conduit.
- 4.12 Salvage/retain the following elements:
- Tiles to the shopfront plinth.
  - Copper shopfronts including high level lead light and patterned glazing.
  - Ceiling to the ingo.
  - Tiling to the ingo.
  - Timber shop doors including high level window.
  - Metal support bracket for the verandah.
- 4.13 Restore the retained shopfront elements, refer below (section 4.21-24) for the tiles.

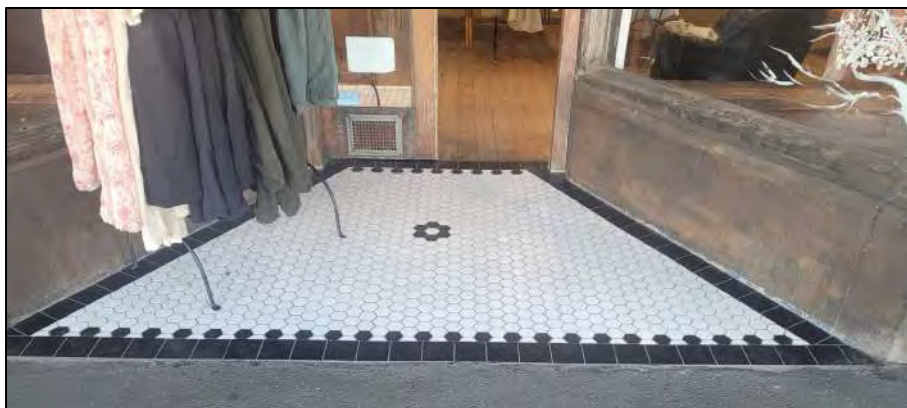
Figure 20 Detail view of the tiles to shop ingo floor to be retained and restored.

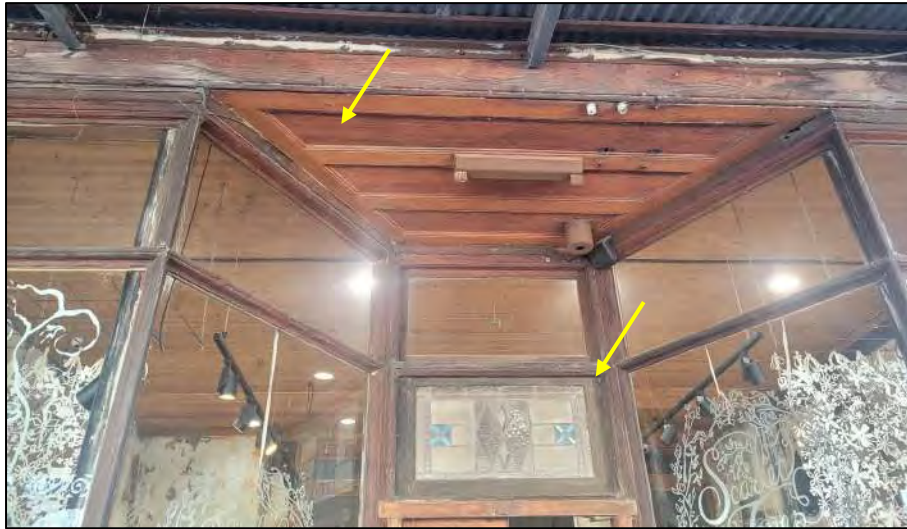
Figure 21 Detail view of the tiles to the shop ingo ceiling and leadlight windows to be retained and restored.

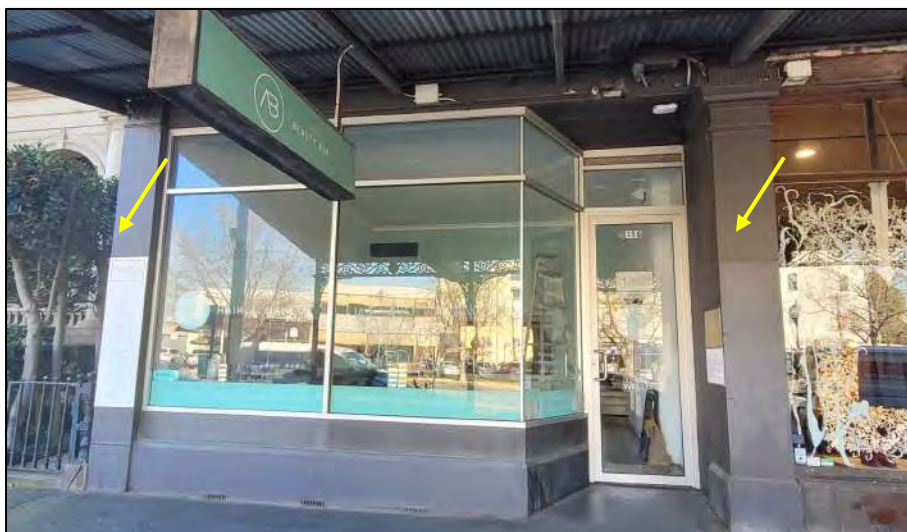
Figure 22 View of the granite pillars including mouldings to either side of shop 150 to be retained and restored.

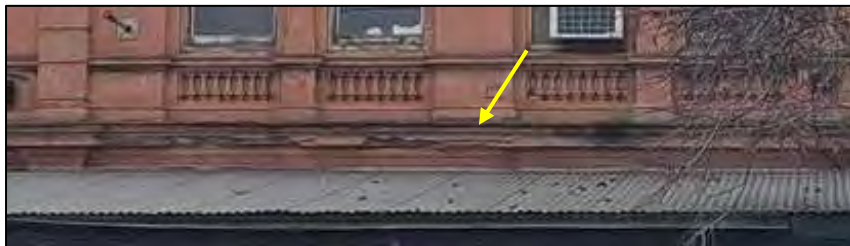
Figure 23 Detail view of the damaged render to string course.

- 5.1 No prefabricated mouldings or other off-the-shelf architectural items are to be used. Fabrication of replacement mouldings should be based on those that are extant.
- 5.2 The string course above the verandah has extensive weather damage and requires significant repair work. Cut back heavily damaged areas and repair using traditional techniques (generally as in 3.7 above) to fair face finish and to match original.

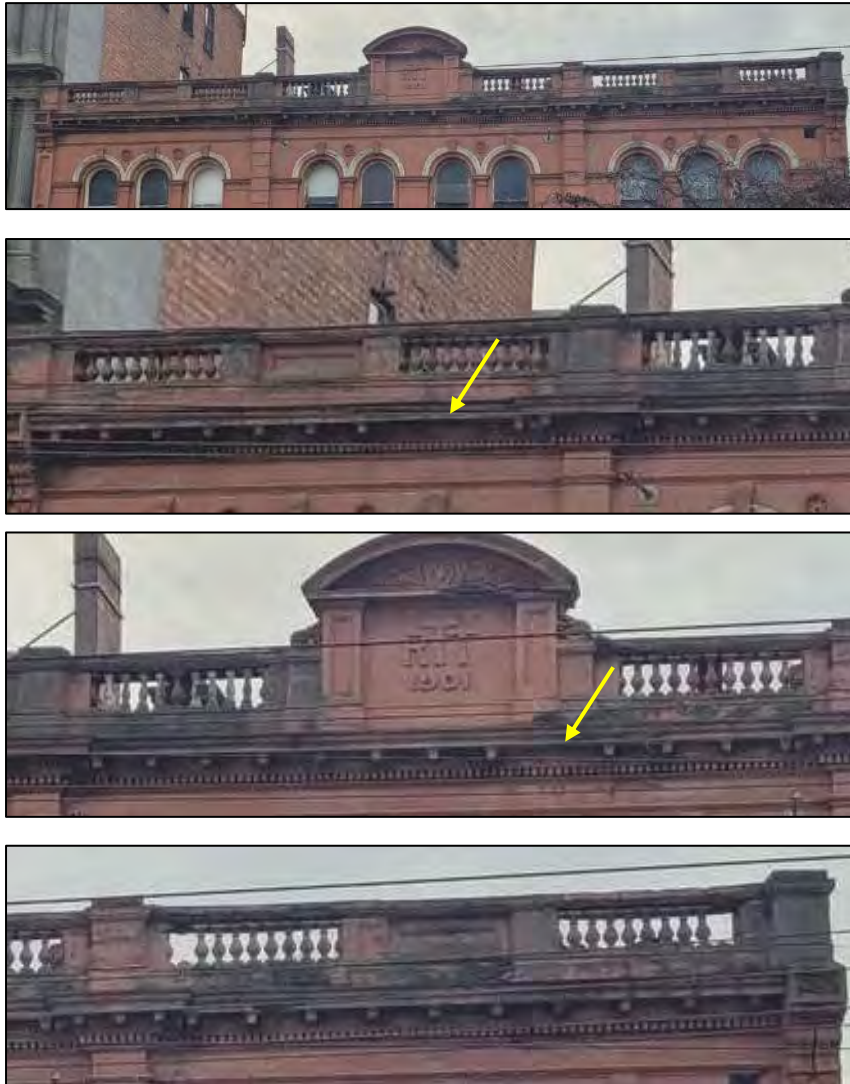
- 5.3 The parapet baluster is in poor condition and requires extensive repairs. The initial suggestion based on a site inspection is to remove the balusters and parapet moulding in order to undertake the necessary repairs and restoration. It is possible engineering advice may be required in terms of the stability of the parapet. All detailing is to be replaced to match the original. Reconstruct the baluster based on the existing.
- 5.4 Replace missing dentils.

Figure 24 Detail view of the general render repairs to parapet baluster and detailing.

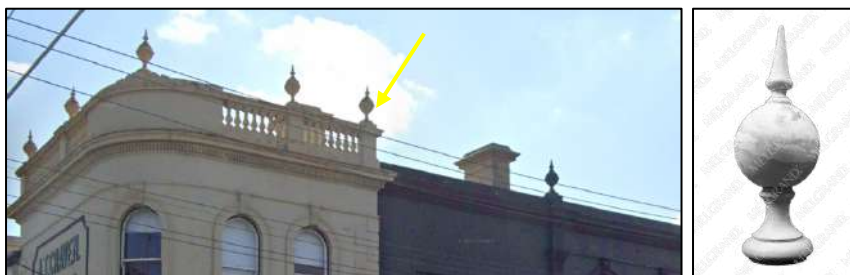
Figure 25 (left) Example of the orbs to be reinstated at 134 Bridport Street and the adjacent shops. (right) example of an orb from Melgrand.

- 5.5 Reinstall parapet urns/orbs to either side (refer to 134 Bridport Street and adjacent shops for precedent urns upon which those to the subject site can be based).  
- refer to Hopkins Plaster Studio or Melgrand

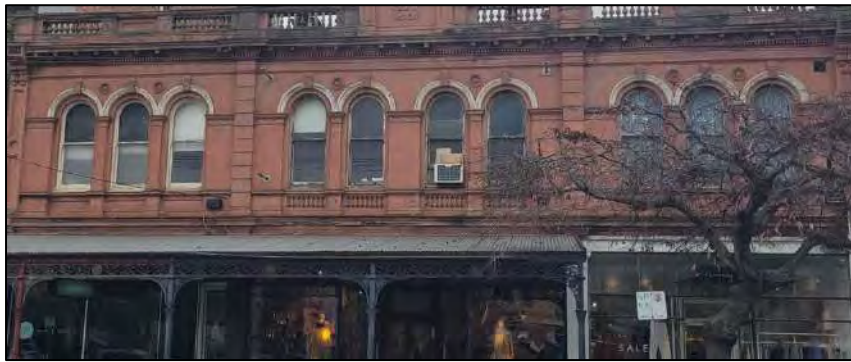
Figure 26 View of the first floor timber windows.

- 6.1 Retain existing double-hung timber-framed windows and joinery where possible or where otherwise indicated. Make good window joinery and glazing as required. Ensure all double-hung timber-framed sashes are operable where practicable. If double glazing is required, augment the existing frames internally. Any windows that cannot be repaired and require replacing are to match the existing.
- 6.2 Remove loose/flaking paint to provide sound, even surface for refinishing (refer section 7.1), and fill holes in existing timber joinery prior to the application of a priming coat.

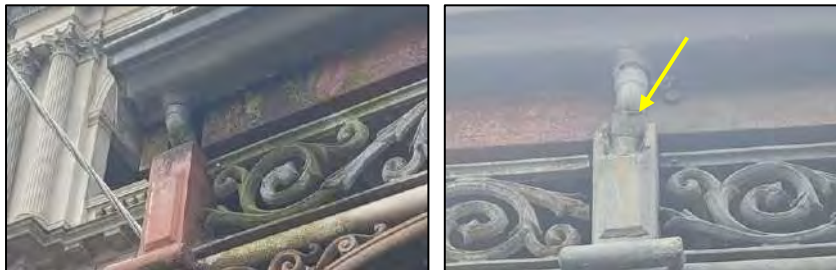
Figure 27 Detail of the downpipes inserted into the verandah column; note the damage to column in the image to the right.

- 4.5 Damage from the crudely inserted down pipes to the verandah columns is to be made good – the original/traditional stormwater function is to be recovered.

- 7.1 No gutters or rainwater goods are visible due to the parapet. All services to be concealed to prevent damage to the retained heritage fabric.
- 7.2 Prepare a scheme for a rationalised system that retains rainwater heads and downpipes in their original locations only, non-original locations are to be removed and the associated damage made good. Including the verandah.
- 7.3 Verandah downpipes have been inserted into the columns, make good damage and detail appropriately.
