PHOTOGRAPHIC RECORD

Project: Detailed Site Investigation – 46-58 Marlborough Street, Balaclava, Victoria

Reference: 991.4

Date: 23 May 2020

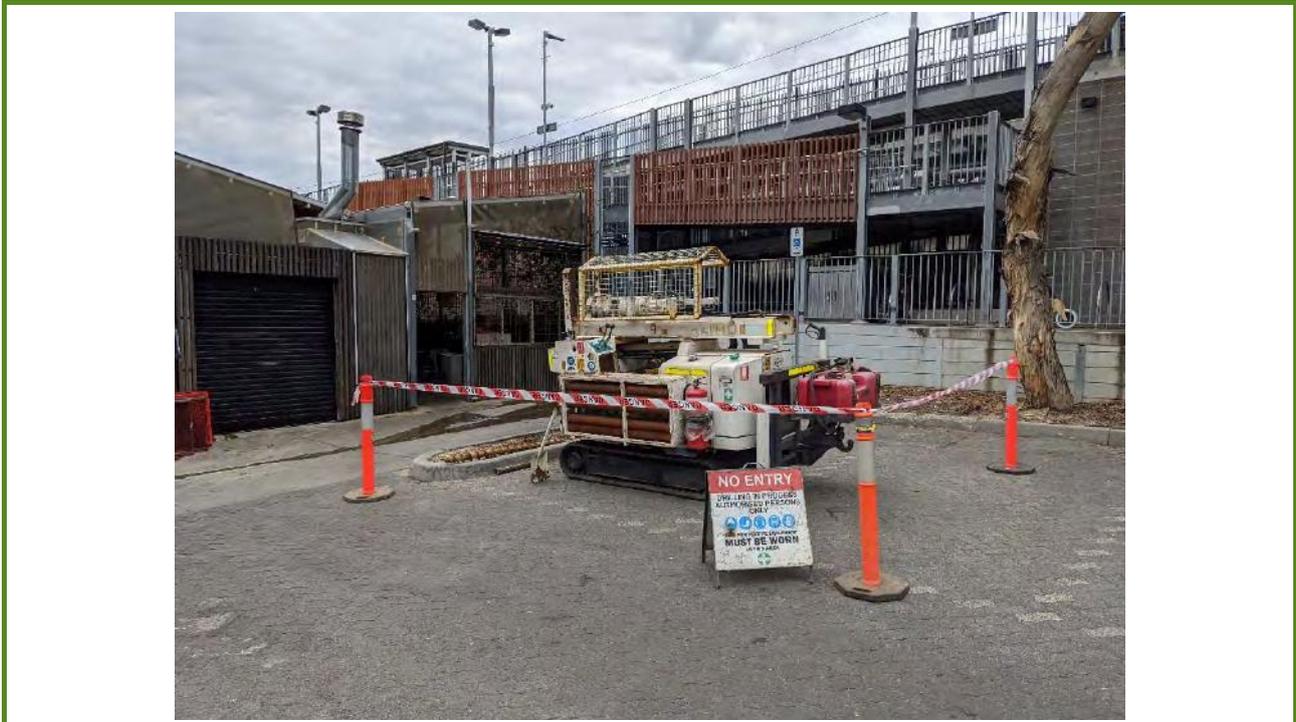
Photo ID: 1 – Drilling works being conducted in the north east of the site

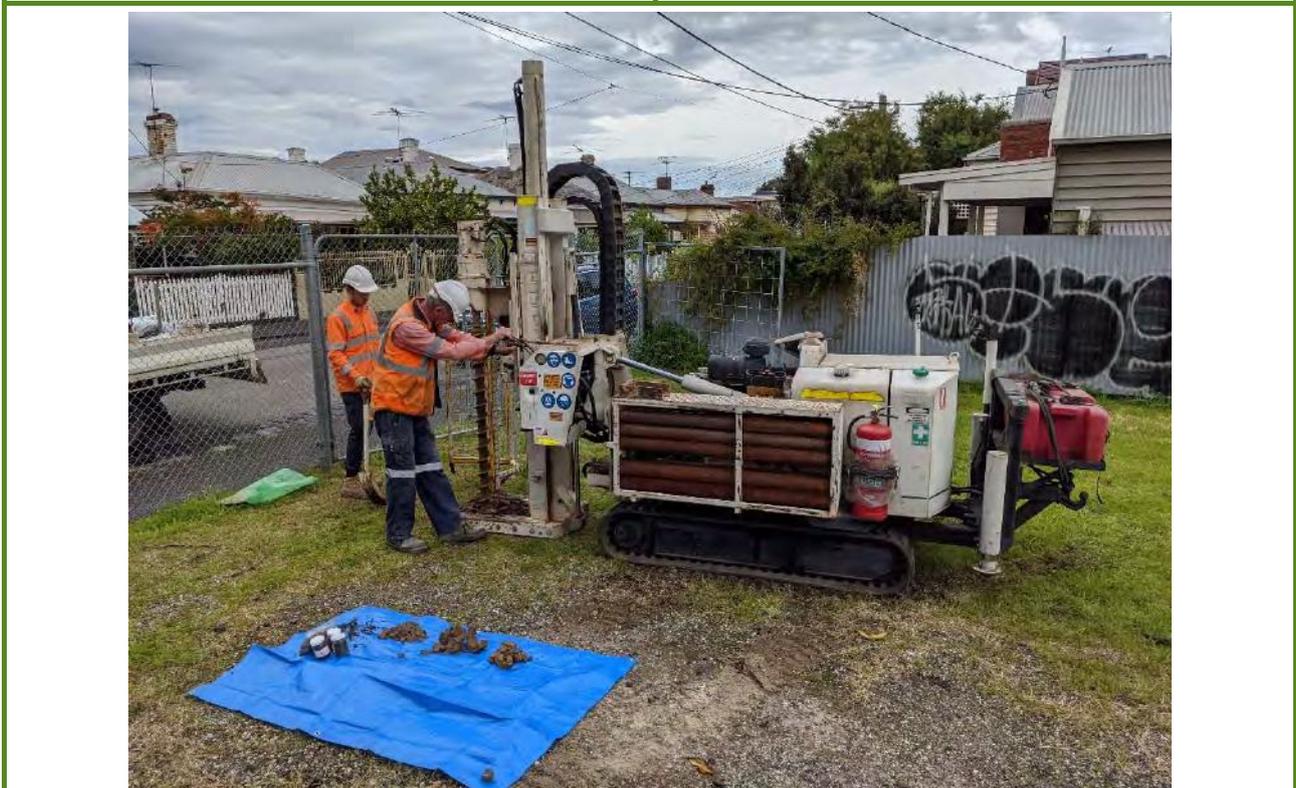
Photo ID: 2 – Drilling works being conducted in the south west of the site

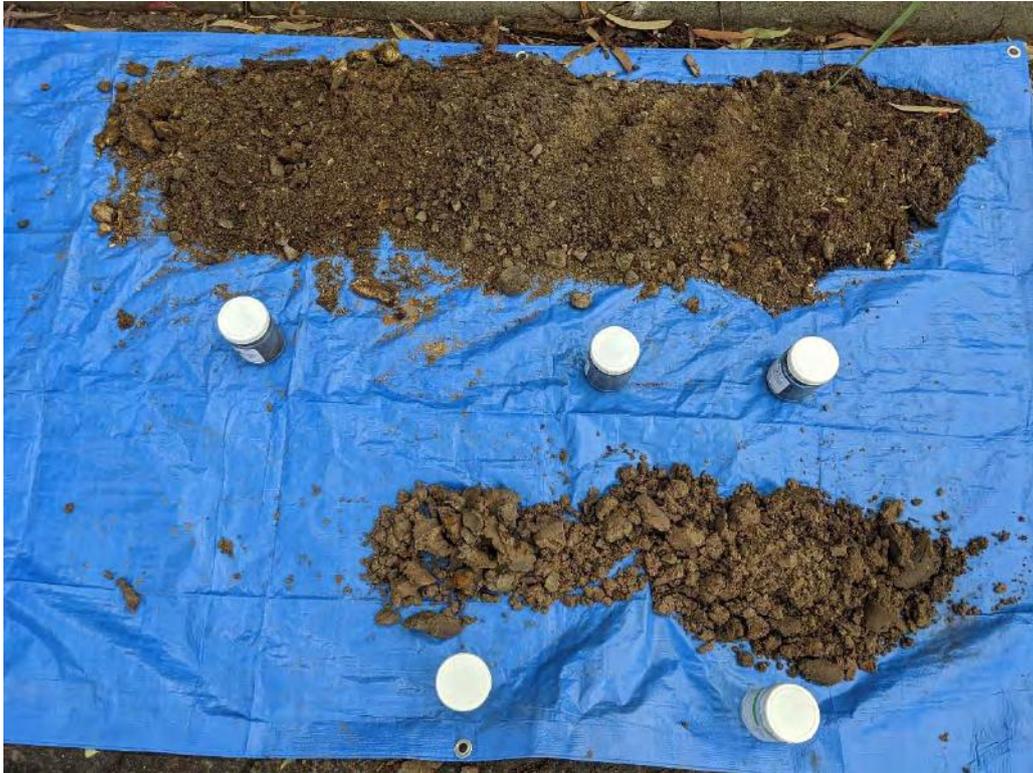
Photo ID: 3 – Soil exacted from SB08

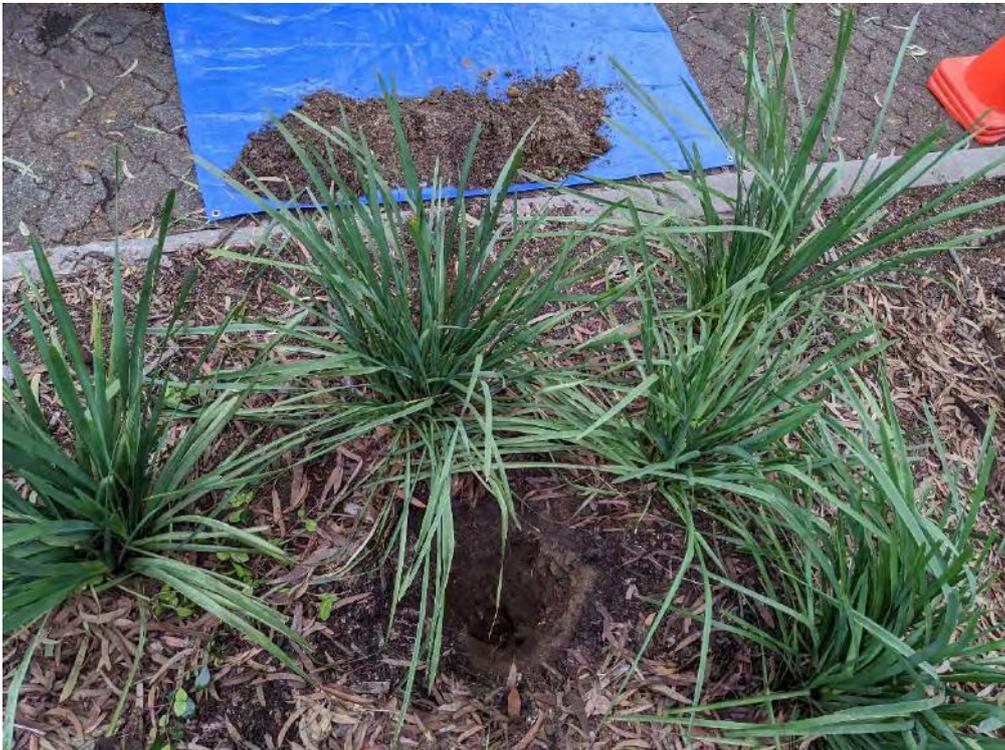
Photo ID: 4 – View of sampling location SB10

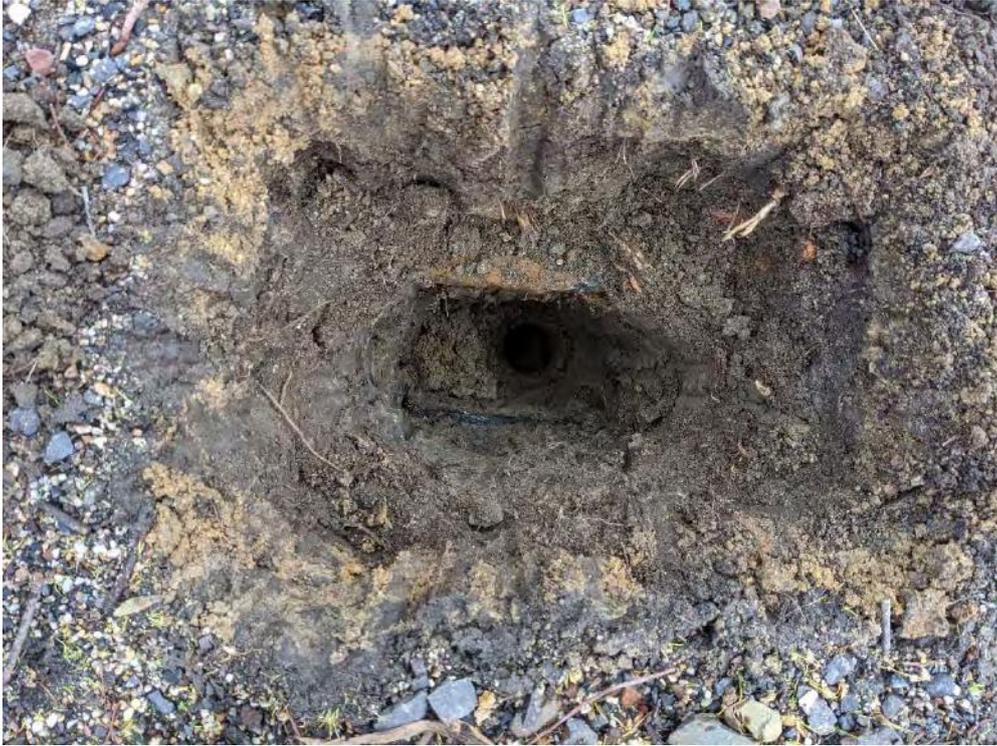
Photo ID: 5 – Example of 200mm diameter pit within fill material (SB06)

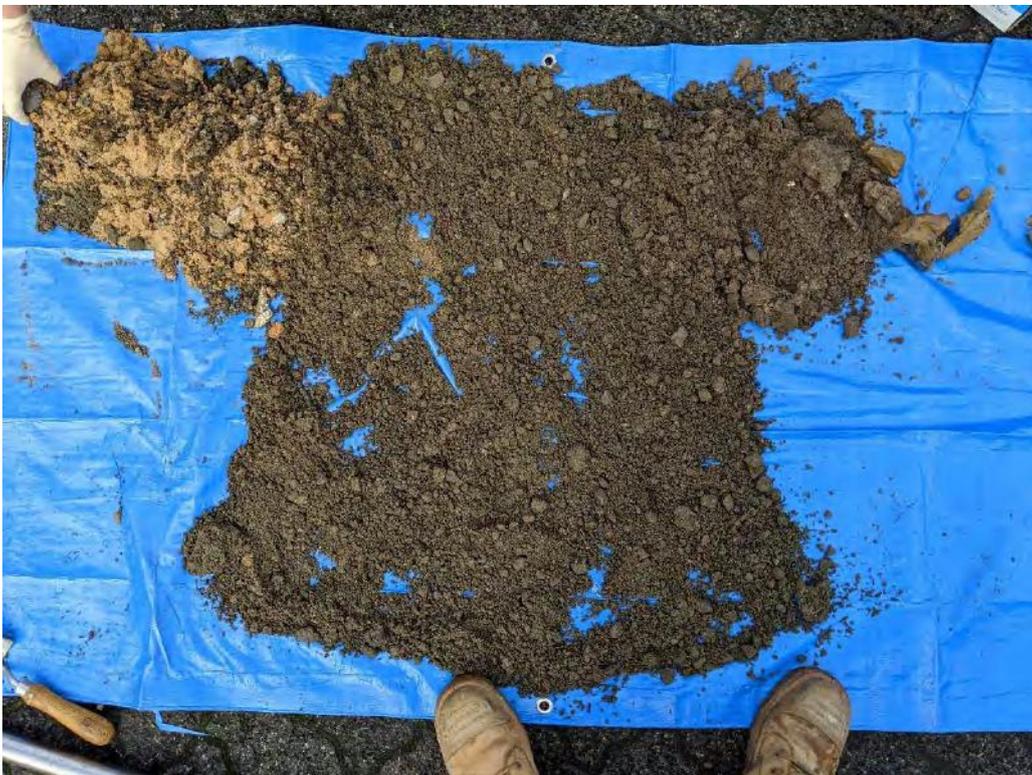
Photo ID: 6 – Example of soil inspection for fibrous material within fill (SB05)

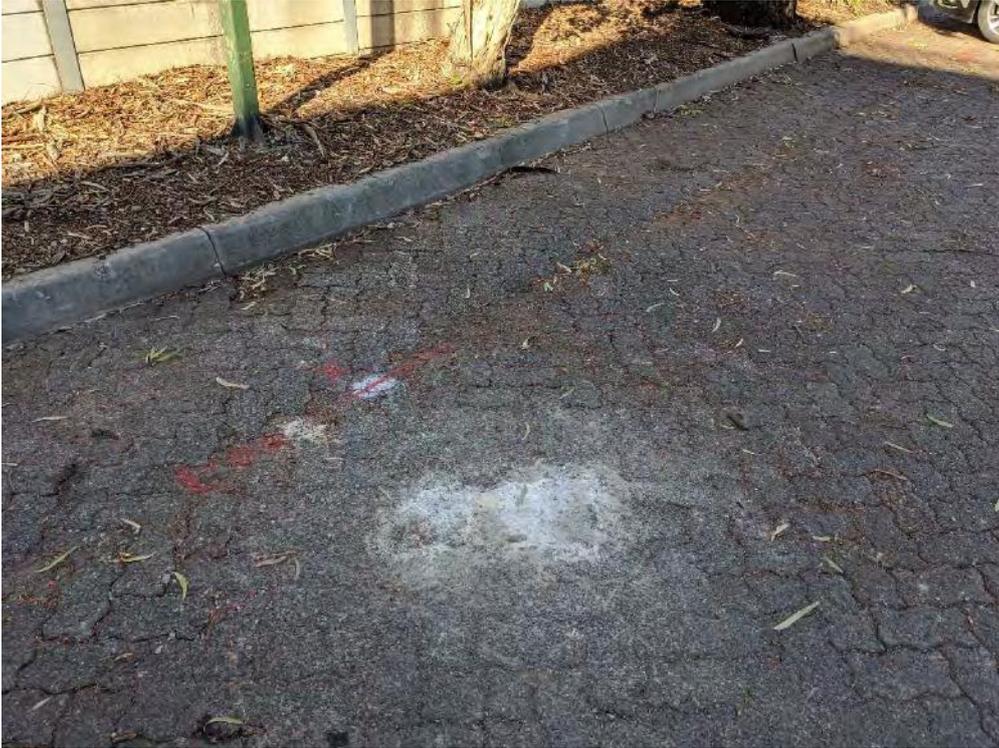
Photo ID: 7 – Reinstated concrete in car park (SB07).

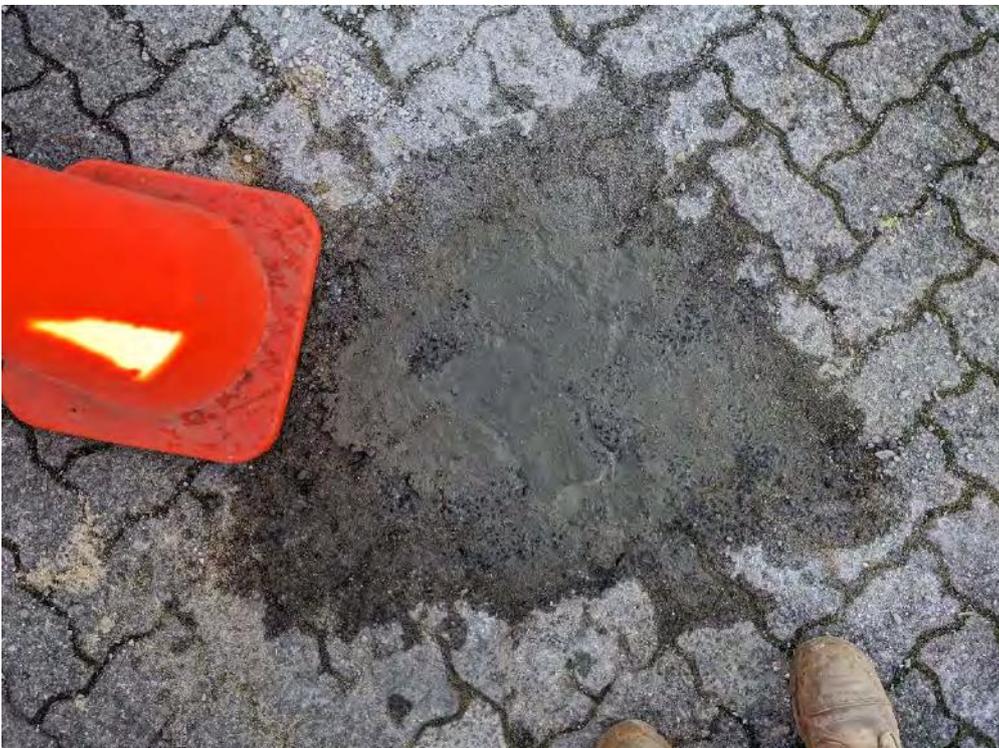
Photo ID: 8 – Reinstated concrete in car park (SB05).

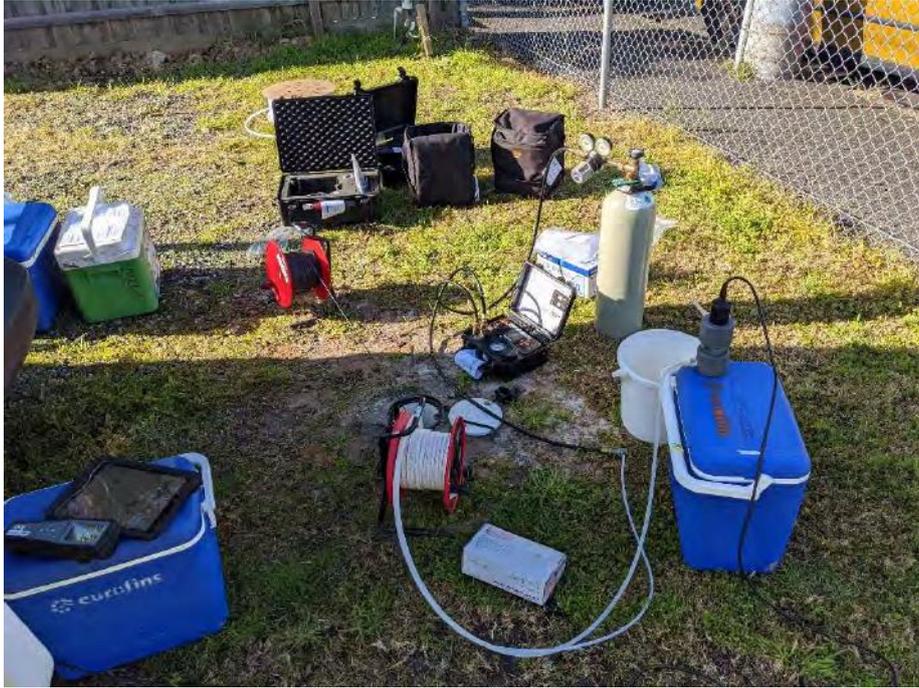
Photo ID: 9 – Groundwater low flow monitoring set up at GW02.

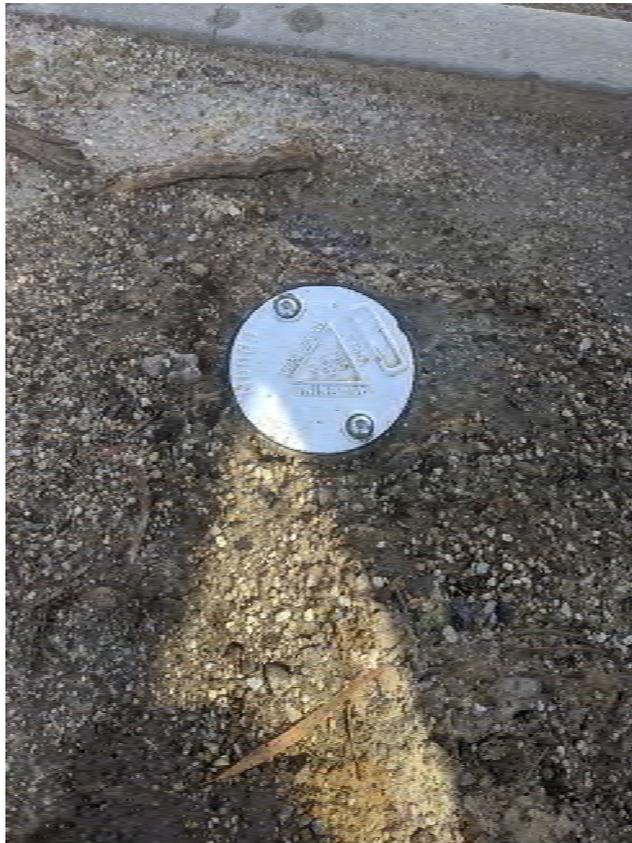
Photo ID: 10 – Example of installed groundwater monitoring bore (GW03).
