Report on
Geotechnical and Prelim. Environmental Investigation

Multi Storey Car Park Redevelopment
30-36 Jackson Street, St Kilda

Prepared for
City of Port Phillip

Project : 79797.00
R.001.Rev0
26 February 2019

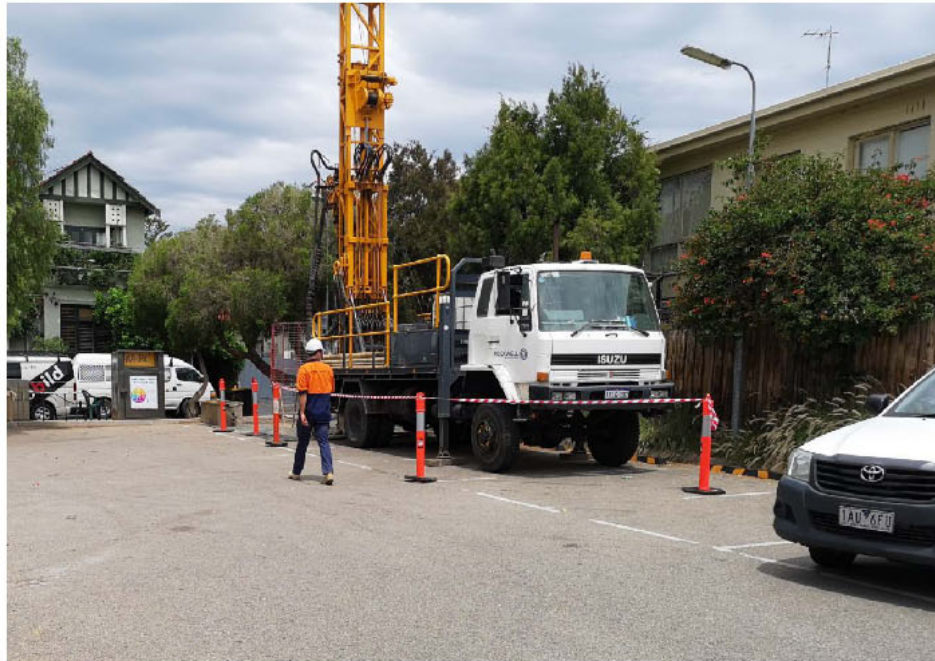
Photograph 1 : Drilling rig setup at borehole location BH01 (facing south)

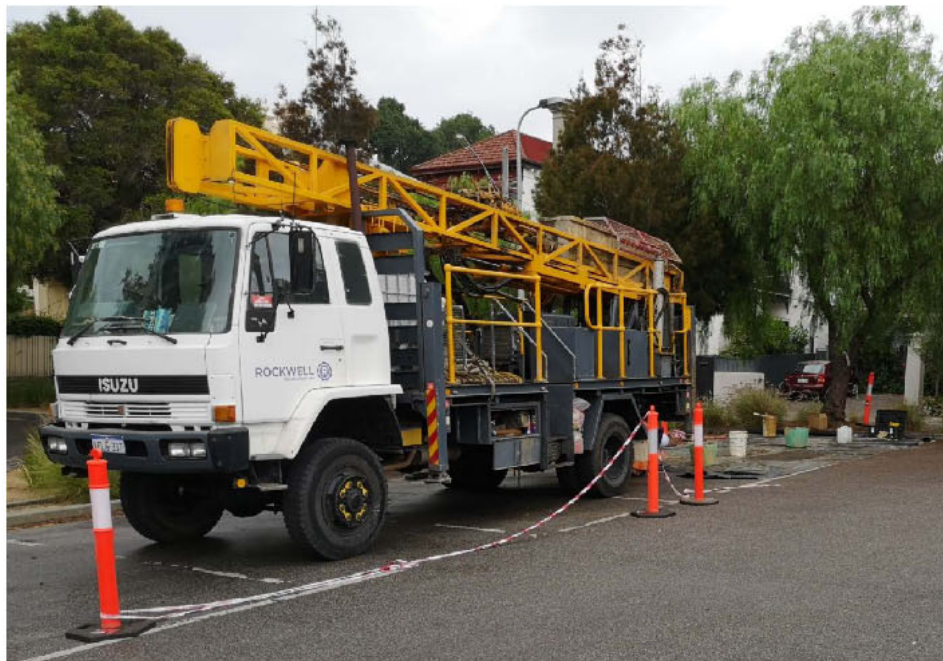
Photograph 2 : Drilling rig setup at borehole location BH03 (facing south east)

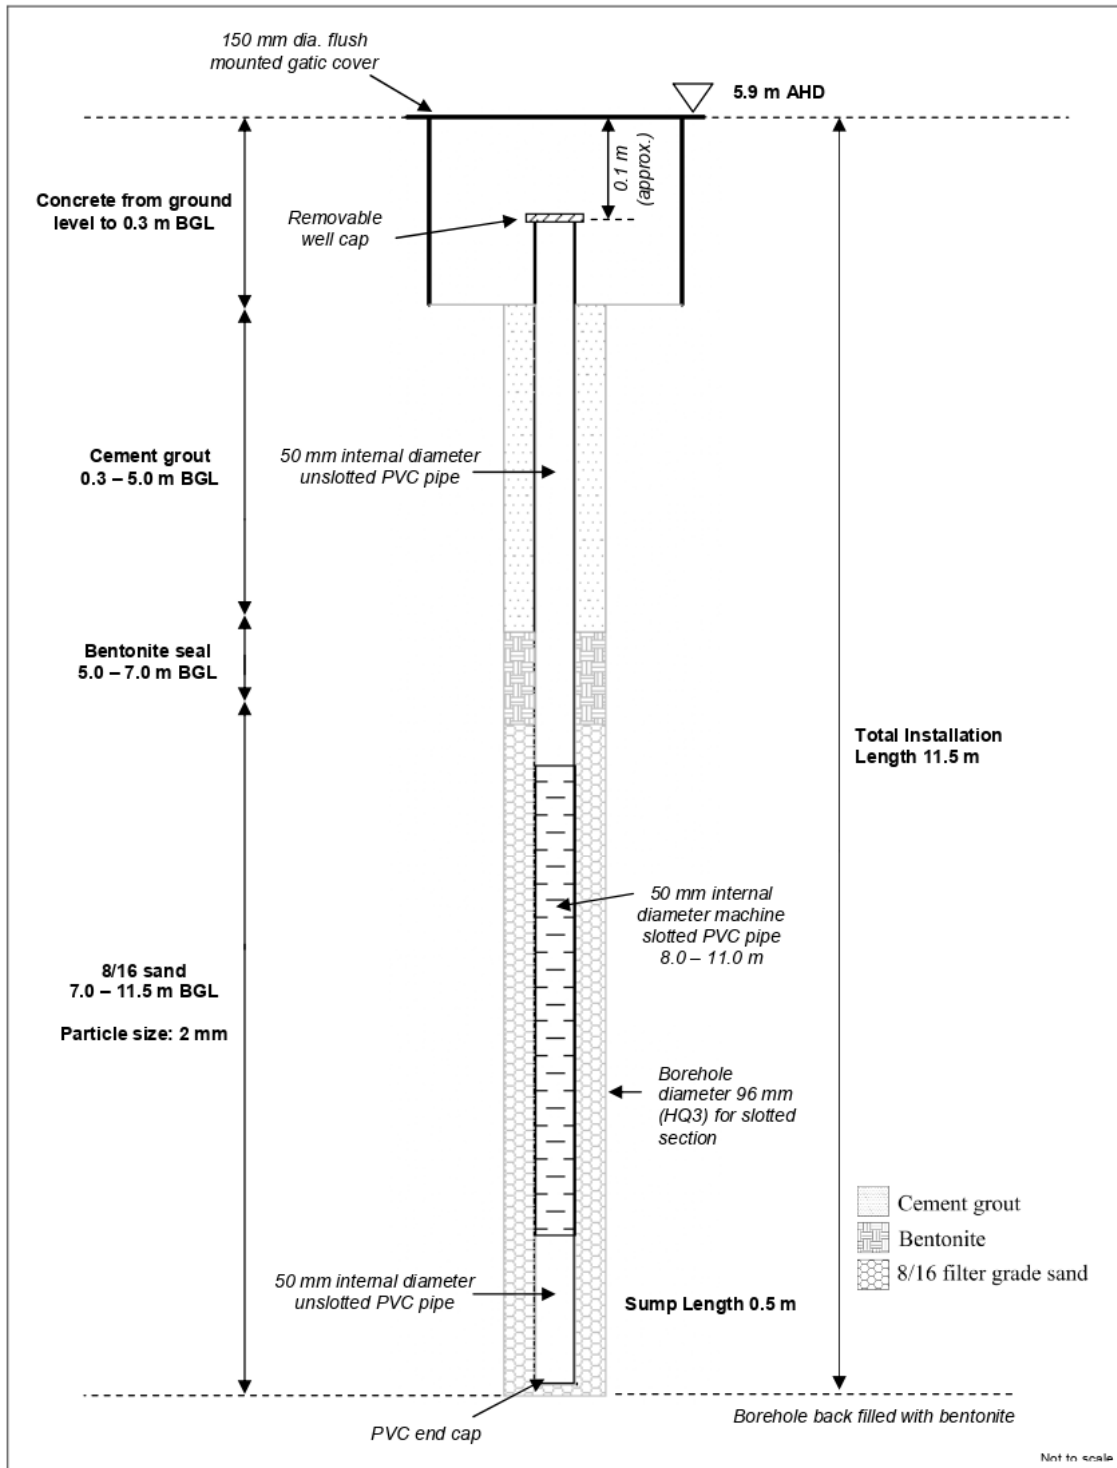
PROJECT:	Proposed Multi Storey Redevelopment	Standpipe Sketch BH-02	
CLIENT:	City of Port Phillip	30-36 Jackson Street, St Kilda	
  Douglas Partners Geotechnics Environment Groundwater	Installation Date :	17/01/2019	
	Borehole Termination Depth	11.5 m

Based on the measurements of the standpipes, groundwater should be expected from depths of about 3.2 m below the existing surface (i.e. approximately RL 2.6 m to RL 3.0 m AHD). Groundwater levels can vary seasonally, following periods of rainfall and due to local factors, such as permeability of the soil or rock, changes to drainage conditions and nearby underground services or basements. It is recommended that ongoing measurement of groundwater levels be undertaken. Perched water may be present in some areas.

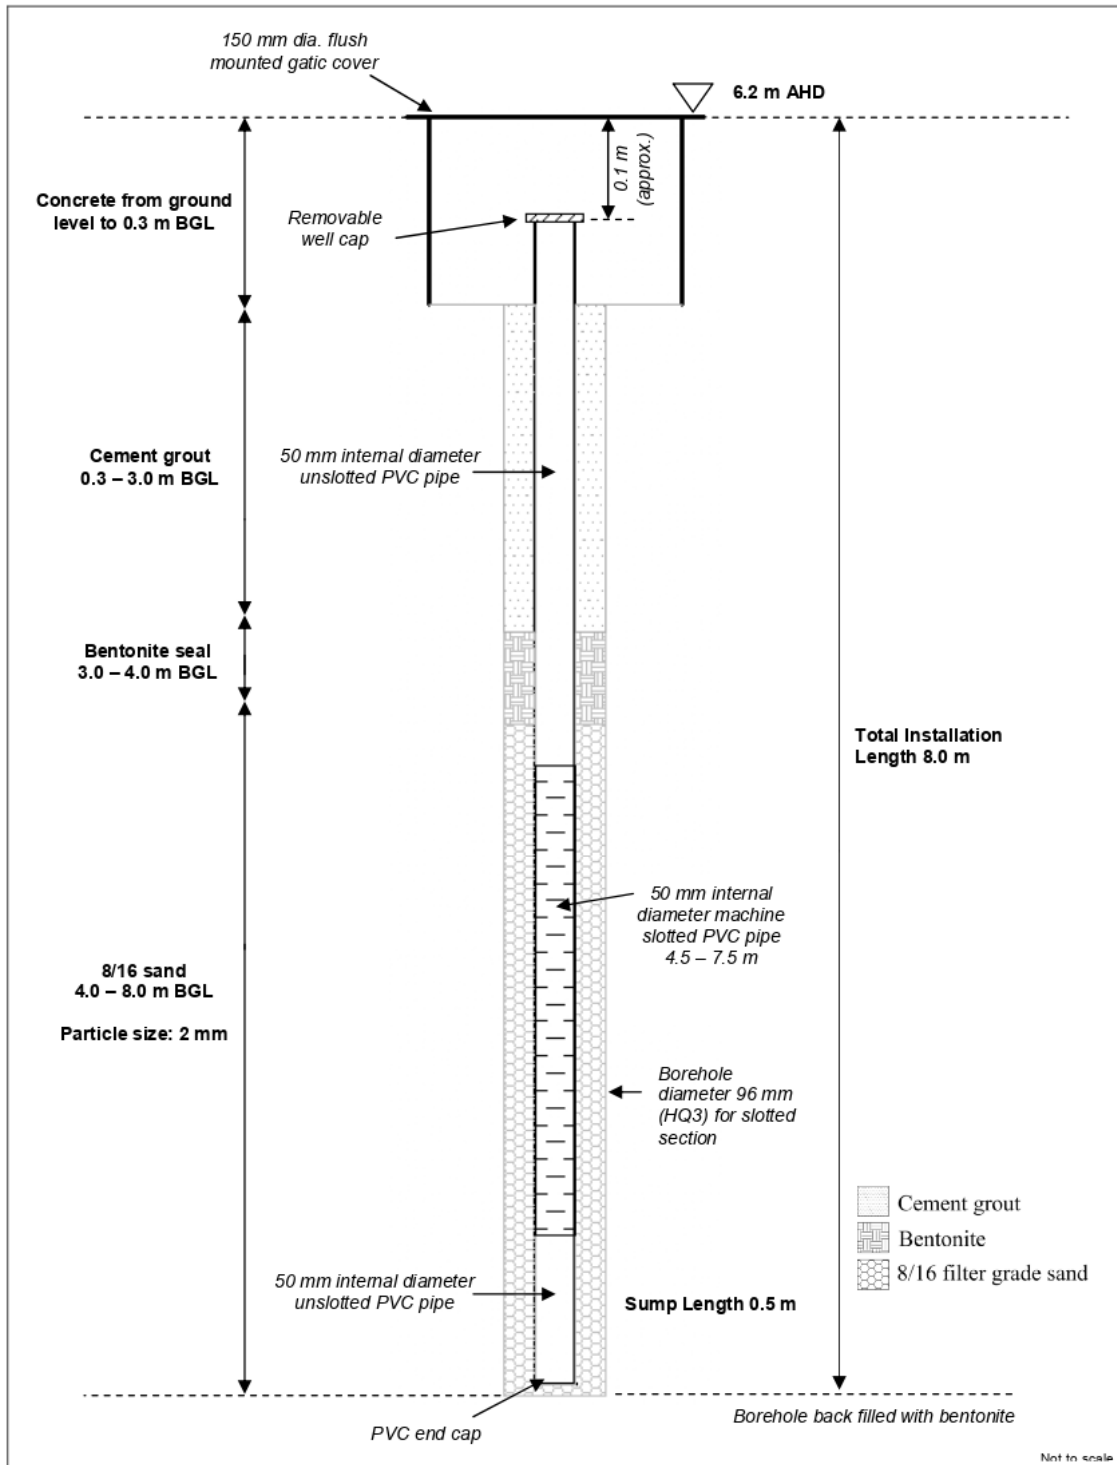
PROJECT:	Proposed Multi Storey Redevelopment	Standpipe Sketch BH-03	
CLIENT:	City of Port Phillip	30-36 Jackson Street, St Kilda	
  Douglas Partners Geotechnics Environment Groundwater	Installation Date :	18/01/2019	
	Borehole Termination Depth	8.0 m

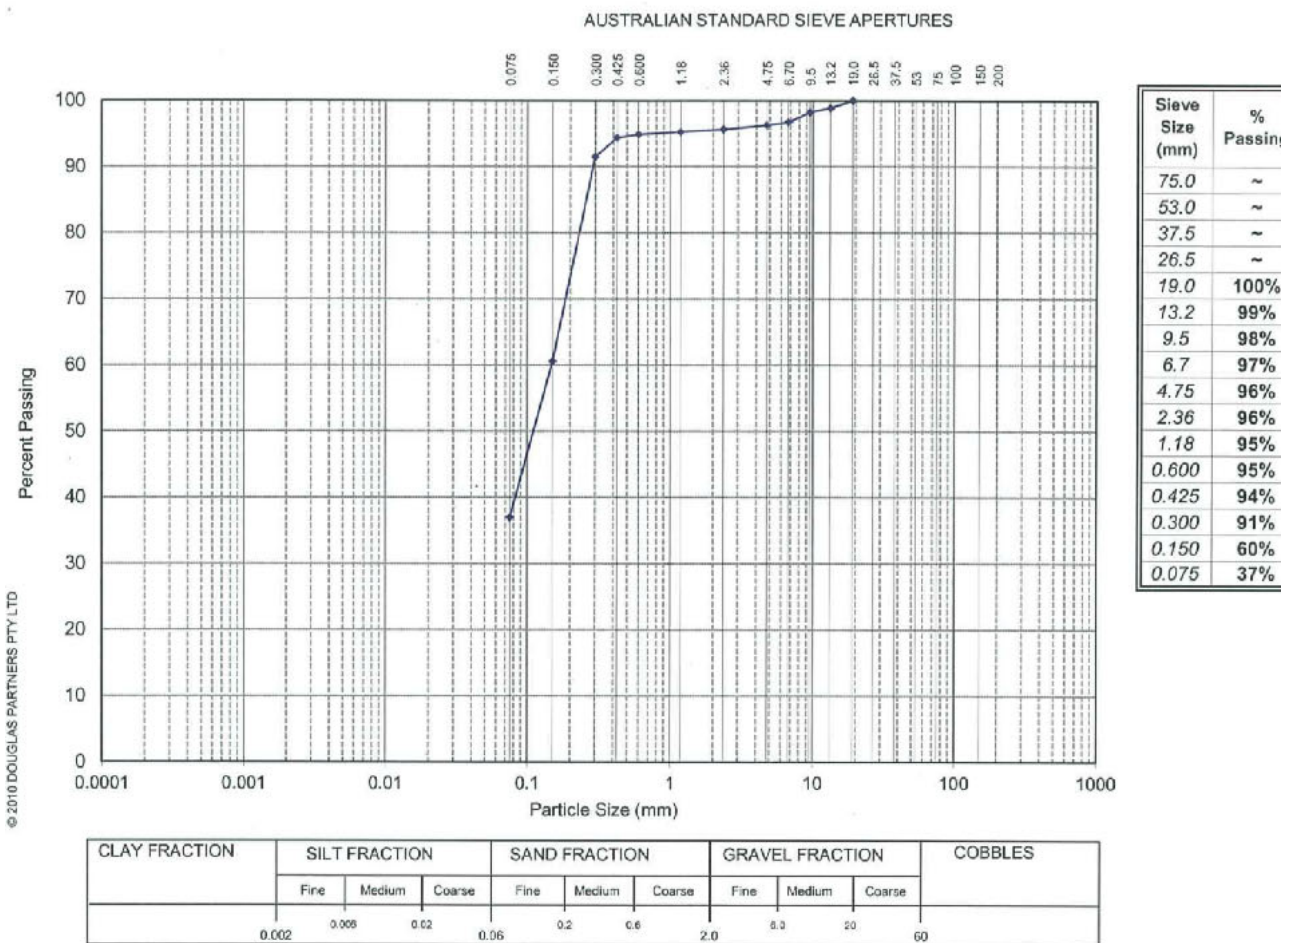
Results of Particle Size Distribution

Description: CLAY and SAND, trace gravel
Test Method(s): AS 1289.3.61
Sampling Method(s): Sampled by Engineering Department
Remarks:

A selected soil and rock samples recovered from the boreholes were submitted to DP’s Melbourne NATA accredited laboratory for determination of relevant engineering properties. One soil sample was taken and tested for the particle size distribution. A total of 10 rock core samples were selected for laboratory testing which comprised saturated moisture content tests on each sample and point load index testing on 7 of the samples. Laboratory test certificates are presented in Appendix D. A summary of the soil and rock results are separately provided in Tables 4 and 5, respectively.
