**Balaclava Retail Renewal
Precinct**

Geotechnical Investigation

Prepared for
Port Phillip City Council
Prepared by
Tonkin & Taylor Pty Ltd
Date
December 2018
Job Number
1008831.0.v1

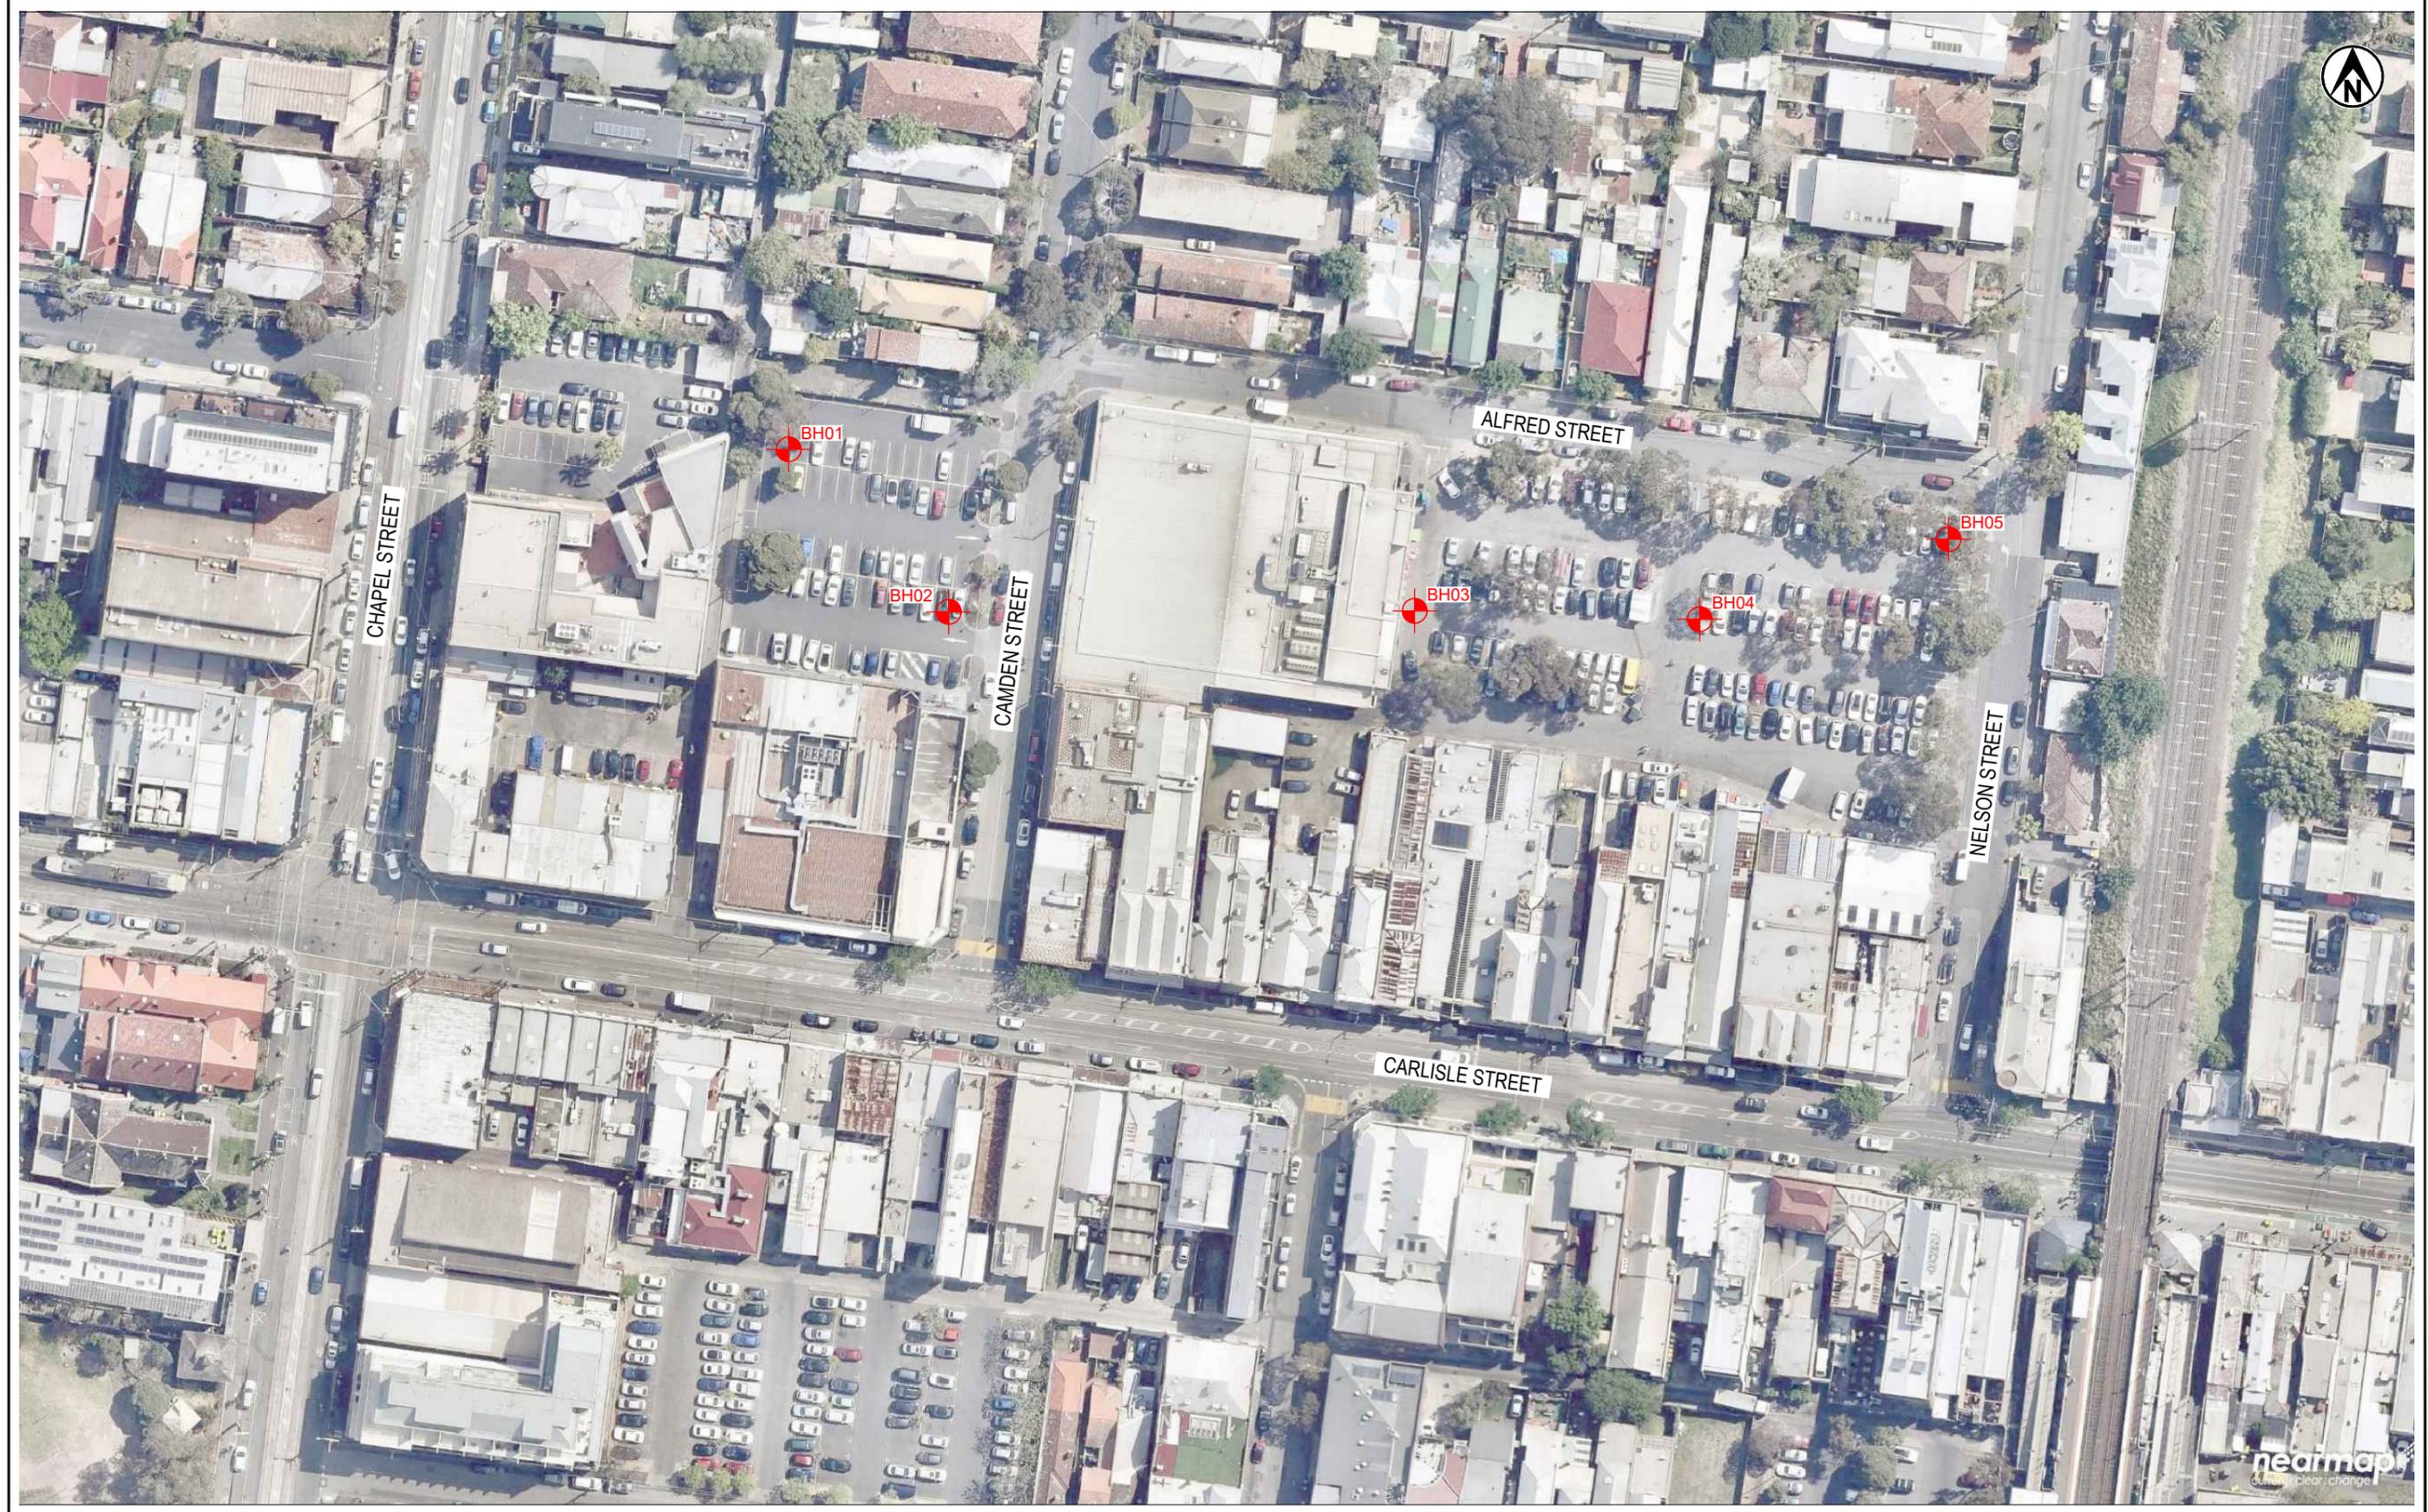
Figure A1 – Borehole Layout Plan

A total of five boreholes numbered BH01 to BH05 were drilled to 20m below ground level to provide information on the subsurface conditions. Boreholes BH01 and BH02 were drilled within the car park site at the front of Woolworths while boreholes BH03 to BH05 at the car park site at the front of Coles.

BOREHOLE LOCATIONS

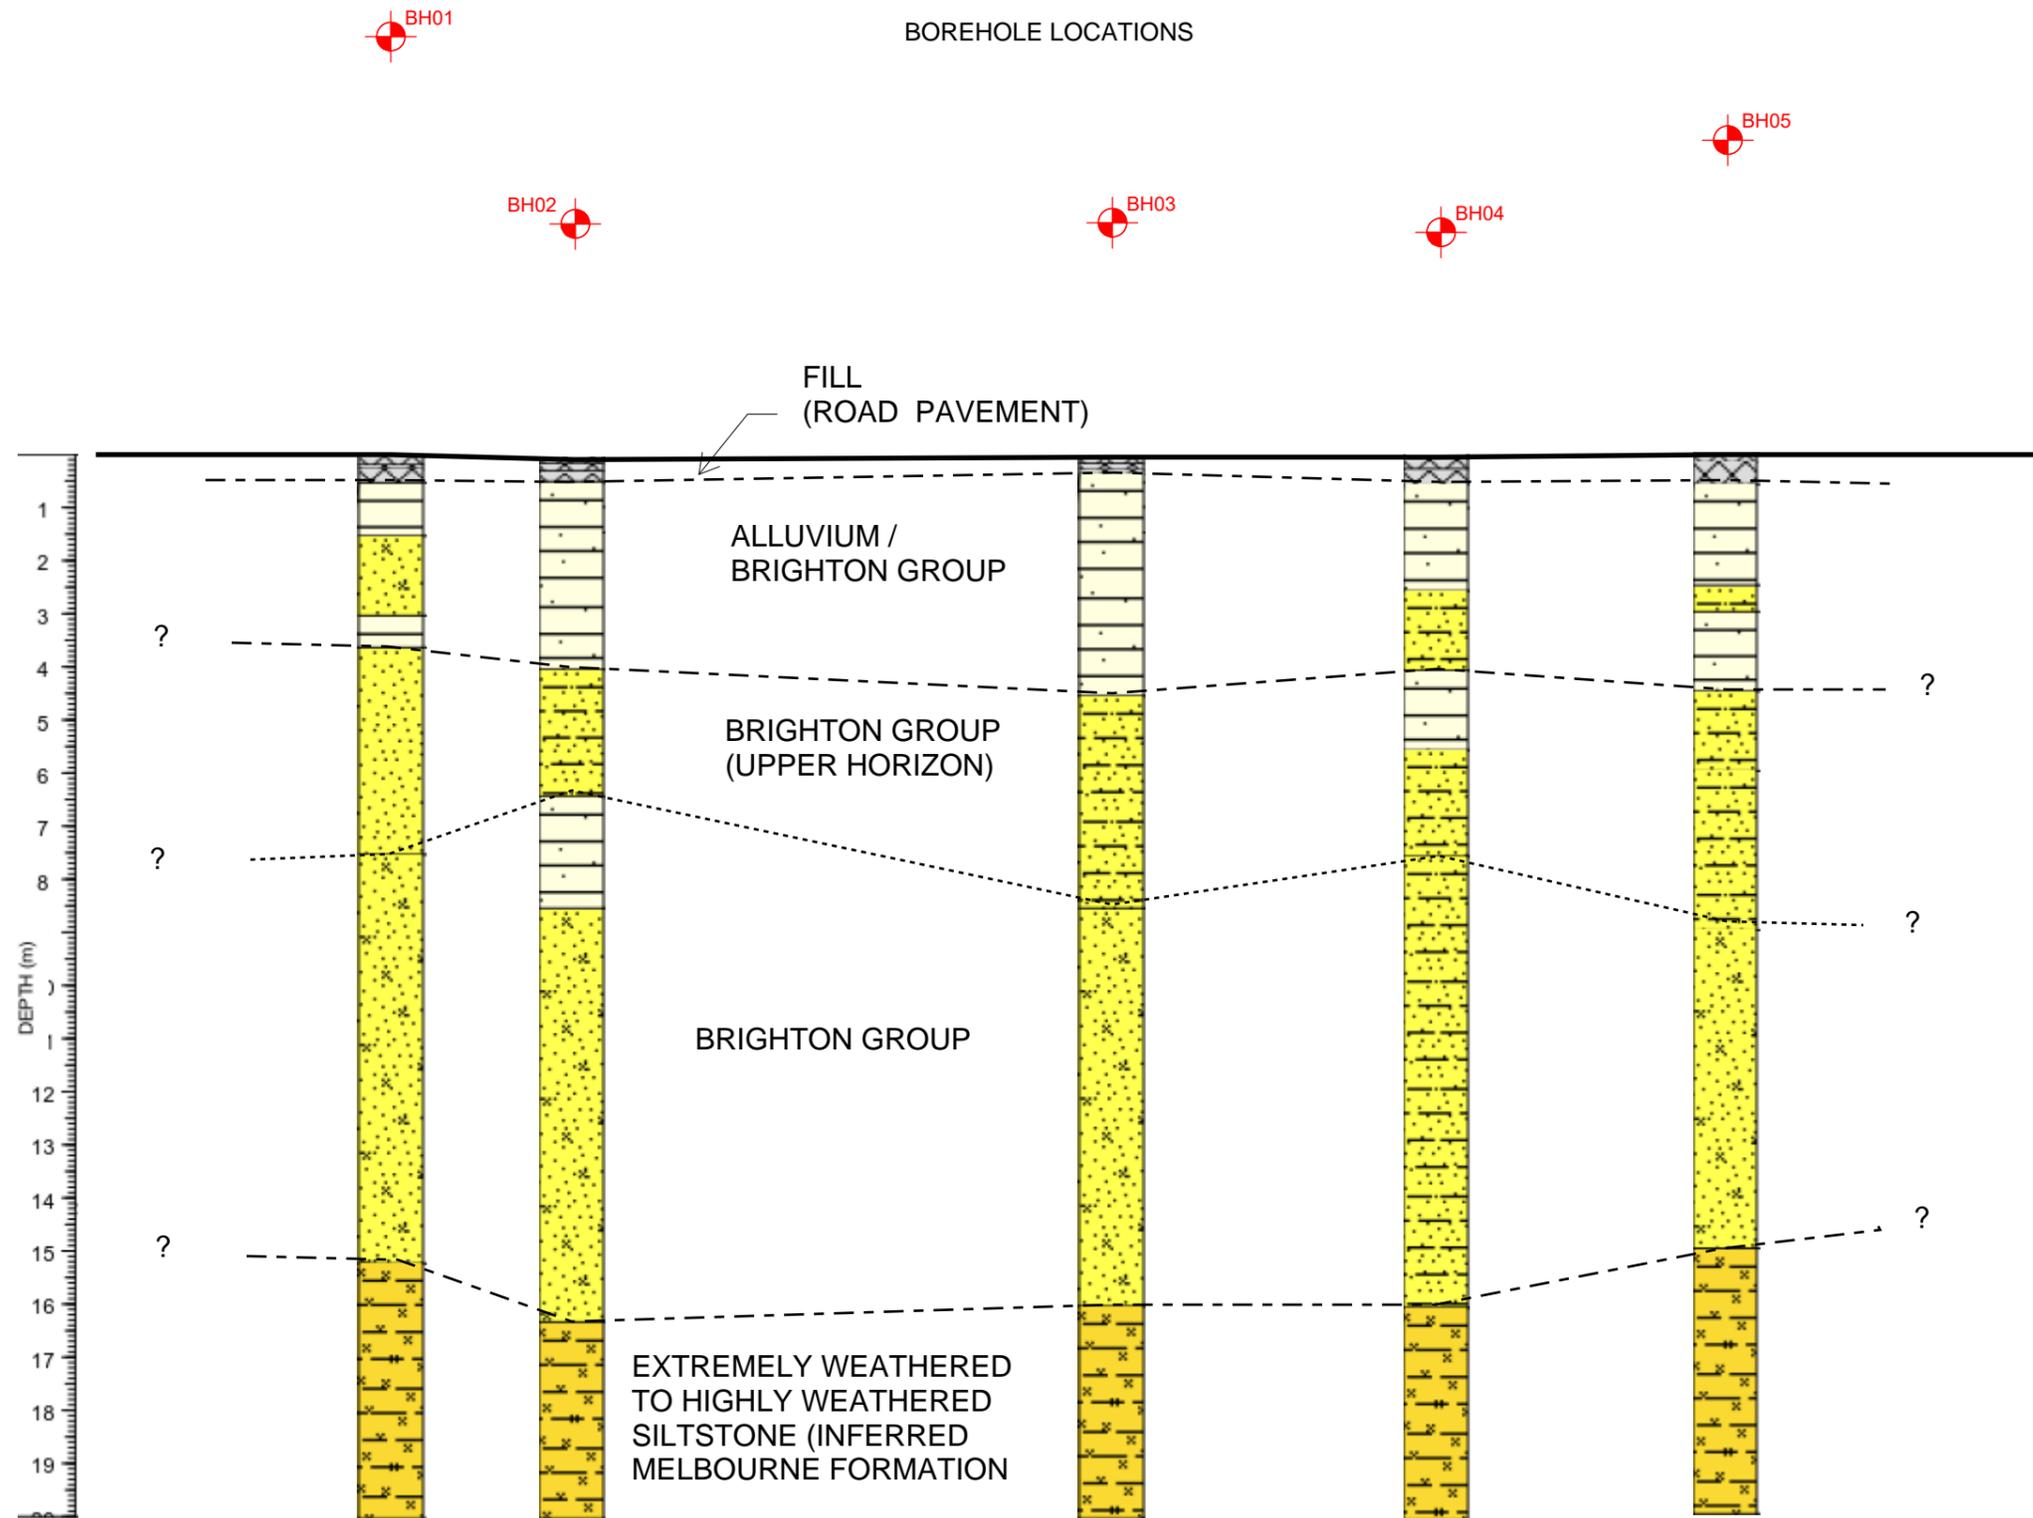
Figure A2 – Inferred Geological Section

The investigation found Tertiary period Brighton Group, typically comprising sands and clay soils, to be underlying alluvial deposits which in turn underlies by Silurian age Melbourne Formation.

Brighton Group predominantly comprising clayey SAND, silty SAND and sandy SILT was encountered below Unit 2 and extended to depths between 15m and 16.3m. The soil was described as fine to coarse grained, yellow-brown, pale grey, brown, orange-brown, trace of fine to medium grained gravel, and loose to very dense. Sandy CLAY of low to medium plasticity and stiff to very stiff was encountered in borehole BH02 between 6.5m and 8.5m depth. Interbedded cemented band was encountered within the upper horizon in boreholes BH01 and BH02.

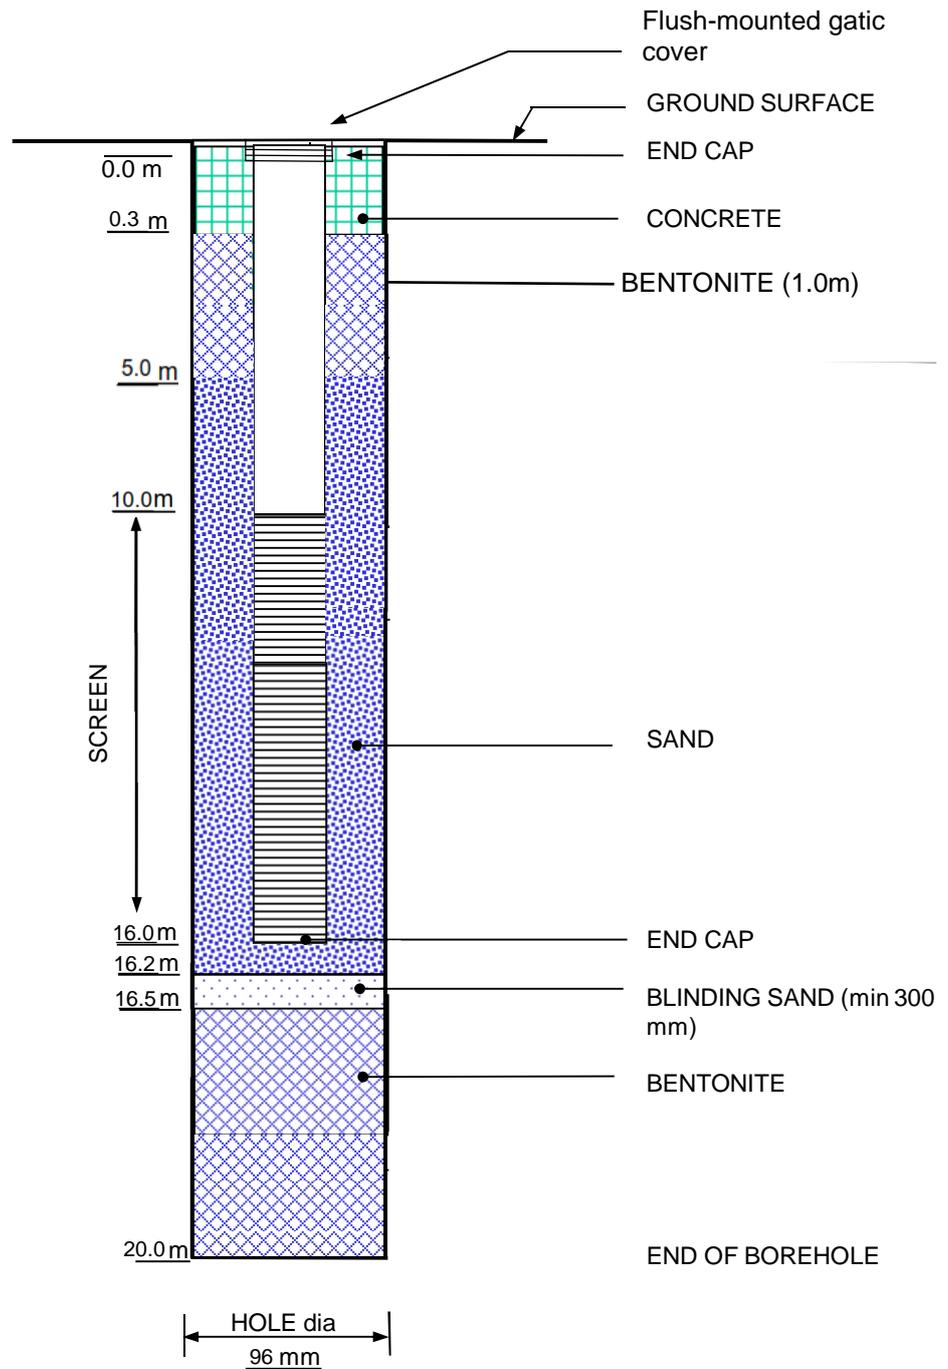
FIGURE B1

Prior to purging, water level in the standpipes was measured which returned 2.9m and 3.55m below ground level for BH02 and BH05 standpipe, respectively. A rubber hose was then inserted to the bottom of the standpipe and pumping commenced at the bottom to draw the water out from the standpipe. Initially, the water was observed to be murky and, as such, the rubber hose was kept at the bottom until the water became clear. The hose was then slowly withdrawn from the standpipe until 3m below the top of the standpipe while the pumping continued. Thereafter, the hose was kept in the standpipe until at least 200 litres of water was withdrawn.

Upon termination of the purging process, the water level in the standpipe was measured which returned a level of 2.94m and 3.55m in borehole BH01 and BH05, respectively. The recovery was noted to have taken place within a time span of about 10 minutes. This quick recovery indicates that the subsurface materials are highly permeable, which is expectable considering the material predominantly consisted of granular soils.

STANDPIPE: 50 mm internal diameter PVC

As noted in Section 6.3, the groundwater levels measured on 19 and 21 November 2018 in the standpipes in Boreholes BH01 and BH05 were between 2.9m and 3m, and between 3.55m and 3.7m, respectively. It should be noted that groundwater levels are subject to variations due to the influence of rainfall, temperature, local drainage, and the seasons. It is possible that the groundwater table may be different from these measurements at the time of the construction.

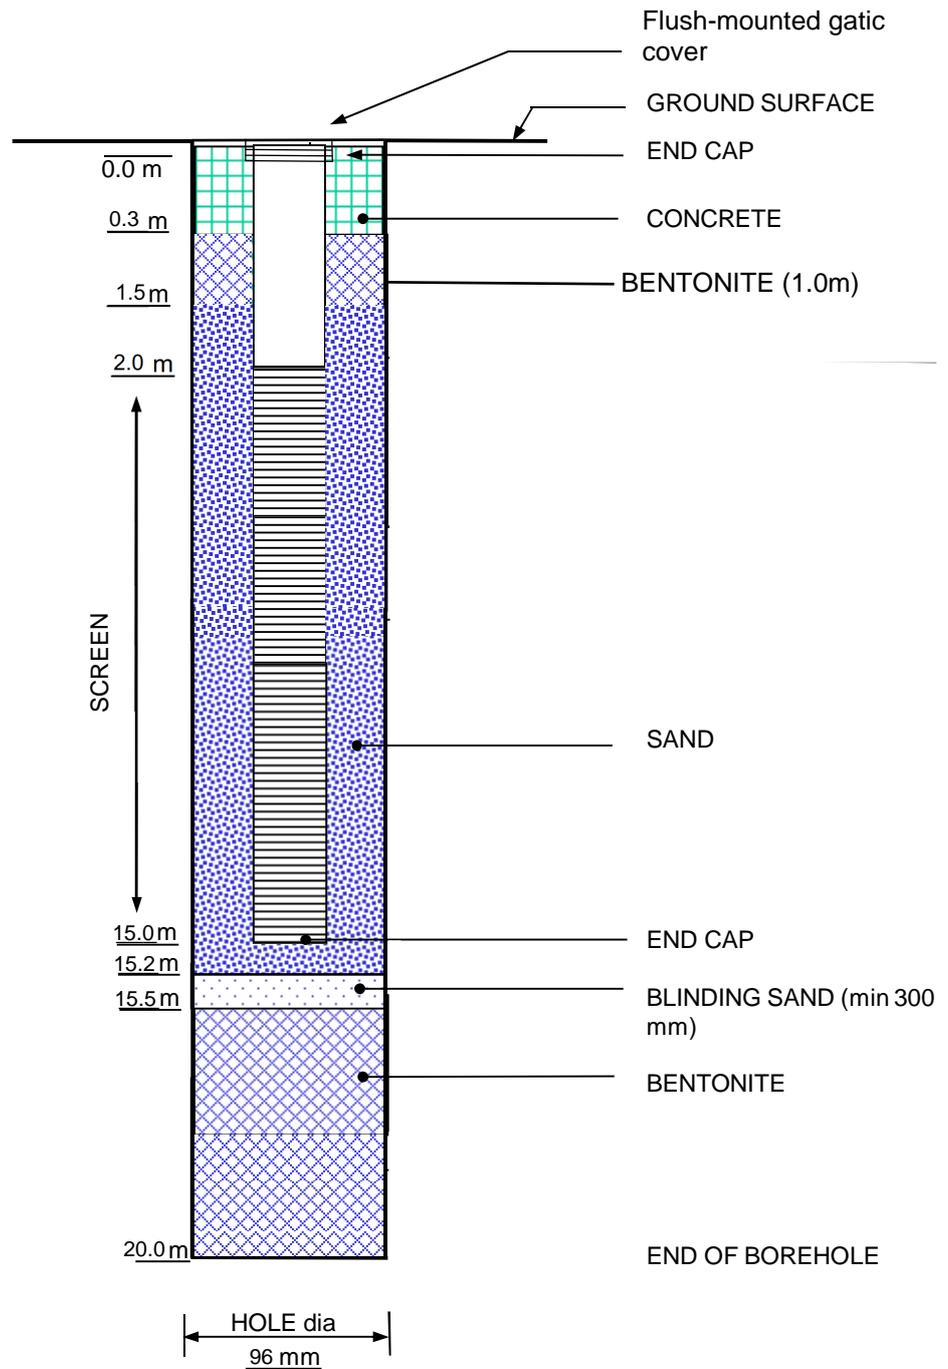
FIGURE B2

STANDPIPE: 50 mm internal diameter PVC

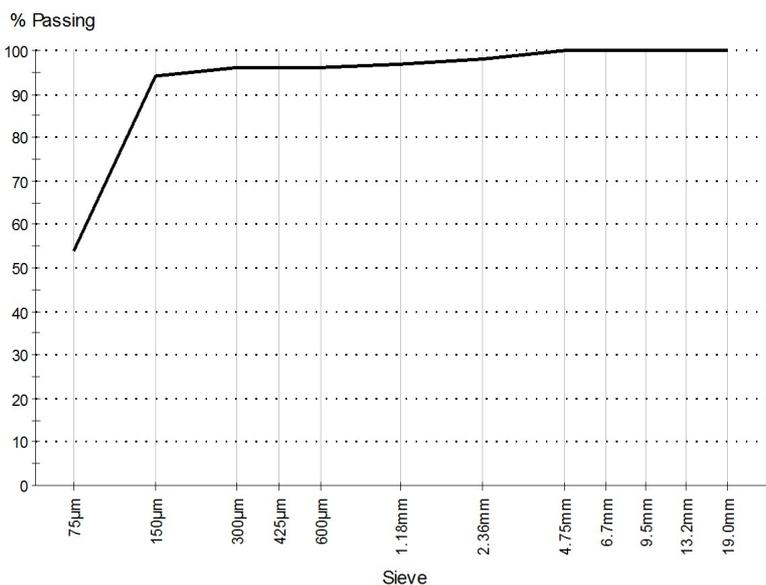
Particle Size Distribution

AS 1289.3.6.1

Note: Sample Washed
