PORT PHILLIP CITY COUNCIL

ELECTRIC LINE CLEARANCE MANAGEMENT PLAN

2023-2024

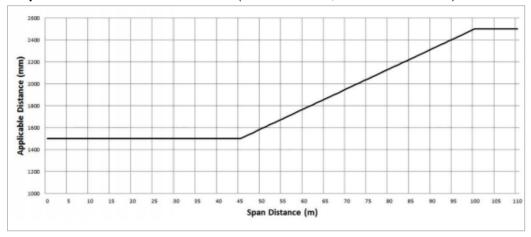
Graph 3: Uninsulated HV Electric Line (other than a 66,000 volt electric line) in LBRA

The formula by which the applicable distance for the middle two thirds of a span of uninsulated high voltage electric line (other than a 66,000 volt electric line) in a low bushfire risk area is calculated is as follows:

- A. if the span distance is less than or equal to 45 metres the applicable distance equals 1500 millimetres; or
- if the span distance is greater than 45 metres and less than or equal to 100 metres, the applicable distance is calculated in accordance with the following expression –

C. if the span distance is greater than 100 metres the applicable distance equals 2500 millimetres.
