# ASSESSMENT OF TOWN HALL CLOCK TOWER

South Melbourne Town Hall

Prepared for City of Port Phillip

Report Title: Assessment of Town Hall Clock Tower  
Client: City of Port Phillip

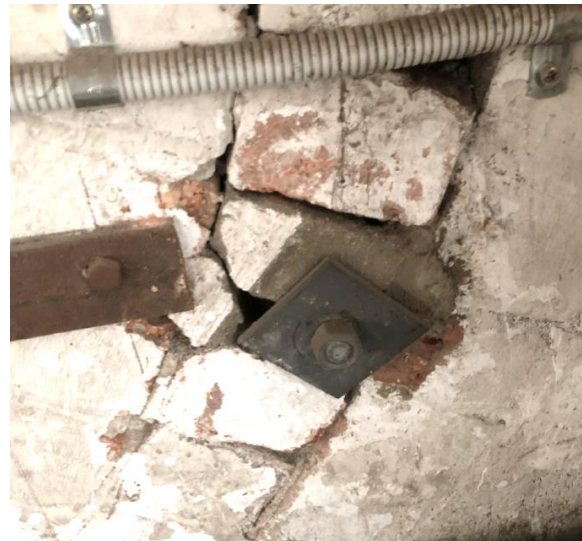
It appears that the clock face has been re-attached to the brick walls with through bolts. The brickwork around the bolts has come loose. The brickwork at the attachment points on the east side was in the worst condition.

Figure 4: Clock Face fixing

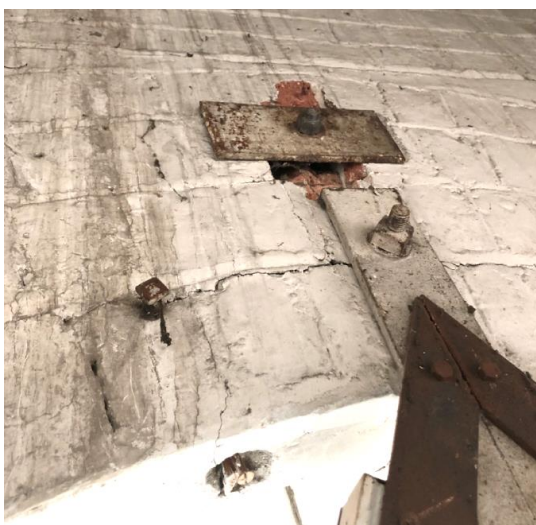
Figure 5: Top Clock face fixing

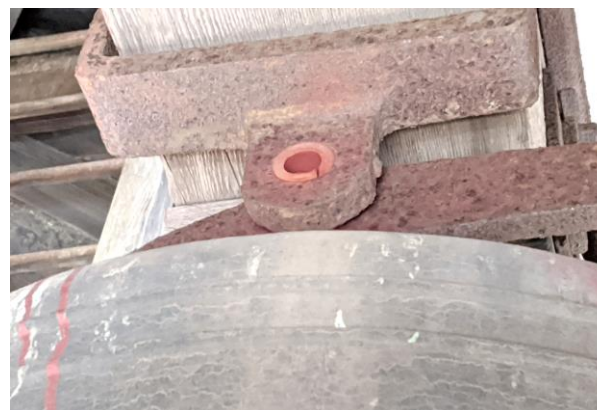
Where the pivot pin runs through the support bracket, the bush that houses the pin has become ovalized on the west side and has cracked on the east side. The pin has slid towards the ovalized opening such that only a short section of the pin is supported on the east side. The bell clapper has become offset and no longer striking the bell square on. At some point in time, the bracket supporting the bell clapper has been strengthened by the addition of a bracket over the beam welded to the support bracket.

**Figure 12: Bell Clapper pivot pin not visible**
