# Coles Car Park Alfred St. Tree Retention Survey

**Prepared for:** Jacob Vittorio,  
C/O City of Port Philip  
St Kilda Town Hall  
99a Carlisle Street,  
St Kilda, Victoria 3182

**Prepared by:** John Petrie  
Dip Arboriculture

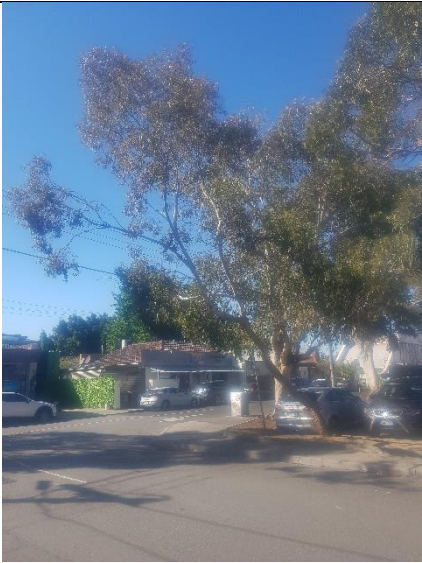
<b>No.</b>	10

<b>Botanical Name</b>	<i>Eucalyptus leucoxylon</i>			
<b>Common Name</b>	Yellow Gum			
<b>DBH (cm)</b>	22	<b>Origin</b>		Native
<b>DARB (cm)</b>	27	<b>Health</b>		Fair
<b>Height / width</b>	9 x 8	<b>Structure</b>		Poor
<b>Tree A/Z</b>	25	<b>ULE</b>		Medium
<b>TPZ (m)</b>	2.6	<b>Comments</b>		Extreme lean over road, crossing branches damage from passing traffic
<b>SRZ</b>	1.9			
<b>10% of TPZ area (m<sup>2</sup>)</b>	1.8

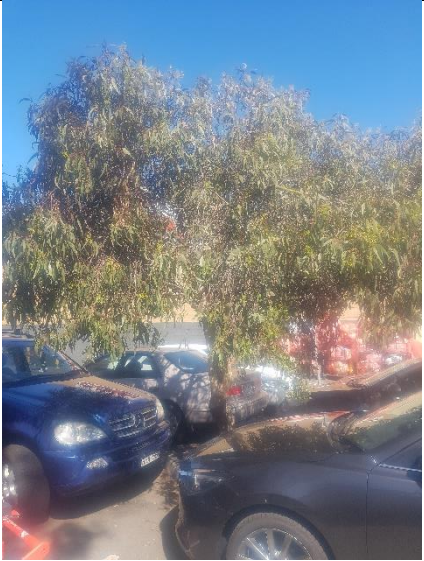
<b>No.</b>	12

<b>Botanical Name</b>	<i>Eucalyptus leucoxylon 'rosea'</i>			
<b>Common Name</b>	Dwarf Yellow Gum			
<b>DBH (cm)</b>	17	<b>Origin</b>		Native
<b>DARB (cm)</b>	20	<b>Health</b>		Fair
<b>Height / width</b>	5 x 7	<b>Structure</b>		Fair
<b>Tree A/Z</b>	Z1	<b>ULE</b>		Long
<b>TPZ (m)</b>	2			
<b>SRZ</b>	1.7	<b>Comments</b>		
<b>10% of TPZ area (m<sup>2</sup>)</b>	1.4

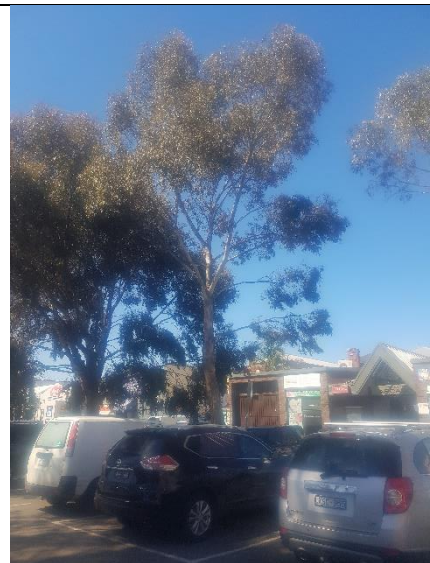
<b>No.</b>	21		
<b>Botanical Name</b>	<i>Eucalyptus melliodora</i>		
<b>Common Name</b>	Yellow Box		
<b>DBH (cm)</b>	43	<b>Origin</b>	Indigenous
<b>DARB (cm)</b>	47	<b>Health</b>	Fair
<b>Height / width</b>	10 x 10	<b>Structure</b>	Fair
<b>Tree A/Z</b>	Z1	<b>ULE</b>	Long
<b>TPZ (m)</b>	5.2		
<b>SRZ</b>	2.4	<b>Comments</b>	Small deadwood in canopy
<b>10% of TPZ area (m<sup>2</sup>)</b>	3.5
