BUILDING ASSESSMENT AND DEVELOPMENT OF REMEDIAL STRATEGIES FOR SOUTH MELBOURNE TOWN HALL

Prepared for City of Port Phillip

April, 2020

Report Title: Building Assessment and Development of Remedial Strategies for South Melbourne Town Hall

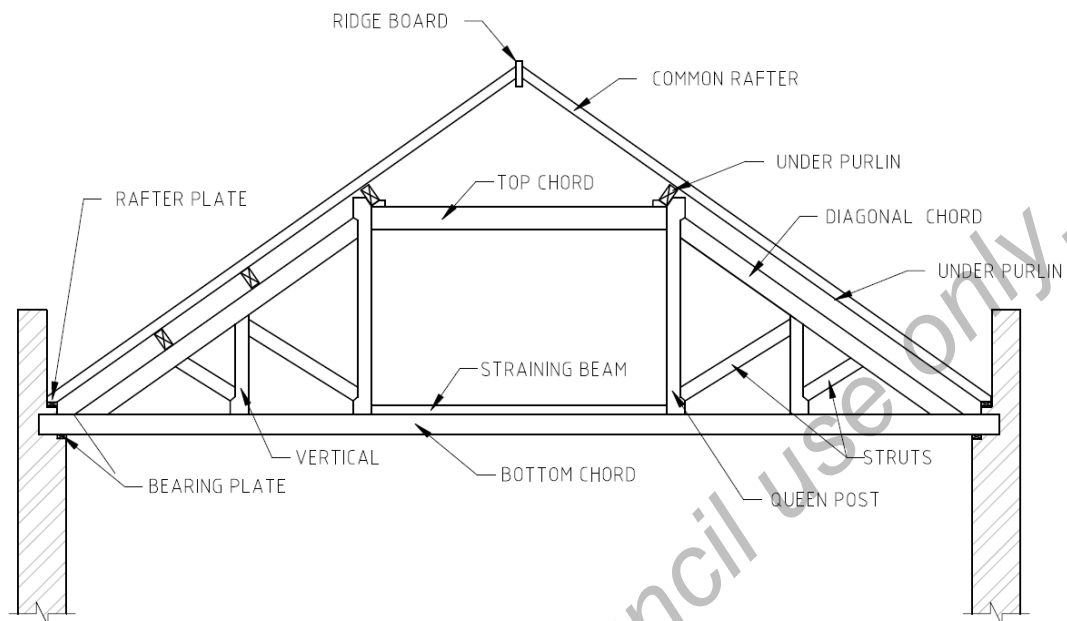
Figure 12. Main Hall truss general arrangement

The trusses are queen post trusses, where the angled outer chord stops at the queen post rather than extending through to the ridge as per a King Post truss. Unlike most trusses there are no diagonal members through the centre third of the truss and therefore rely on the stiffness of the bottom chord acting like a beam to balance any out of balance roof loads. Refer to Figure 12 - 13 for the general arrangement of the trusses. Figure 12 is the general arrangement over the Main Hall and Figure 13 is the general arrangement over the South, East and West Wings.

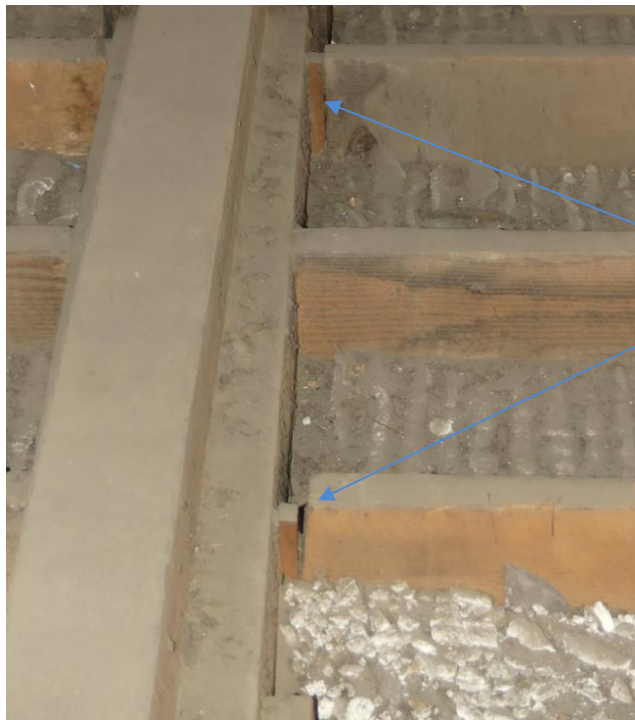
Main Hall.

Ceiling joists with a packer between the end of the joist and the truss bottom chord.

Figure 16. Ceiling joists with a packer between the end of the joist and the truss bottom chord

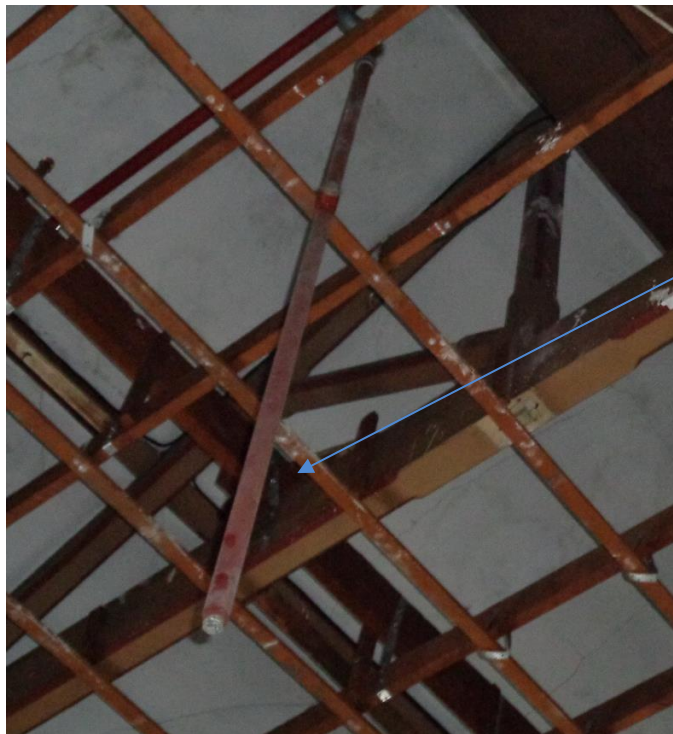
West Wing

Added ceiling framing hanging off the bottom chord of the truss via a hanging beam.

Figure 18. Added ceiling framing

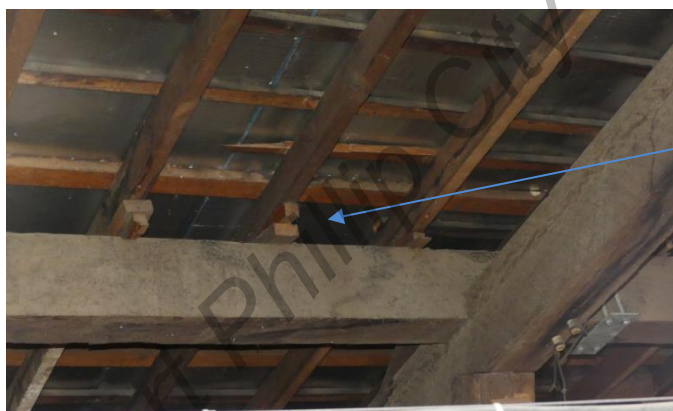
Main Hall.

Over the Mail Hall and the internal elevations of the wing buildings the slate roof has been replaced with a corrugated metal deck roof. This change typically reduces the weight of the cladding from around 60kg/m² for a slate roof to 5kg/m² for a metal deck roof. With the lighter weight roof wind is more likely to lift the roof off the building. Current Australian codes require the roof to be tied down to a suitable anchorage point. This starts with the fixing of the roof sheet to the battens, then the battens to the rafters and the rafters to the underpurlins. Presumably when the roof sheeting was installed it was screwed down in accordance with the manufacturers' recommendations. From the inspection it was not possible to determine if the battens, to which the roof sheeting is fixed, were provided with the required additional fixings to comply with AS1684/AS1720. From the photograph, Figure 19, it can be seen that packers have been provided between the rafters and the underpurlin with no obvious tie downs provided between the two.

Rafters packed up off underpurlins.

No obvious tie down provided.

Figure 19. Rafters packed up off underpurlins without evident tie down.

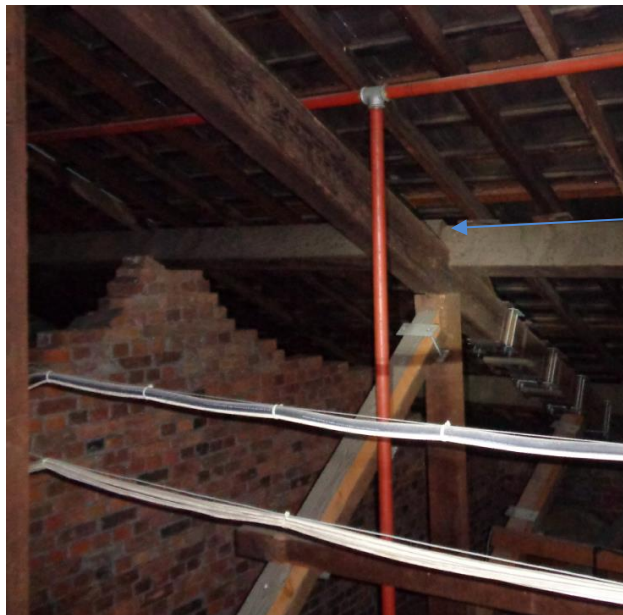
To prevent the roofing lifting off the building in high winds the underpurlins should be tied down to the roof trusses. As can be seen in the photograph Figure 20, the underpurlin has lifted off the roof truss. In the Main Hall roof there was no safe access to inspect this connection. The connection between the underpurlins and the trusses should be inspected to confirm that it is adequate to resist wind up lift. The inspection and assessment is required for all the underpurlin inspection.

Underpurlin lifted off top chord of truss. Possibly not tied down.

Figure 20. Underpurlin raised off top chord, possibly not tied down.

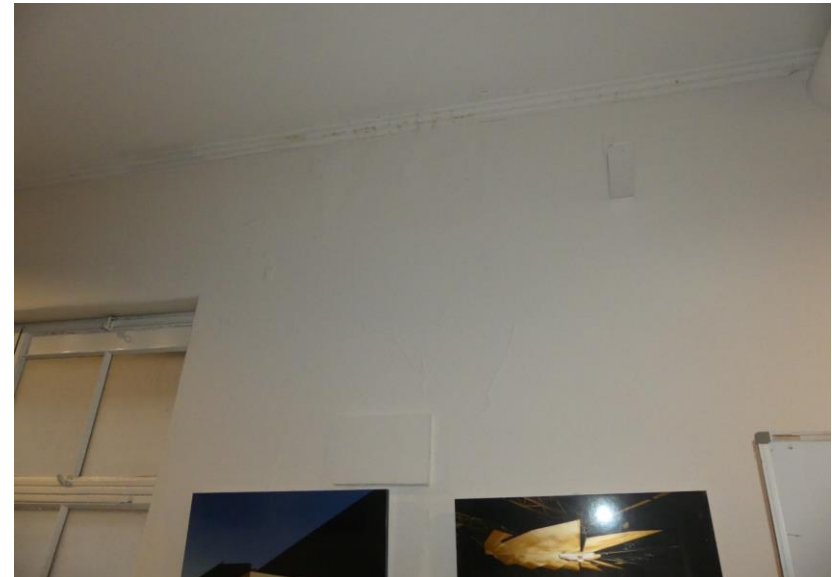
Figure 82 CB-F18-F-001 P1040595

Cracking	Wall	F19	External cracking around north eastern corner of façade	Condition to be monitored and patched during scheduled maintenance.	Low	Address as part of regular maintenance works.
Cracking with water damage	Wall	F18	Horizontal wall cracking to east wall reflecting through to external façade.	Condition to be monitored and patched during scheduled maintenance.	Low	Address as part of regular maintenance works.
Waterproofing on external landing.	Landing / Roof	F8/F9	Waterproofing membrane is not present behind pipes and vents installed adjoining F8 and along upstand of F17 likely acting as a location for water ingress below waterproofing membrane.	Issue to be addressed when applying new waterproofing to Council Building Deck.	Low	Refer to “Waterproofing and Concrete Repairs to Council Building Deck” in Table 1.
Water damage / Ingress	Ceiling	G16	Bathroom ceiling exhibiting water damage along east edge of roof line.	Condition to be monitored and remediated during scheduled maintenance.	Low	Address as part of regular maintenance works.

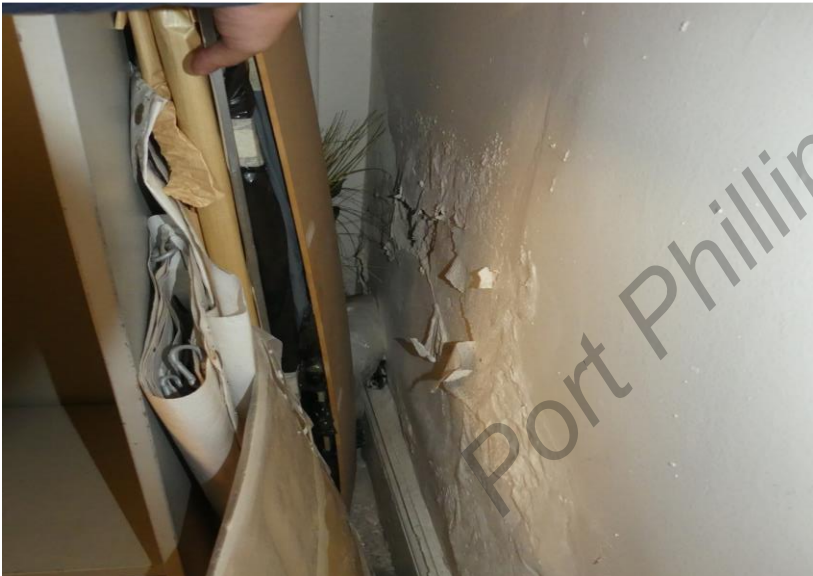
Figure 247 MH-G28-W-9001-20200316 (15)

Damp under the floor in rooms G27 to G33 need to be investigated as it is potentially leading to rot in the subfloor structure and potential foundation movement causing cracking in the walls over. In general, subfloor ventilation should be reviewed to ensure high levels of humidity do not lead to termite, rot or fungal issues with the timber framing.

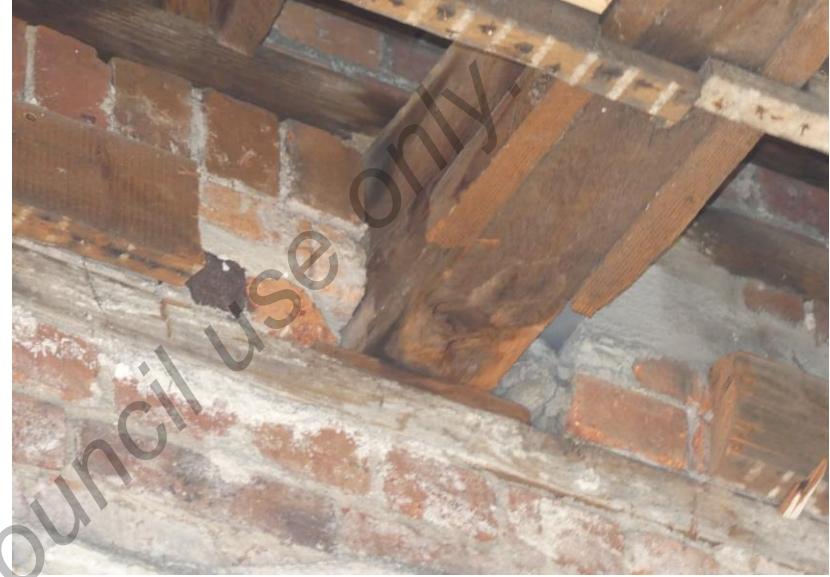
Figure 258 SW-F02-R-001 P1050130

On the 24th of March, during our global inspection of the South Melbourne Town hall, along with Infracorr Consulting P/L, it was observed that the support of the roof trusses along the south wall of room F2 had deteriorated to the point that we were concerned about the possible collapse of the roof.
