# South Melbourne Town Hall

Conservation Management Plan

208-220 Bank Street, South Melbourne, Victoria

LOVELL CHEN

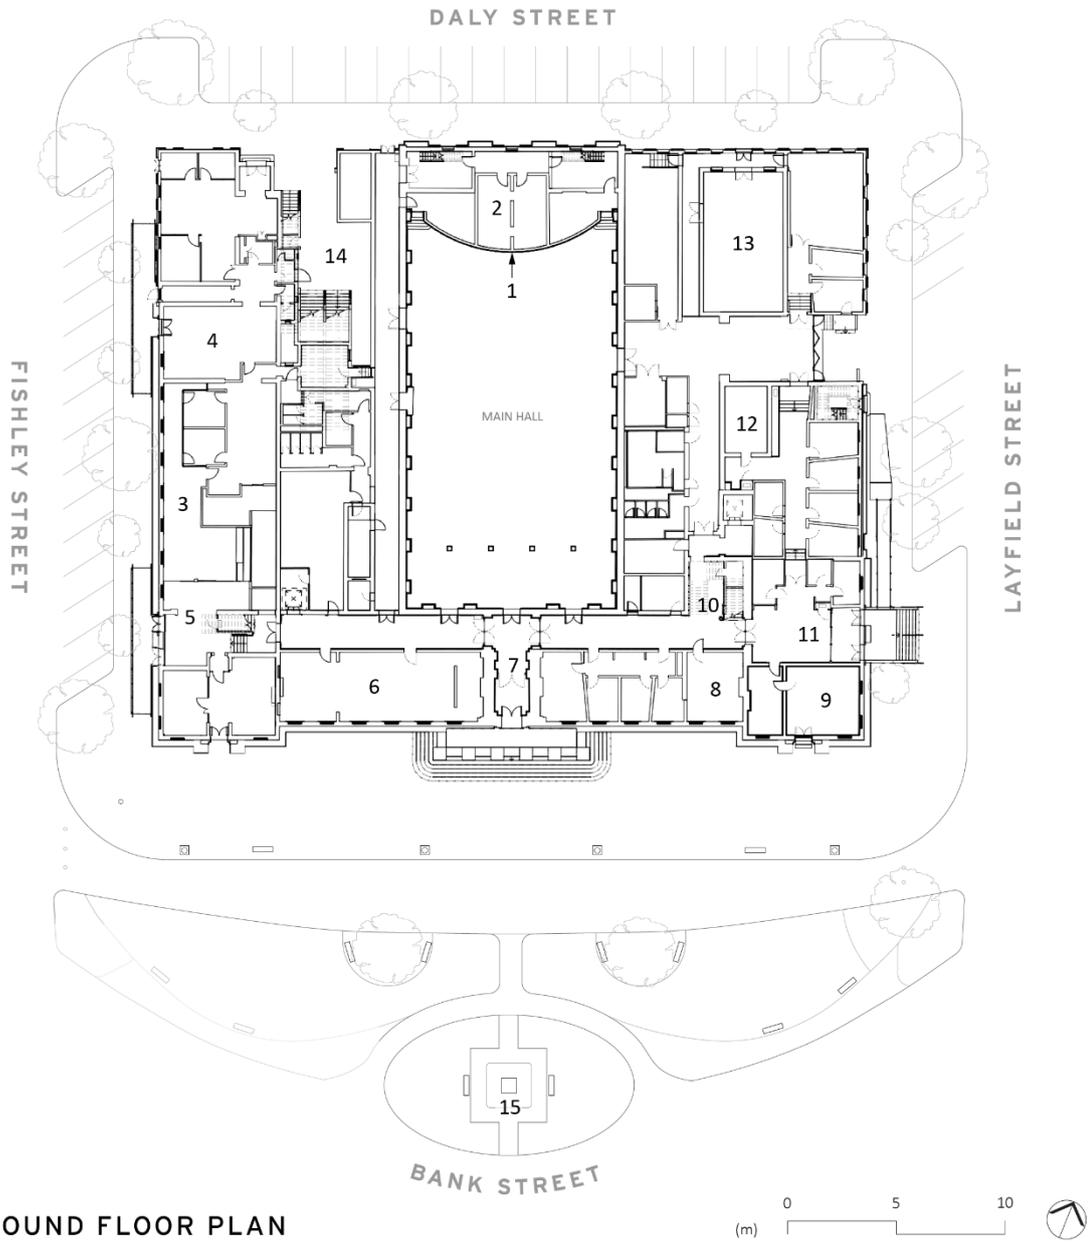
Figure 1 South Melbourne Town Hall, ground floor plan: with key spaces/areas identified

As well as civic functions (ceremonial, bureaucratic and administrative), the facility was built to accommodate multiple other uses, including a court house, post office, Mechanics Institute and fire brigade. These uses changed over time, resulting in physical alterations and interventions, some of them significant. Plans of the building as existing are provided below (Figure 1 and Figure 2), and an aerial view is at Figure 3.

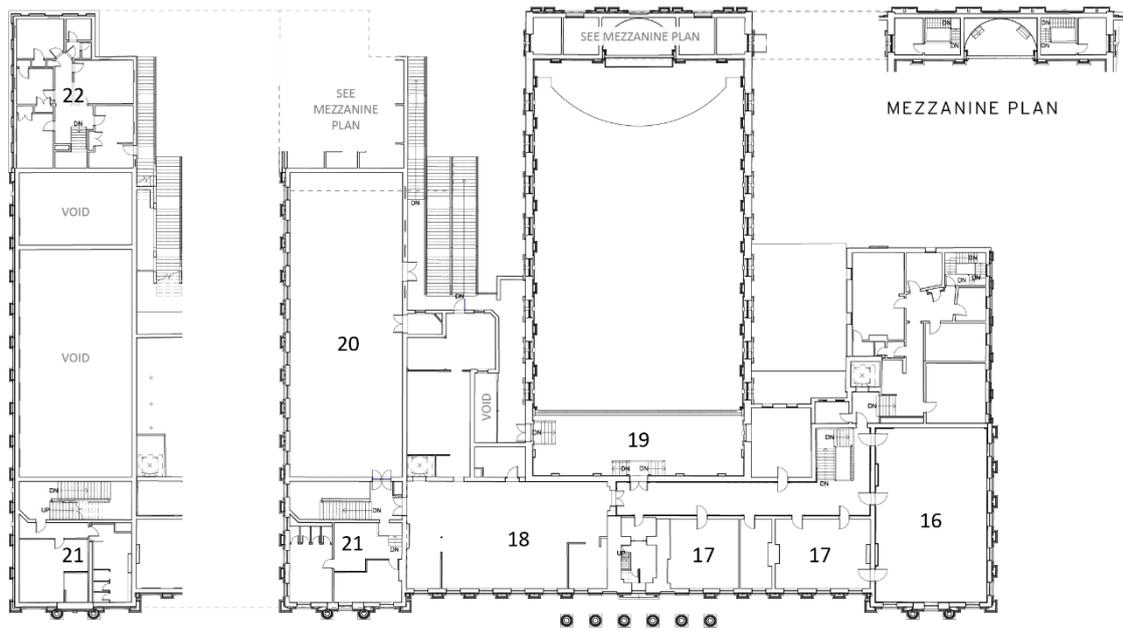
Figure 2 South Melbourne Town Hall, first floor plan: with key spaces/areas identified

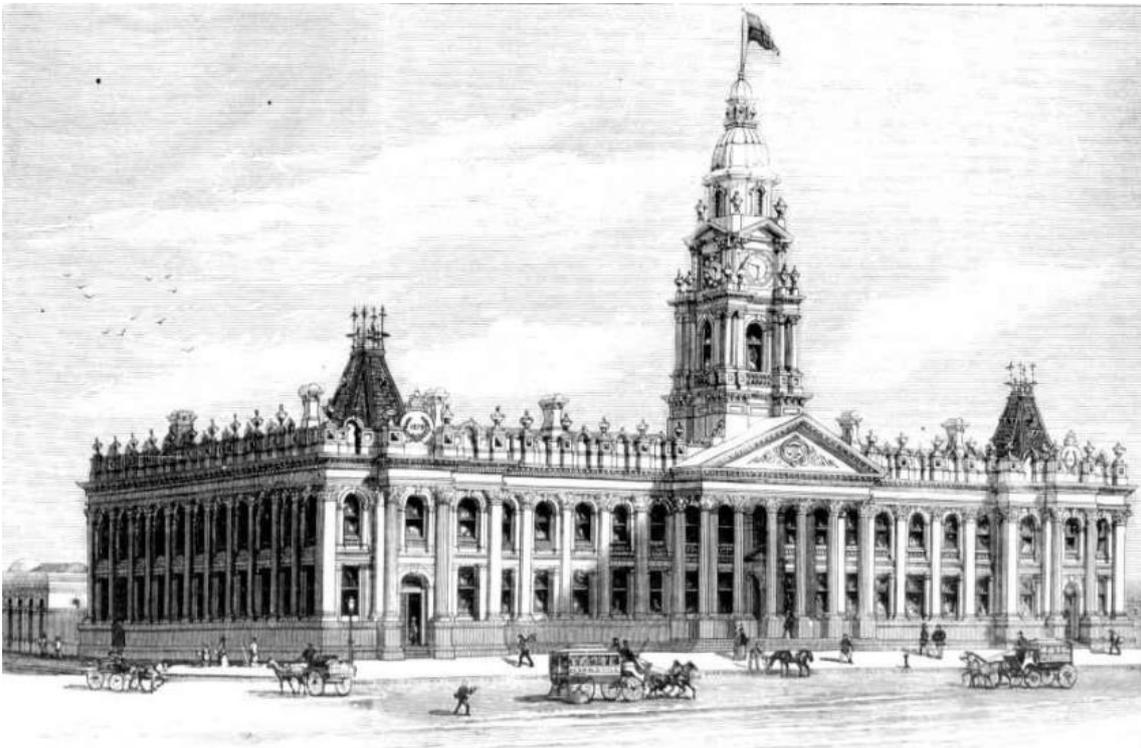
Figure 8 'The New Municipal Buildings, Emerald Hill'; view of south and west (part) elevations  
Source: *The Australasian Sketcher*, 25 February 1879, p. 185

Also in 1878, the council held a design competition for the new Town Hall, selecting the architect Charles Webb to undertake the project with a budget of £22,000 (Figure 8).<sup>26</sup> Webb's then-partnership Webb and Taylor had designed the original Orphan Asylum in 1855,<sup>27</sup> and the architect had by this time already been engaged for the design of the new orphanage at Brighton.

The fronts of the Mechanics' Institute and post-office which constitute the east and west wings of the Bank-street front, have, in each case, a handsome circular headed doorway between fluted columns corresponding with the columns of the central portico, on each side of which are Corinthian pilasters, windows, &c., corresponding with the remainder of the main building. The parapet of each wing has three distinct divisions, the two outer divisions corresponding with the general parapet, and the centre division rising with a plain face to a circular outline, on which a foliated wreath enrichment encircles the year of the erection of the building. Other enrichments of a unique character embellish this portion of the building. A Mansard roof surmounts each wing, the apex of which has ornamental iron cresting. The court-house, police quarters, postmaster's residence, and other one-story buildings occupying, a portion of the north, east, and west frontages, are designed in harmony with the main building, but of a more simple character.

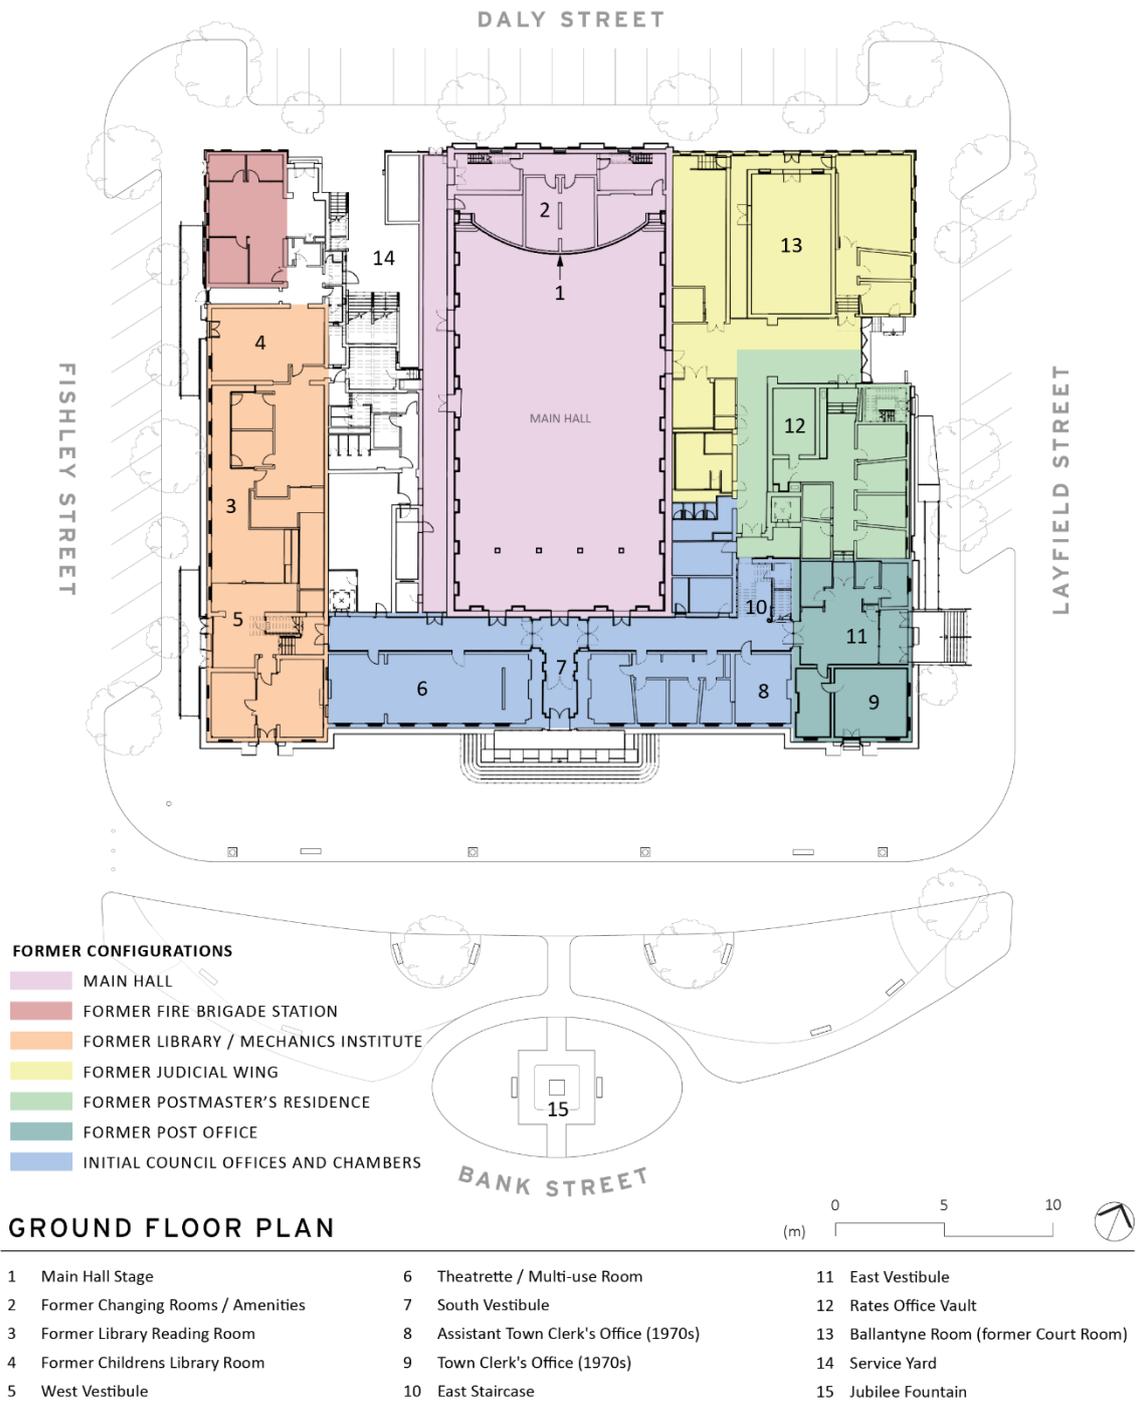
Figure 15 Existing conditions ground floor plan overlaid with locations (approximate) of original functions

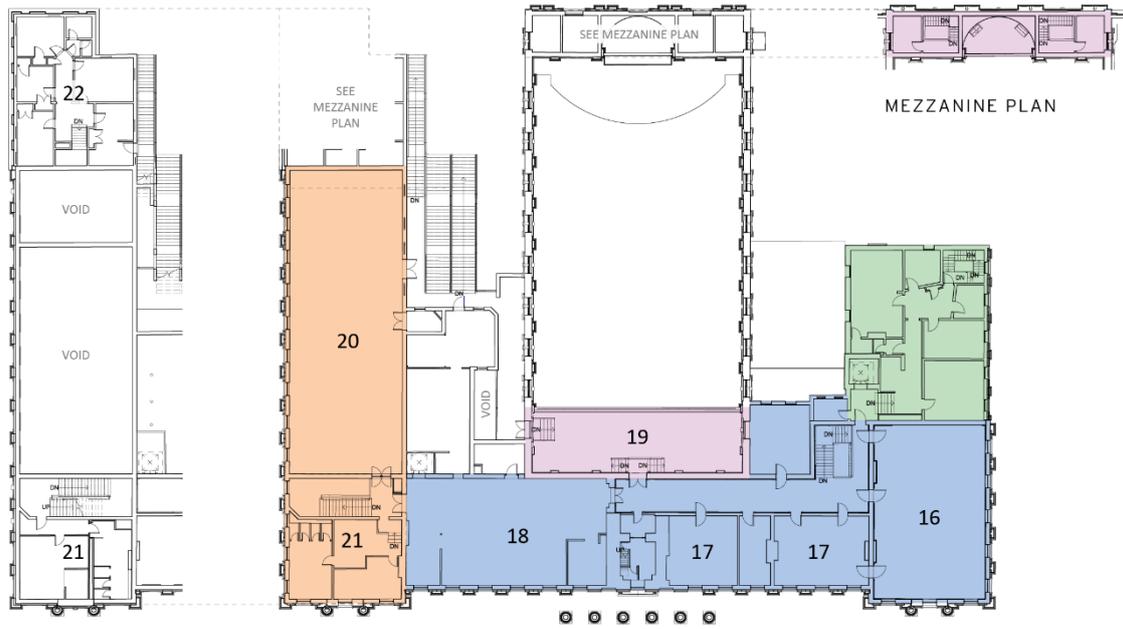
Figure 16 Existing conditions first floor plan overlaid with locations (approximate) of original functions

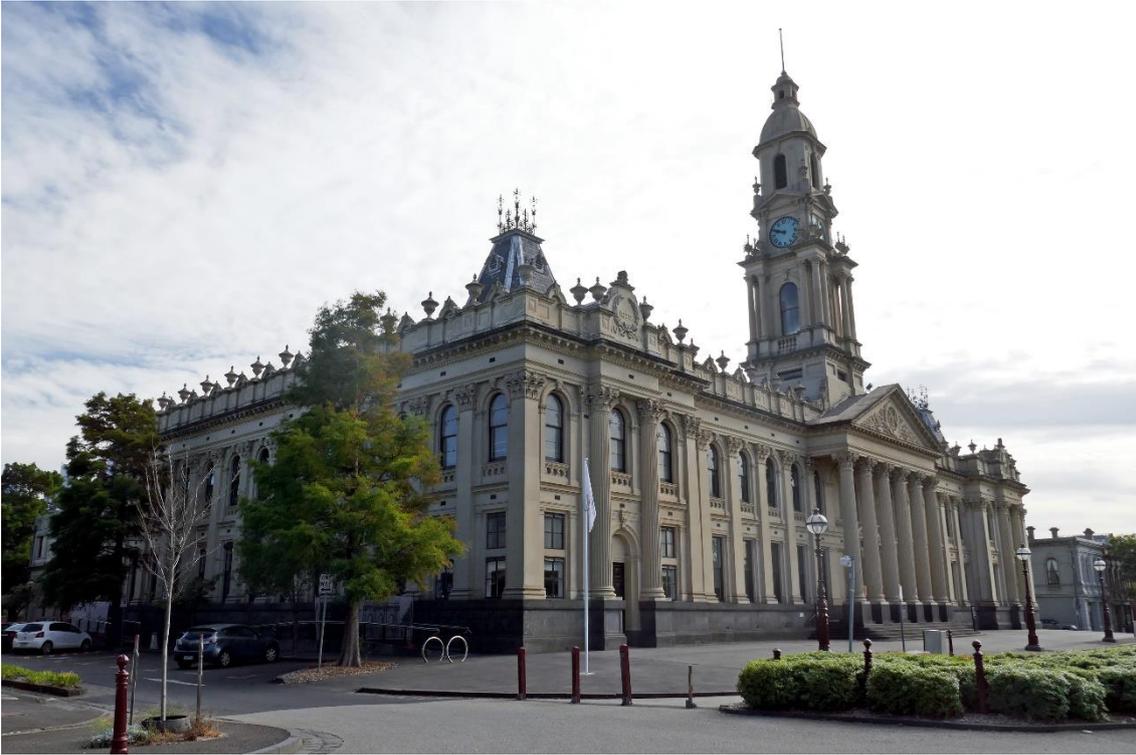
Figure 19 Primary scale elevations of the SMTH, viewed from south-west

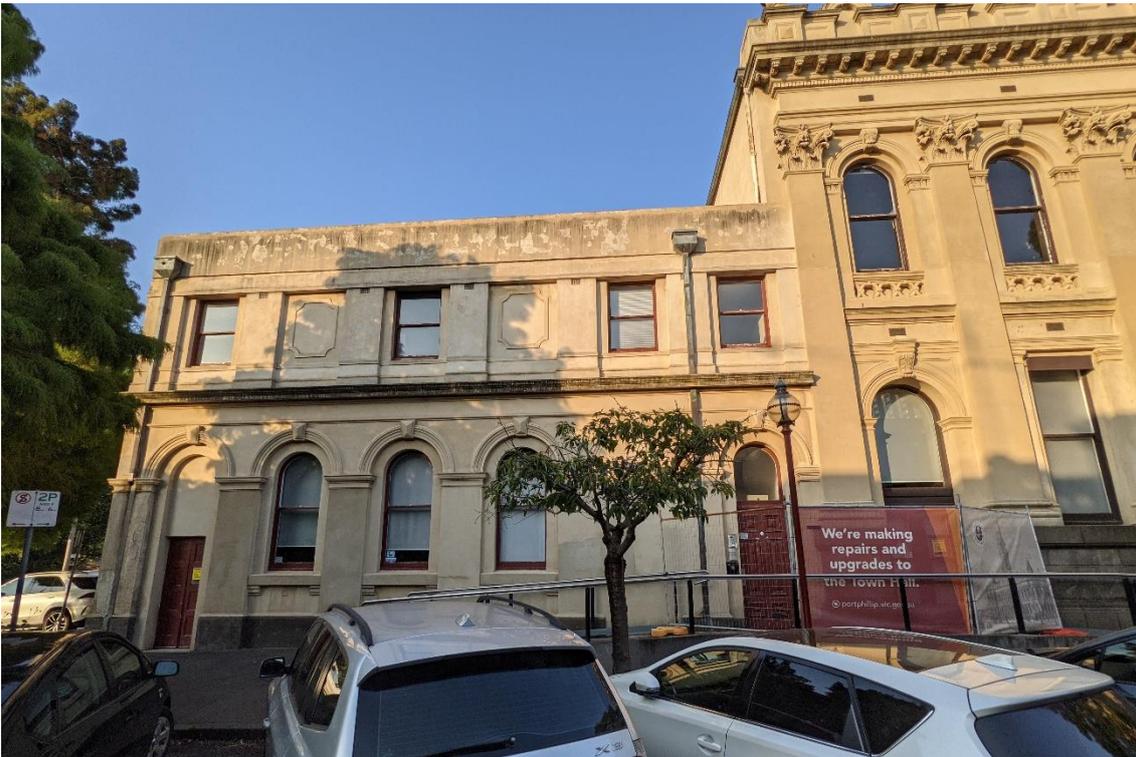
Figure 20 Secondary scale façade at north-west corner of the block, being the former fire brigade station (ground level) with 1938 residential addition above

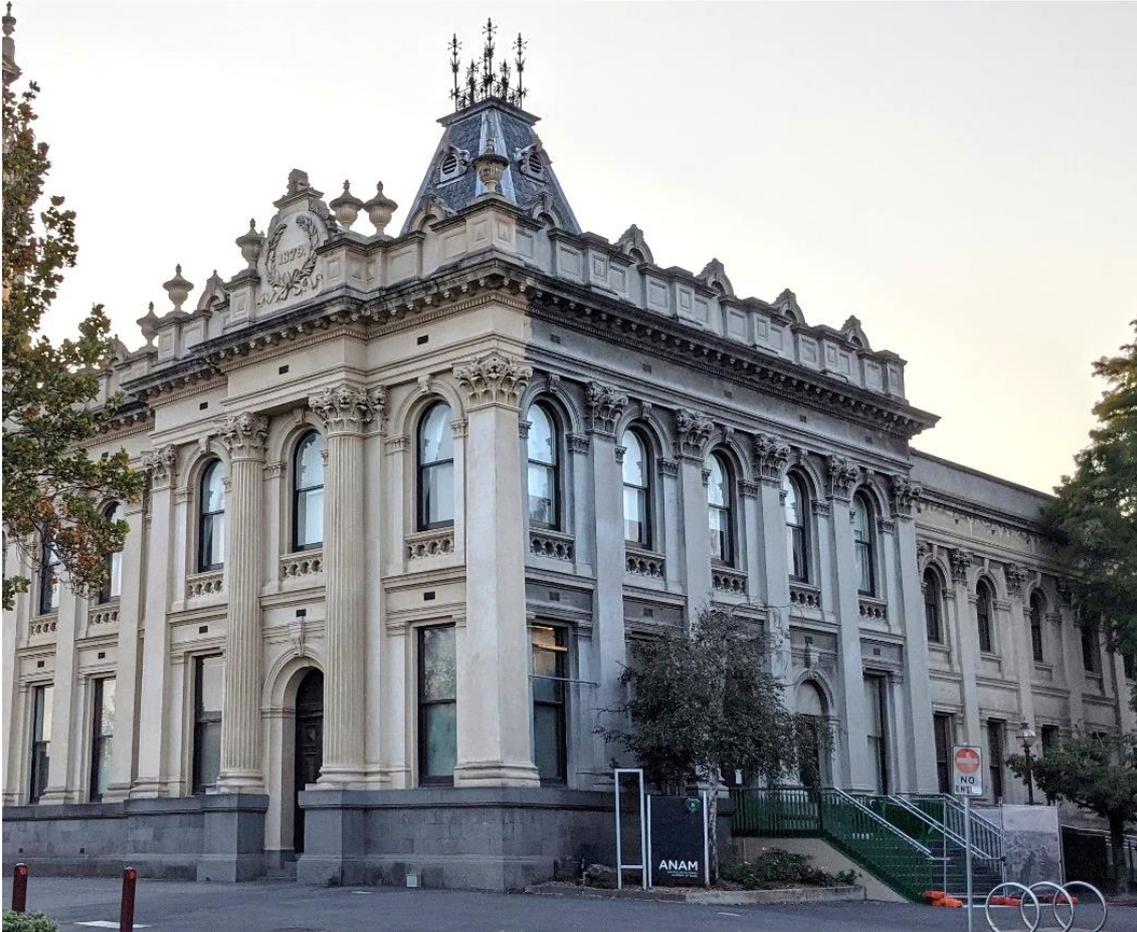
Figure 23 South-east corner of block (former post office) showing step down to the former council rates office (1938, right), and distinction between ochre skim coat (left) reintroduced in 2000s conservation programme and bare (grey) pressed cement render (centre)

The 2000s restoration programme directed by RBA included the restoration of a coloured skim coat to much of the cement rendered façade, based on chemical analysis of traces of the original treatment found on the east facades of the complex. Inspection and rectification of defects in the pressed render facades had required the removal of non-original grey cement bagging across the whole of the structure. The skim coat, developed with the assistance of Professor Miles Lewis of the University of Melbourne, was mixed to a recipe containing lime putty, brick dust, stone dust and cement, and restored the original appearance of the building, which as with many nineteenth century rendered structures had been dressed to emulate the yellow colour of limestone and sandstone buildings.

Due to funding constraints, restoration of the yellow skim coat was not completed on the east elevation, where the cement bagging was removed, leaving the underlying pressed cement rendering and traces of the original skim coat treatment (Figure 23). In some other areas, the replacement skim coat has been observed to have later failed, likely due to insufficient preparation of the underlying render by the builder.<sup>41</sup>

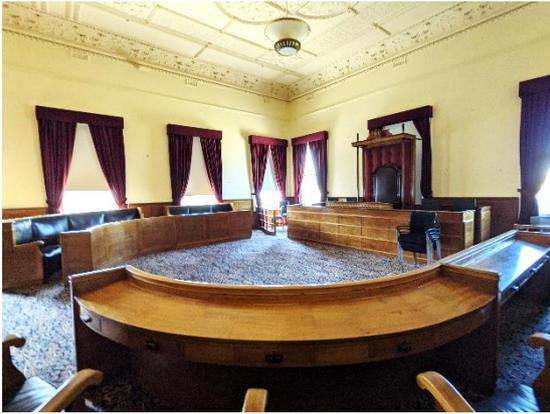
Figure 24 Council Chamber with integral furnishing suite

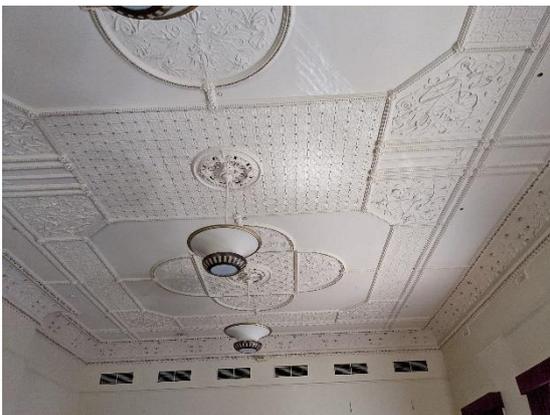
Figure 28 Elaborate plaster ceiling in council chamber

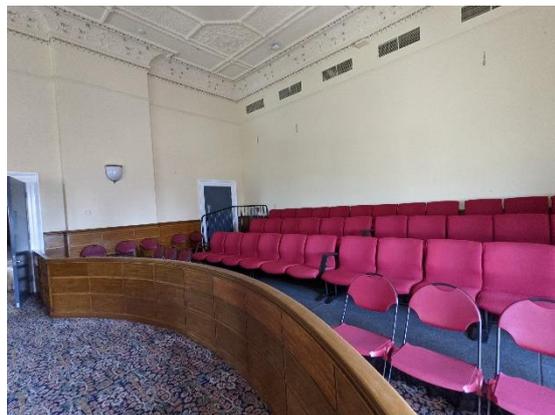
Figure 29 Original 1938 curved public seating divider, with modern seats and risers

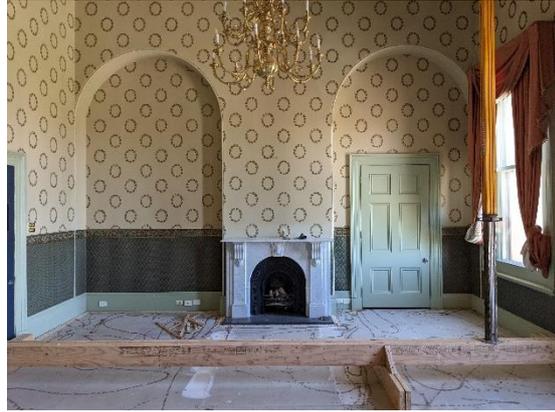
Figure 37 Mayor's Room, as remodelled to a Victorian style in 1991, with temporary structural propping installed and carpet removed

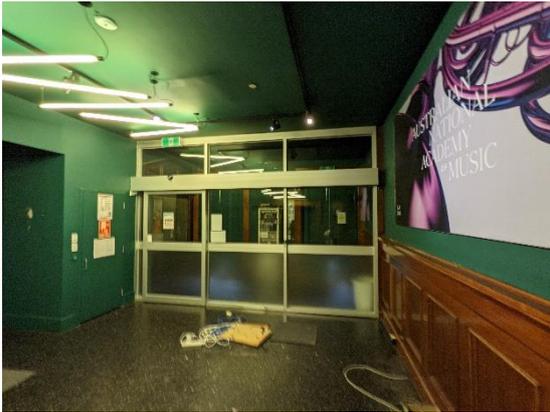
Figure 42 East vestibule, view east

The east vestibule (Figure 42 and Figure 43) originally provided access from Layfield Street to the Telegraph Office. The vestibule was expanded by the Council following the departure of the Post Office to provide public access to the new Rates Office (in the former Postmasters Residence) and through access to adjoining committee rooms and council offices and Main Hall to meet Board of Health compliance requirements. Successive renovations changed the floor level and access arrangements and partitions adjoining and within the vestibule, most recently to adapt the space for ANAM's main entrance and foyer. Although remodelled for ANAM, the vestibule retains substantial sections of the 1938 blackwood timber panelling and architraves.

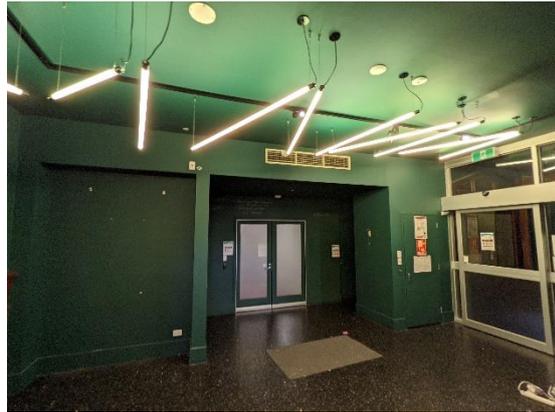
Figure 43 East vestibule, view north

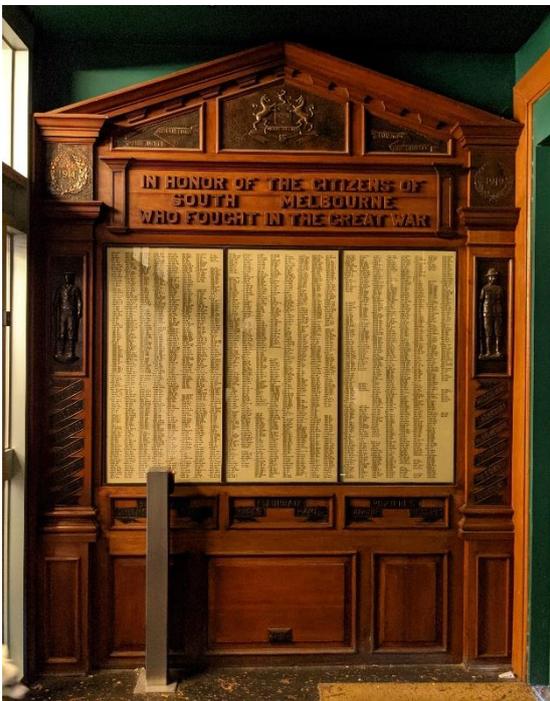
Figure 44 WW1 Honour Board

The WWI Honour Board (Figure 44) is situated in the current ANAM entrance vestibule (former Rates Office entrance, former Telegraph Office entrance) to Layfield Street. The board, an elaborate timber panel in a classical architectural motif (with pilasters and central pediment), includes commemorative bronze pennants and depictions of a soldier and sailor and bears the honourific 'IN HONOR OF THE CITIZENS OF SOUTH MELBOURNE WHO FOUGHT IN THE GREAT WAR' and a three panel glass casement containing more than 3,000 names.

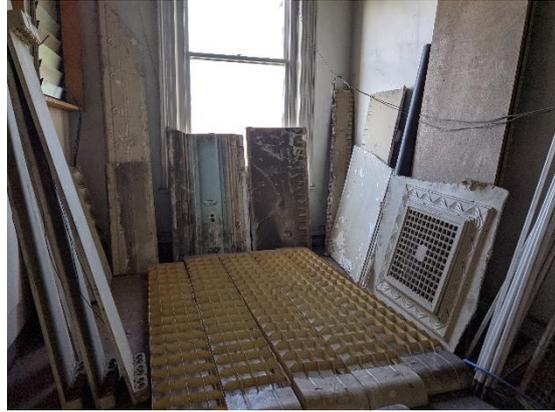
Figure 49 Salvaged room finishes from Supper Room

The room is in a substantially gutted condition due to the roof failure and related damage and to allow for further investigations and the installation of temporary structural supports, and now awaits remediation (Figure 48 and Figure 49).

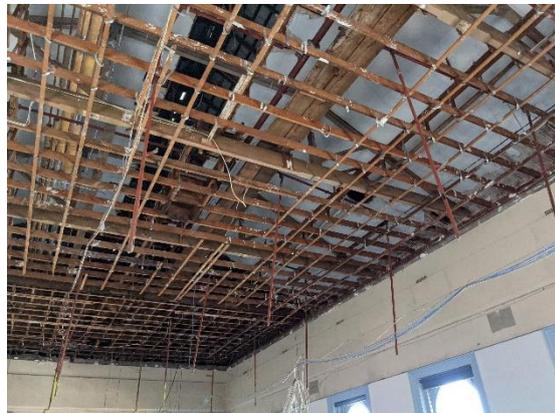
Figure 51 Lodge Room ceiling joists with remnants of earlier raked ceiling behind

Both upper level function rooms were served by a large kitchen and adjoining servery located on the rear side of the building. These were later renovated as offices and storerooms (Figure 50 and Figure 51).

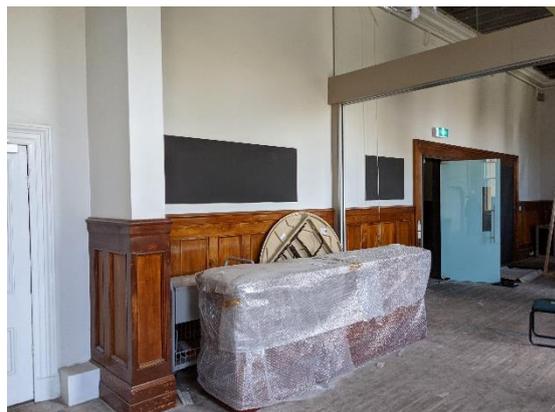
Figure 53 Wood panelling and architraves in part of the multi-purpose room

Floor and ceiling finishes in this room were substantially gutted as a result of the 2018 roof failure and are awaiting remediation. Remaining timber panelling, architraves and ceiling cornices are inconsistently applied throughout the space and reflect its evolution through successive renovations in the 1980s and 1990s to accommodate the library, planning department and later uses (Figure 52 and Figure 53).

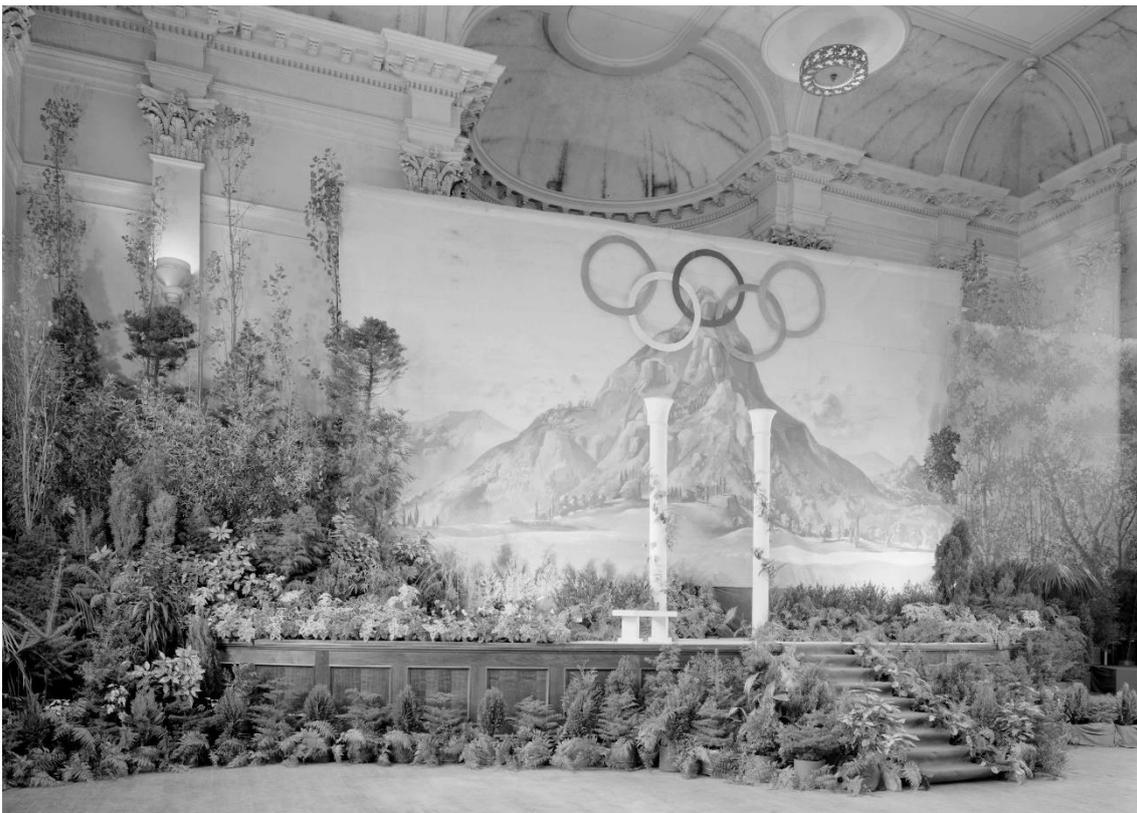
Figure 54 The Main Hall stage dressed for the 1956 Olympic Games: note the cracking to the coved ceiling plaster at top right  
Source: State Library of Victoria

The hall interior has been restored at least twice since the 1938 remodelling. Photographs of the Hall at the time of the 1956 Melbourne Olympics show extensive cracking of the coved ceiling plaster, which was presumably the subject of subsequent repairs (Figure 54). A restoration and redecoration of the Hall interior was reportedly undertaken in 1983 for the City of South Melbourne Centennial Celebration, at which time the current colour scheme (including tones of wine, gold, cream and blue) is presumed to have been implemented (it is not known if the scheme was based on evidence). Electric heaters are mounted to the side walls (there is no other HVAC), and a modern lighting truss is suspended in the front of the stage.

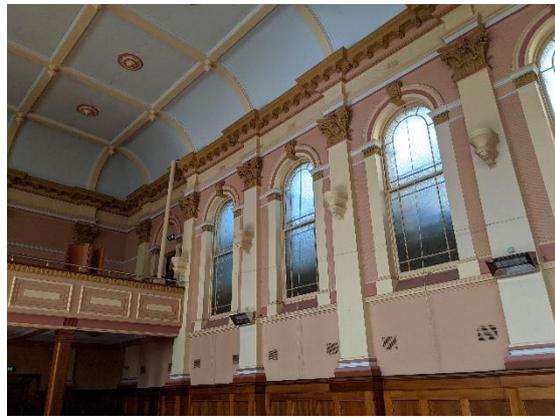
Figure 58 Internal ornamentation, Main Hall

The Main Hall interior has elaborate pressed render and plaster detailing, including Corinthian pilasters and an entablature generally matching the external treatment, as well as additional projecting wall sconces, and ribbing, rosettes and other projections from the lathe and plaster ceiling. Frosted glass arched head windows are partly operable. The hall is lined at ground level with Blackwood panelling matching the renovated offices and hallways, with further panelling on the infill wall behind the semi-circular stage with a decorative carved timber panel above the doorway to the rear. Three large decorative pendant lights are hung from ceiling ribs.

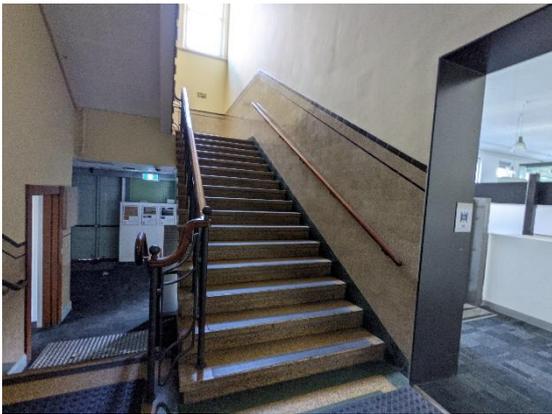
Figure 65 West vestibule

The west vestibule (Figure 65 and Figure 66) was remodelled in 1938 works to provide a new public access foyer to the library, the ground floor council offices, and the first floor Lodge Room and Supper Room. The vestibule also incorporated new mezzanine amenities between the original floor levels, created by lowering the ceiling height within the original Mechanics Institute entry vestibule from Bank Street and adjoining rooms, and by raising the floor level for the Level 1 amenities. The west vestibule includes terrazzo flooring to the stairs and entrance foyer, terrazzo tile dado, and a decorative iron balustrade with timber rail.

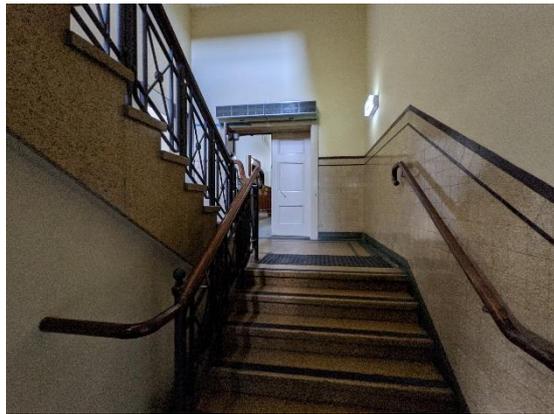
Figure 66 West vestibule at mezzanine level

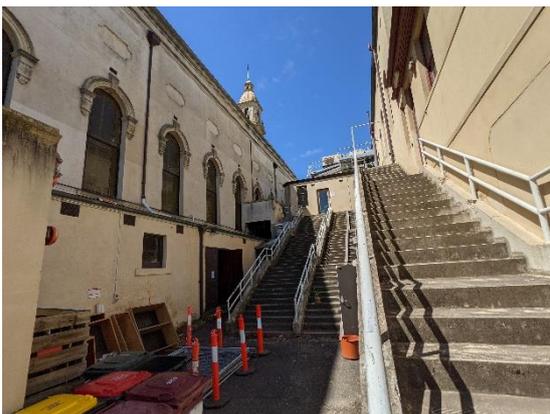
Figure 71 Former service yard with retrofitted concrete fire stairs

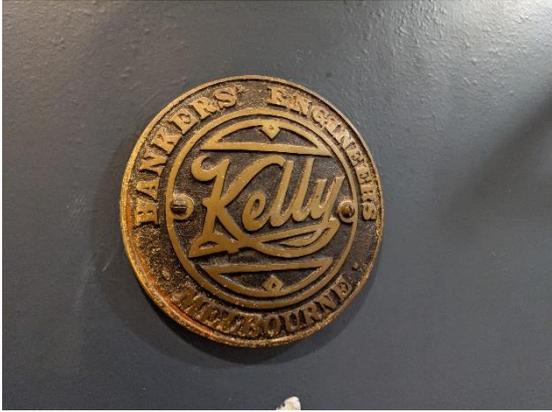
Figure 77 Bronze logomark on former Rates Office Vault (c. 1938)

Two features retained from the 1938 development are a strong room in the centre of the block at ground level (Figure 77), and a timber staircase in the north-east corner of the block (Figure 82). The strong room has an original door bearing the bronze logo of the Kelly safe manufacturing company.

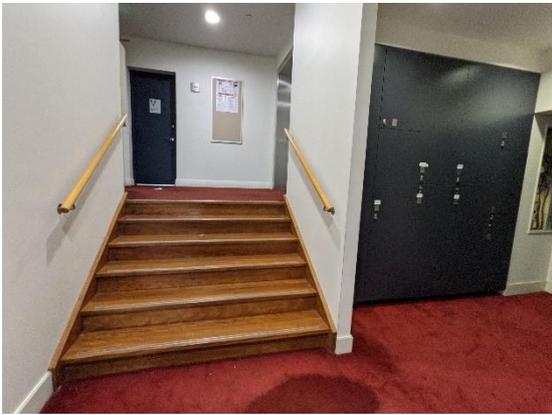
Figure 79 Level change from former residence / offices to first floor of original council offices

To the north of the eastern vestibule, an expanded rates office and first floor residence (Figure 78, Figure 80 and Figure 81) were constructed in 1938 on the modified footprint of the original postmaster's residence, and tied directly into the council offices at both levels (Figure 79). These offices were remodelled repeatedly (and the Hallkeeper's flat removed and replaced with committee rooms) in the latter half of the twentieth century, most recently to accommodate ANAM in the 1990s.

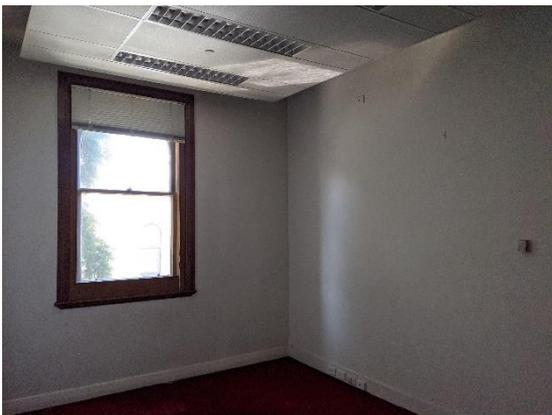
Figure 81 First floor room in former residence / offices

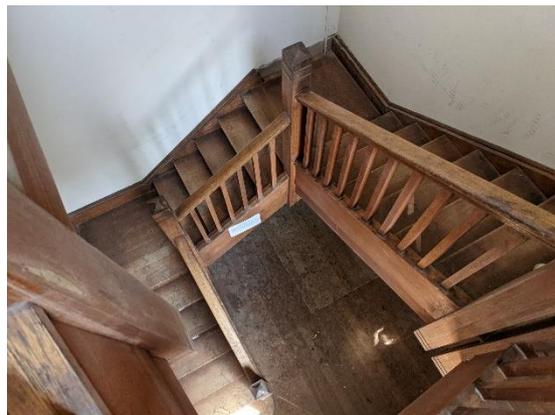
Figure 82 Access stair to former hall keeper's residence

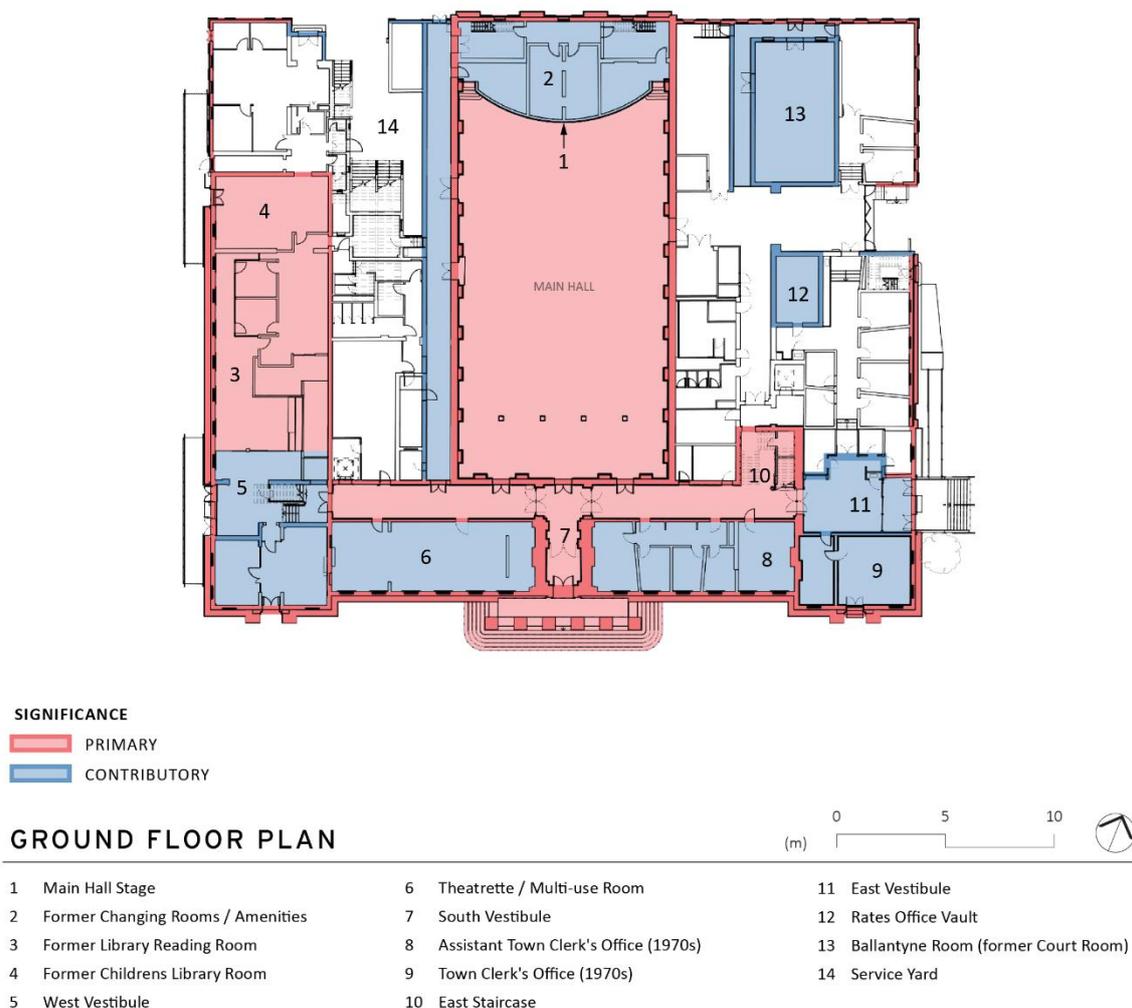
Figure 91 Levels of significance: ground floor

The purpose of the distinctions drawn at Table 3 is to assist in managing the building in a manner that minimises impacts on its cultural heritage values. See also Figure 91 and Figure 92. Room numbers in the table below refer to those identified in Appendix A.

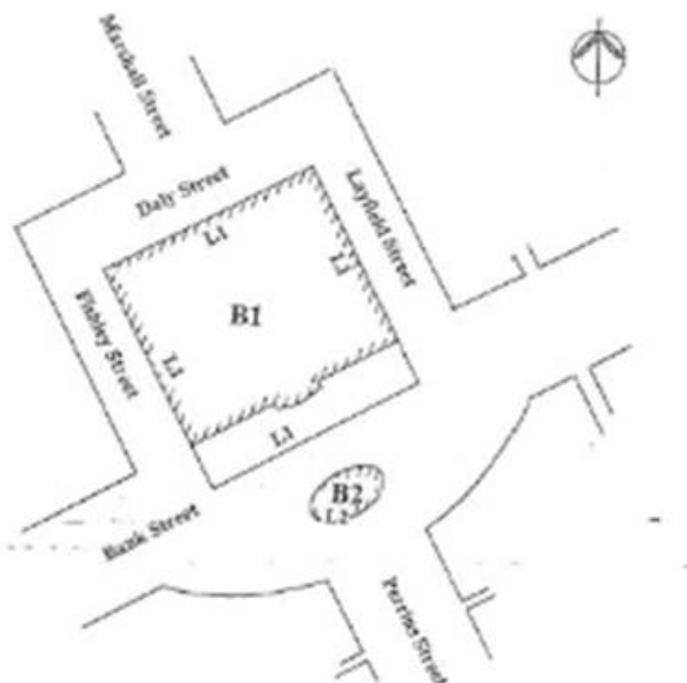
Figure 93 SMTH, extent of registration VHR HO217  
Source: Victorian Heritage Register

The SMTH, and items of furniture within the Council Chamber, are subject to the provisions of the *Heritage Act 2017* through their inclusion in the Victorian Heritage Register (VHR) as HO217. The extent of registration (land and buildings only) is shown at Figure 93 and described as follows:

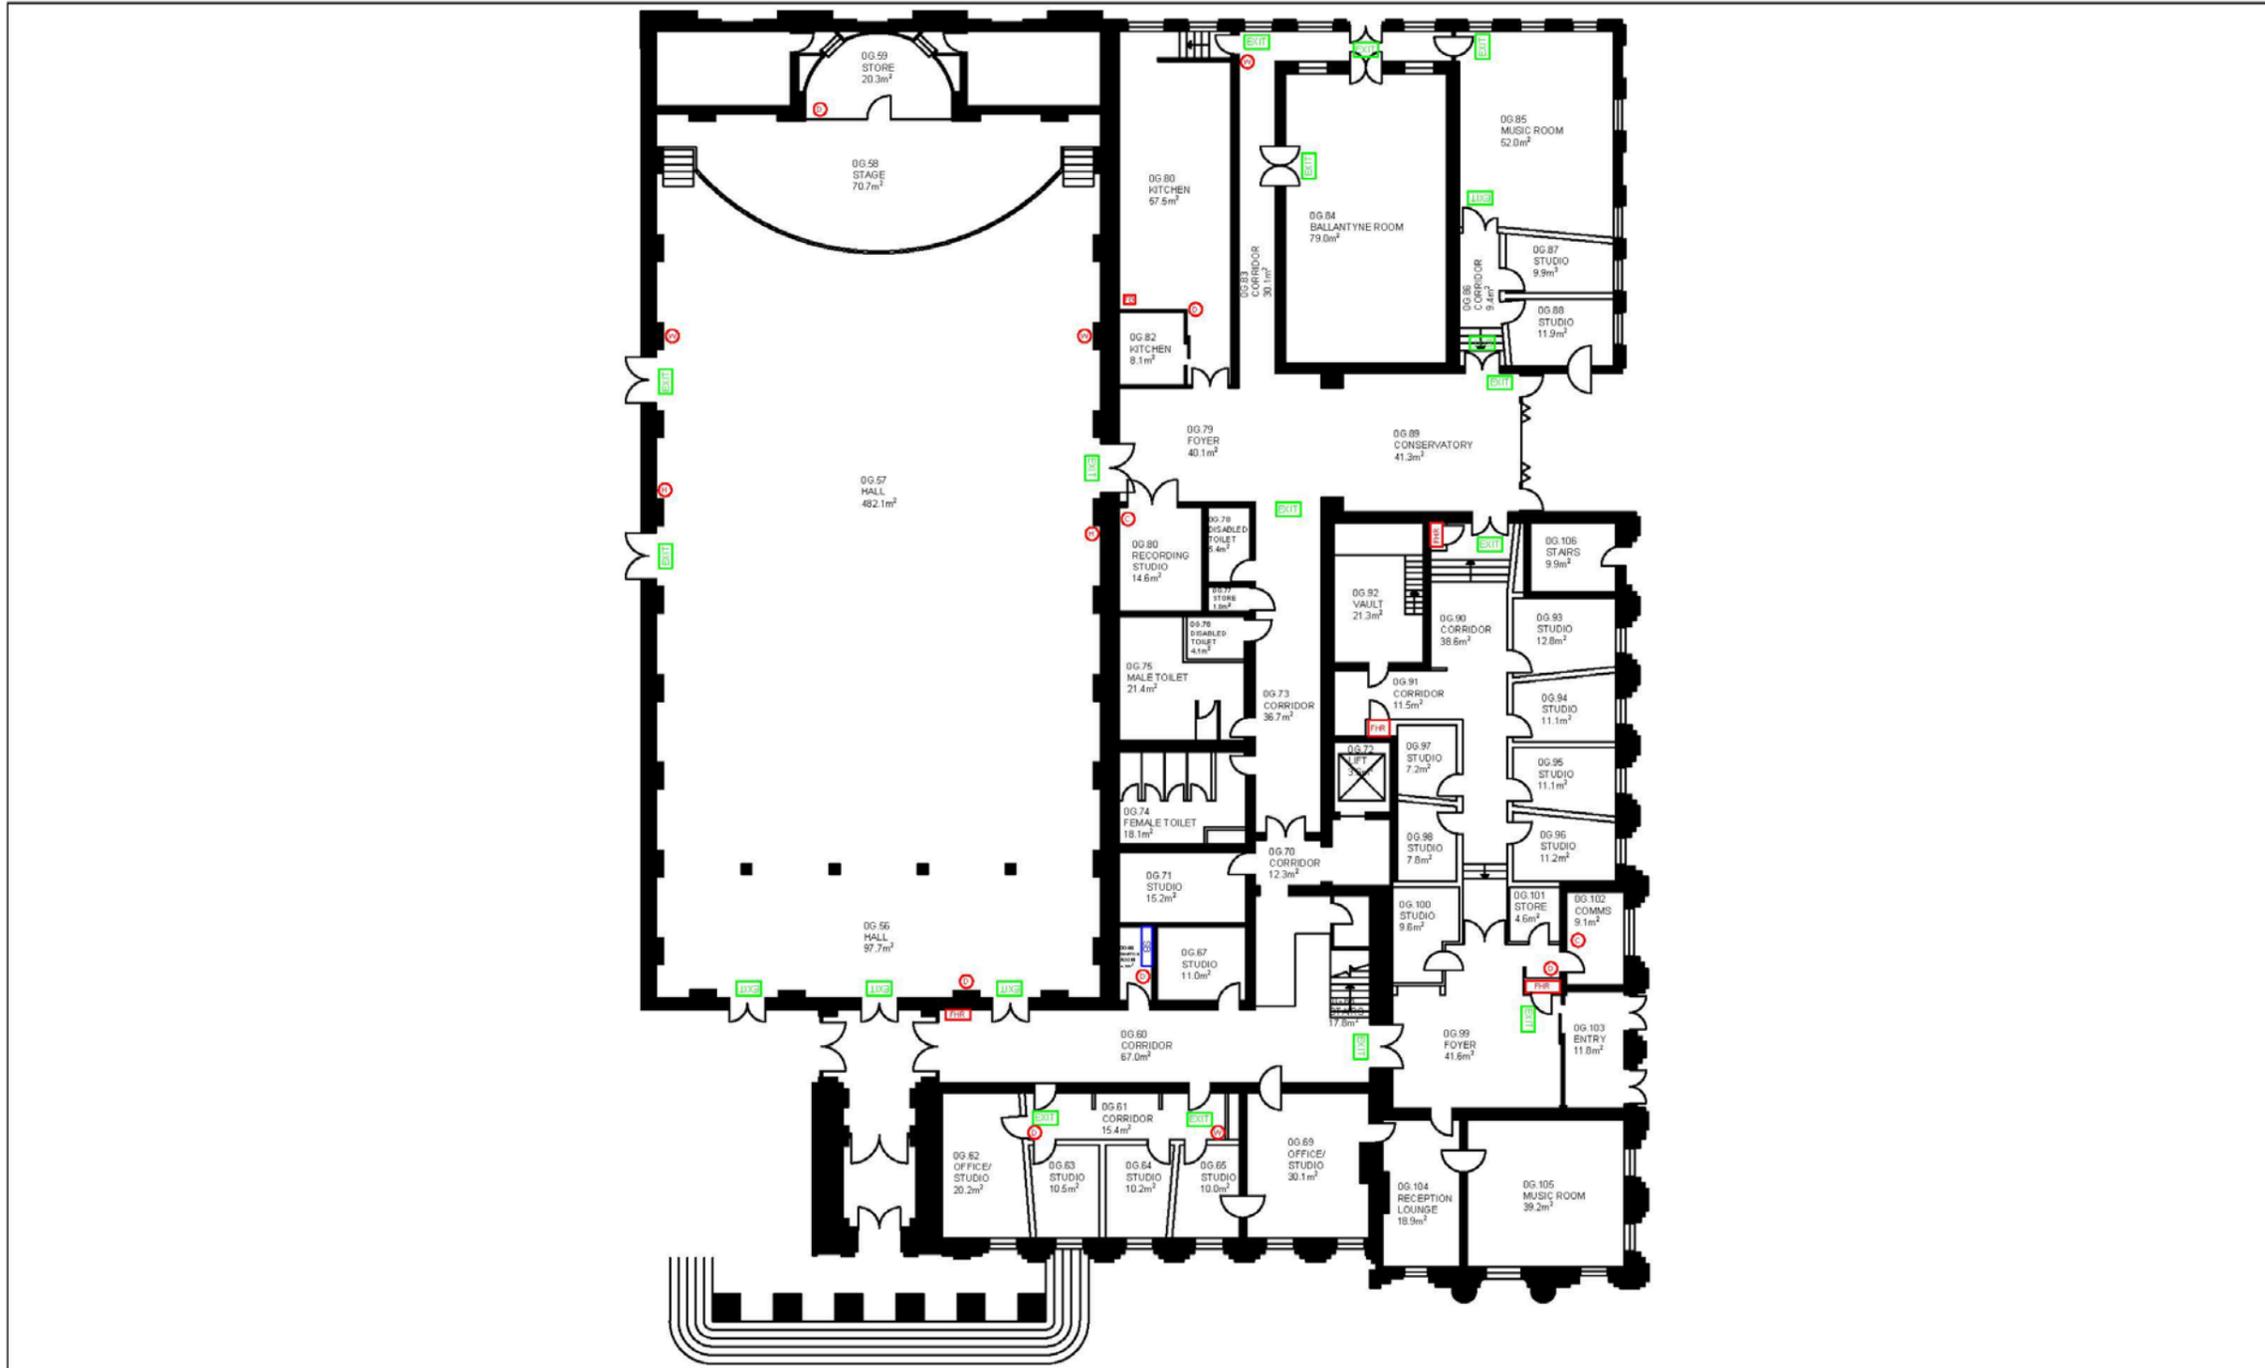
Figure 1 Existing Conditions Plan, SMTH East Wing Ground Level with City of Port Phillip room numbers  
Source: City of Port Phillip
