# South Melbourne Town Hall

Conservation Management Plan

208-220 Bank Street, South Melbourne, Victoria

LOVELL CHEN

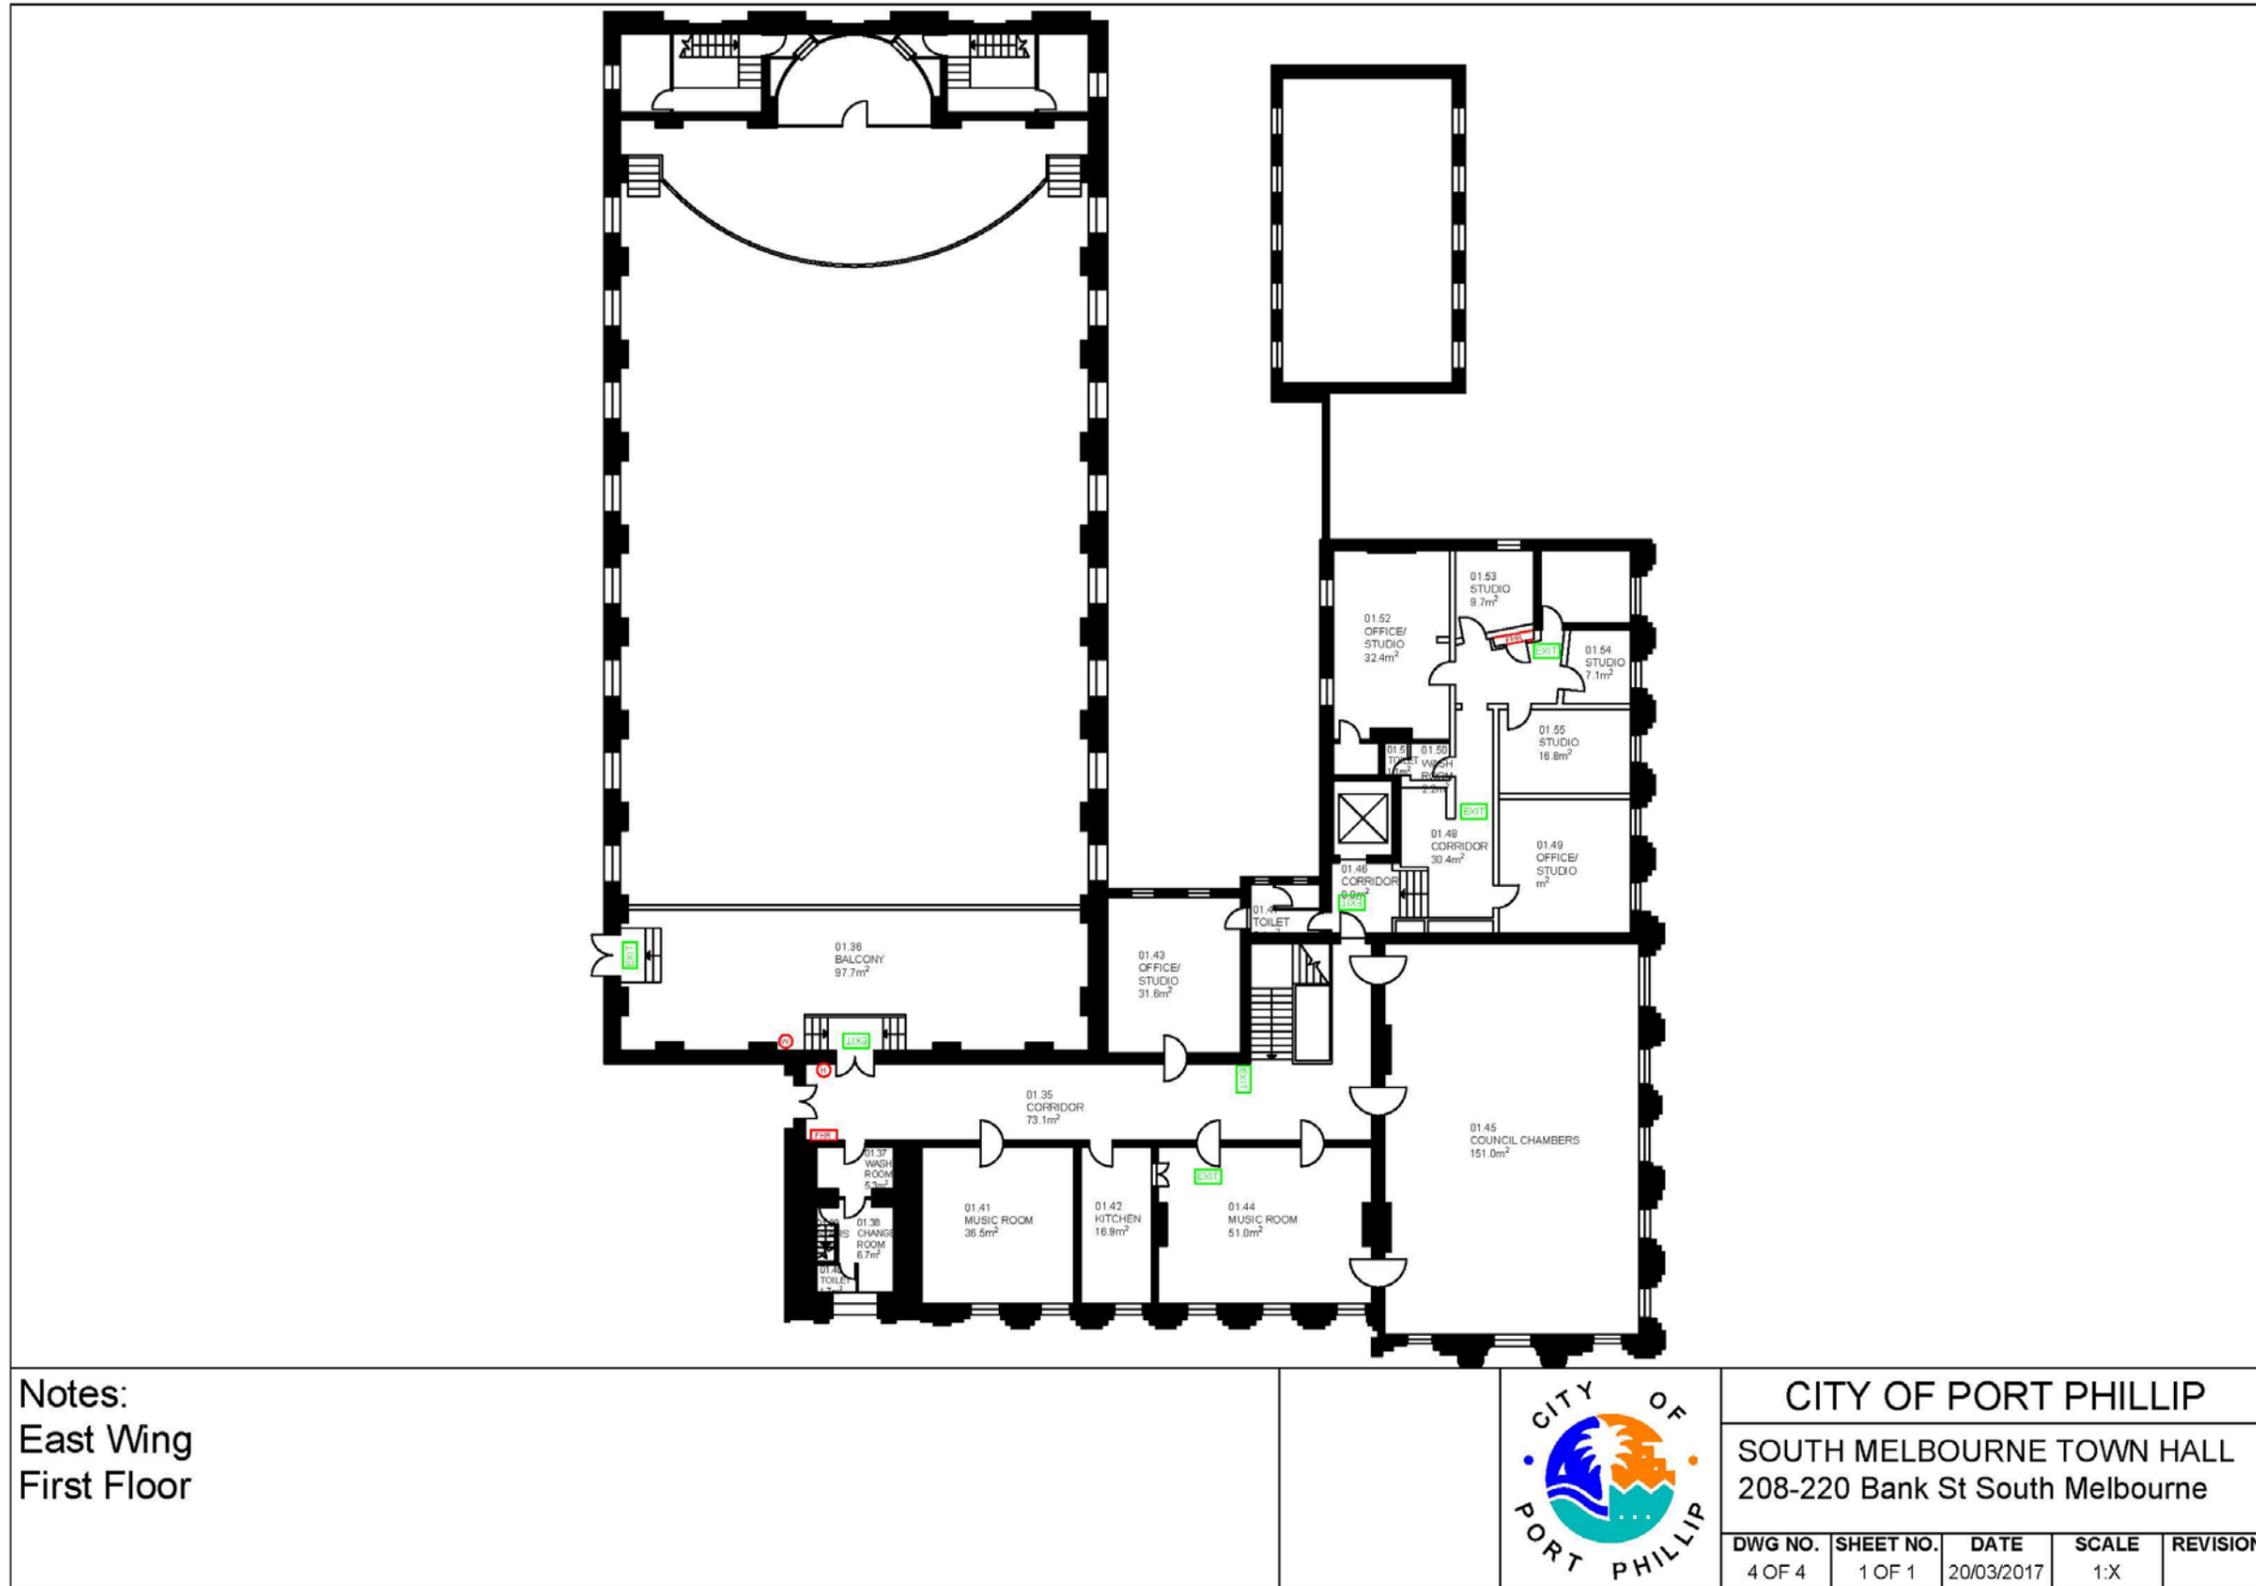
Figure 2 Existing Conditions Plan, SMTH East Wing First Floor with City of Port Phillip room numbers  
Source: City of Port Phillip

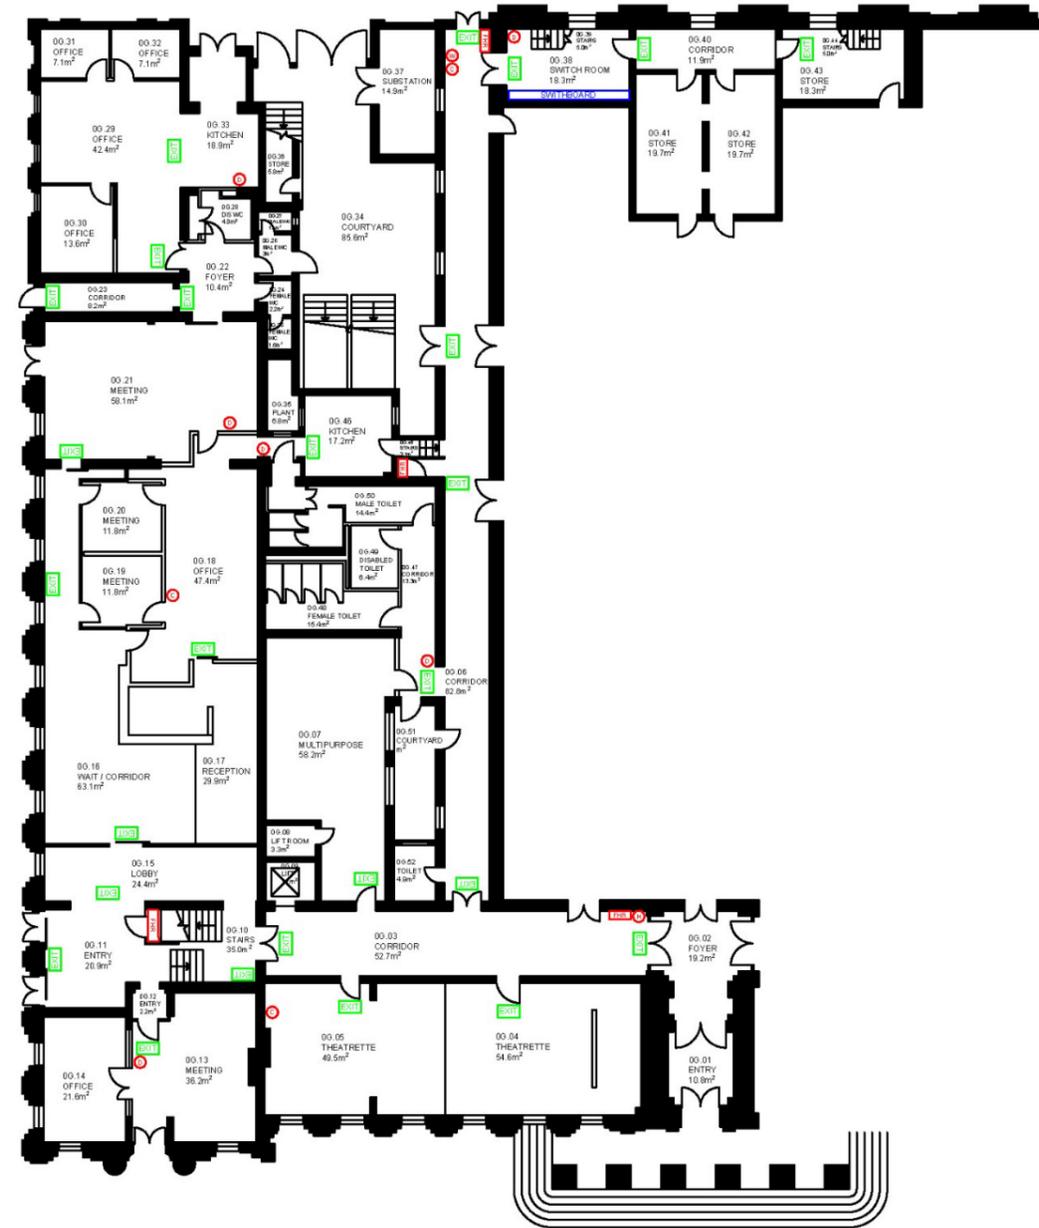
Figure 3 Existing Conditions Plan, SMTH West Wing Ground Level with City of Port Phillip room numbers  
Source: City of Port Phillip

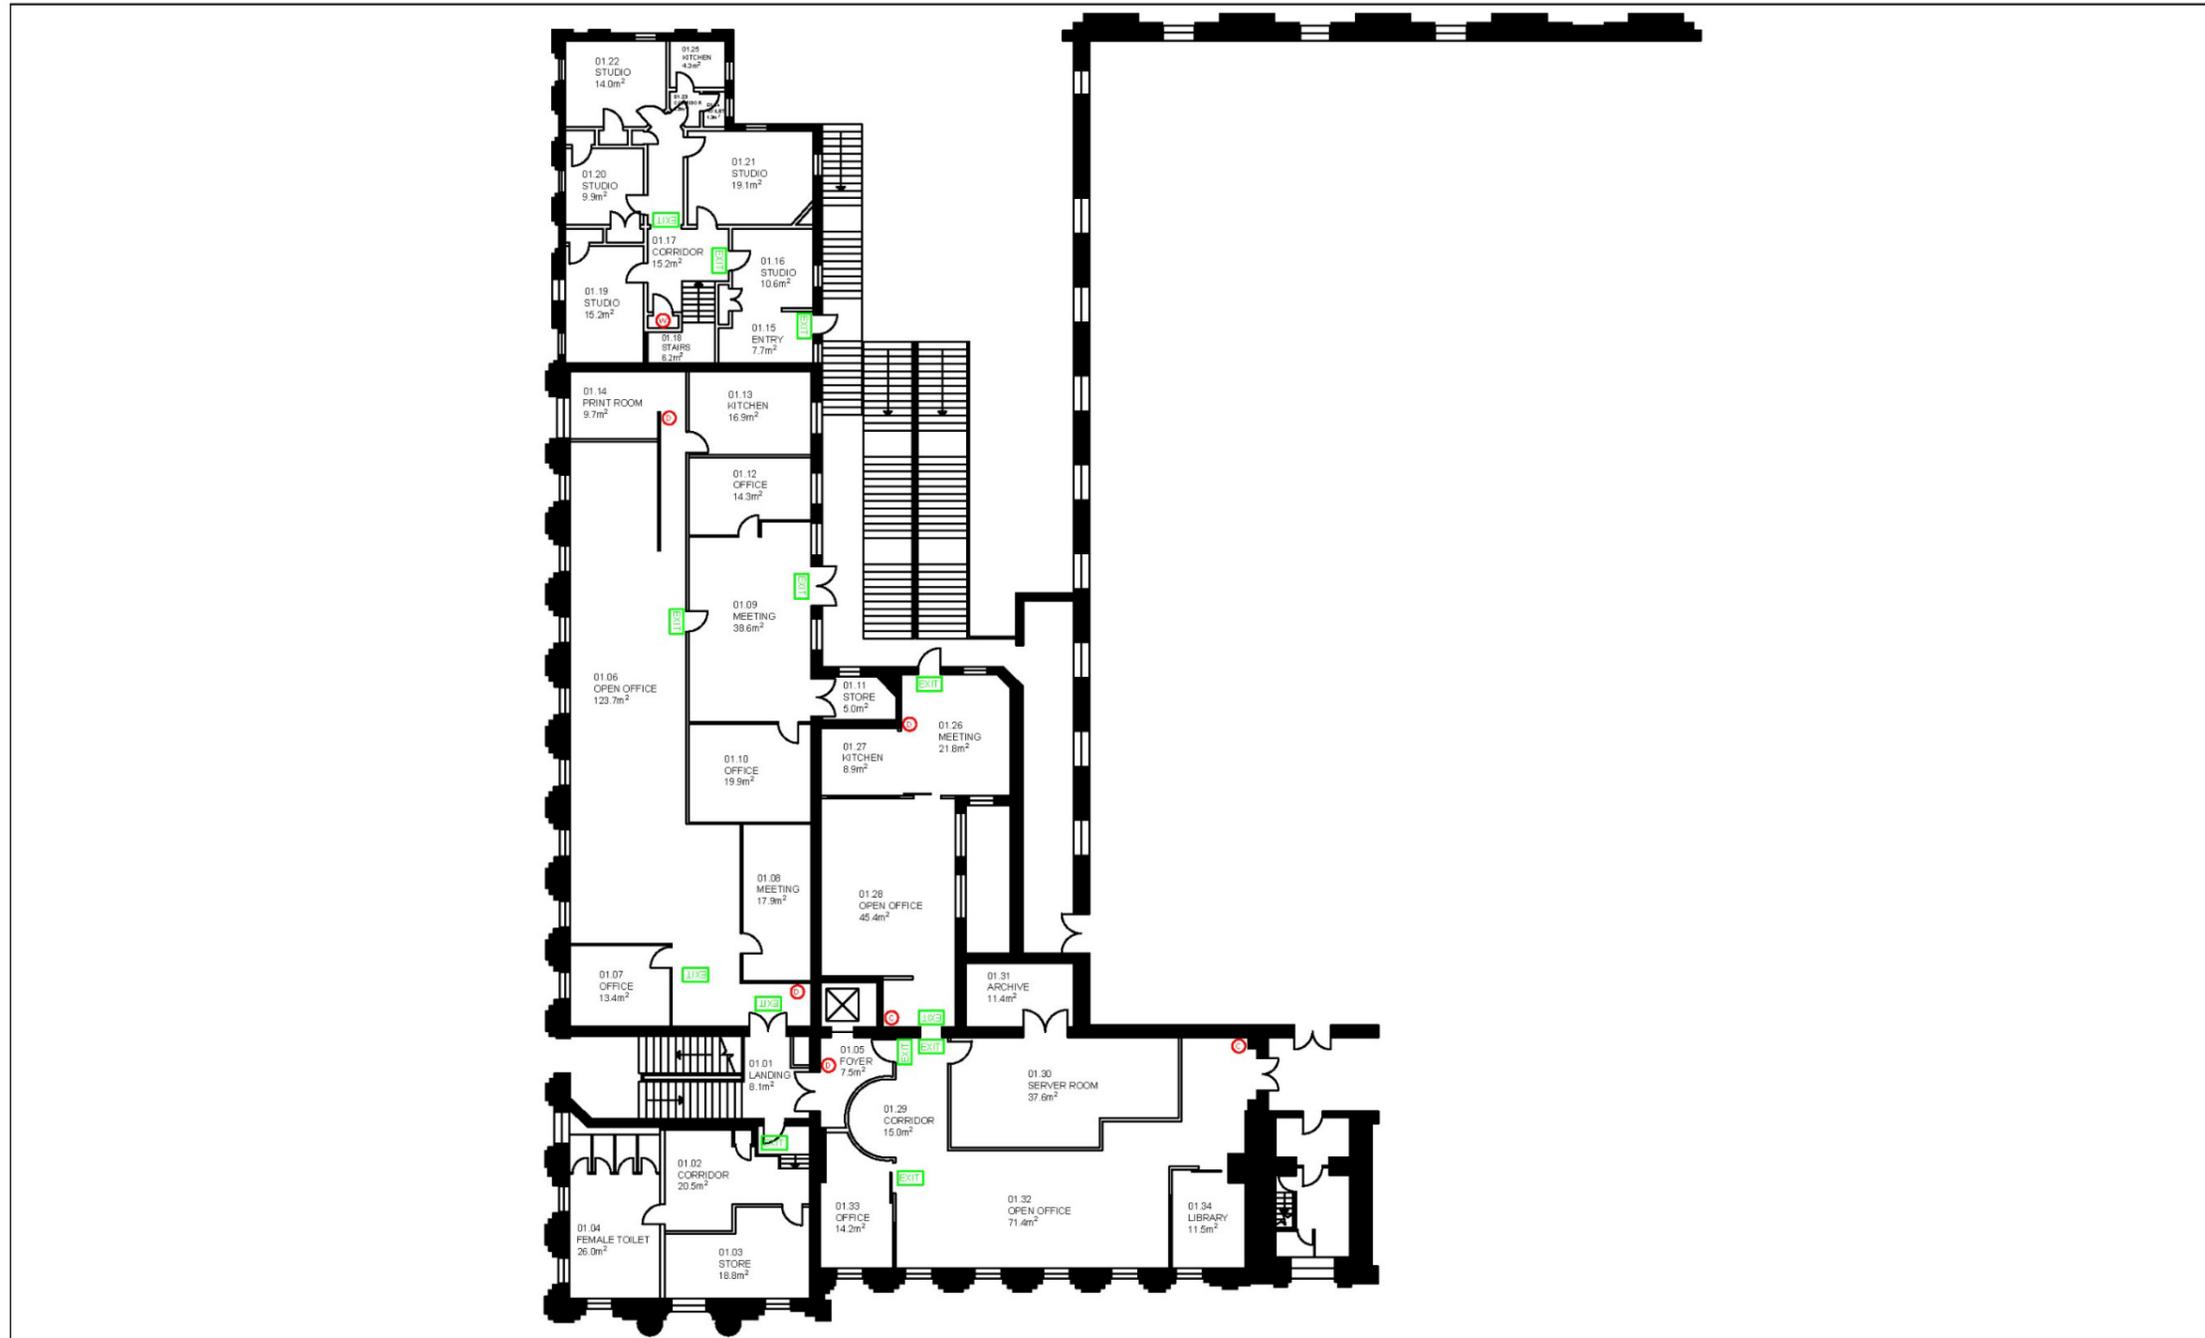
Figure 4 Existing Conditions Plan, SMTH West Wing First Floor with City of Port Phillip room numbers  
Source: City of Port Phillip

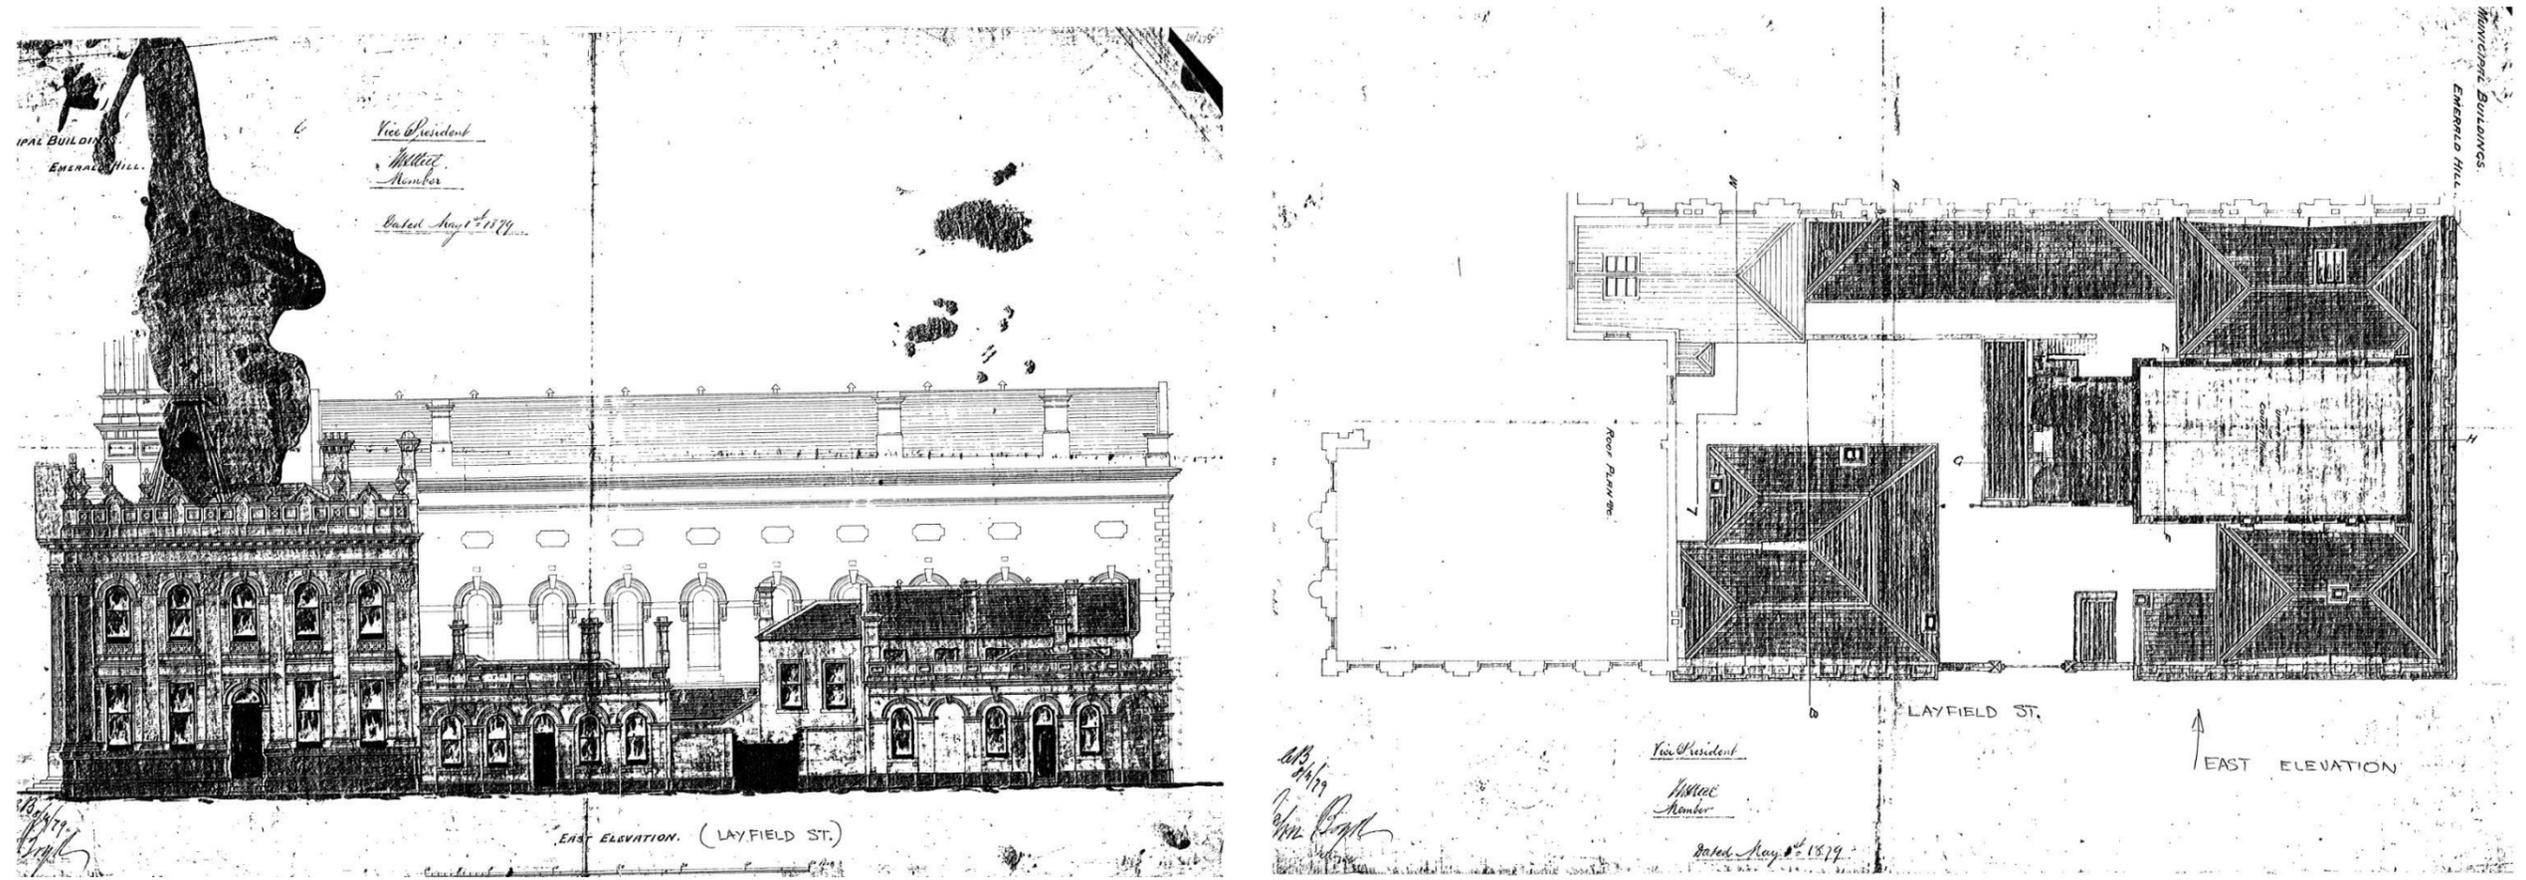
Figure 2 c. 1878 elevation and plan drawing showing the original arrangement of the east wings along Layfield Street (left to right: Post and Telegraph Office; Postmaster's Residence; and Judicial Wing) prior to the subsequent history of renovations and reconstructions that occurred in this area from the 1880s through the 1990s  
Source: City of Port Phillip

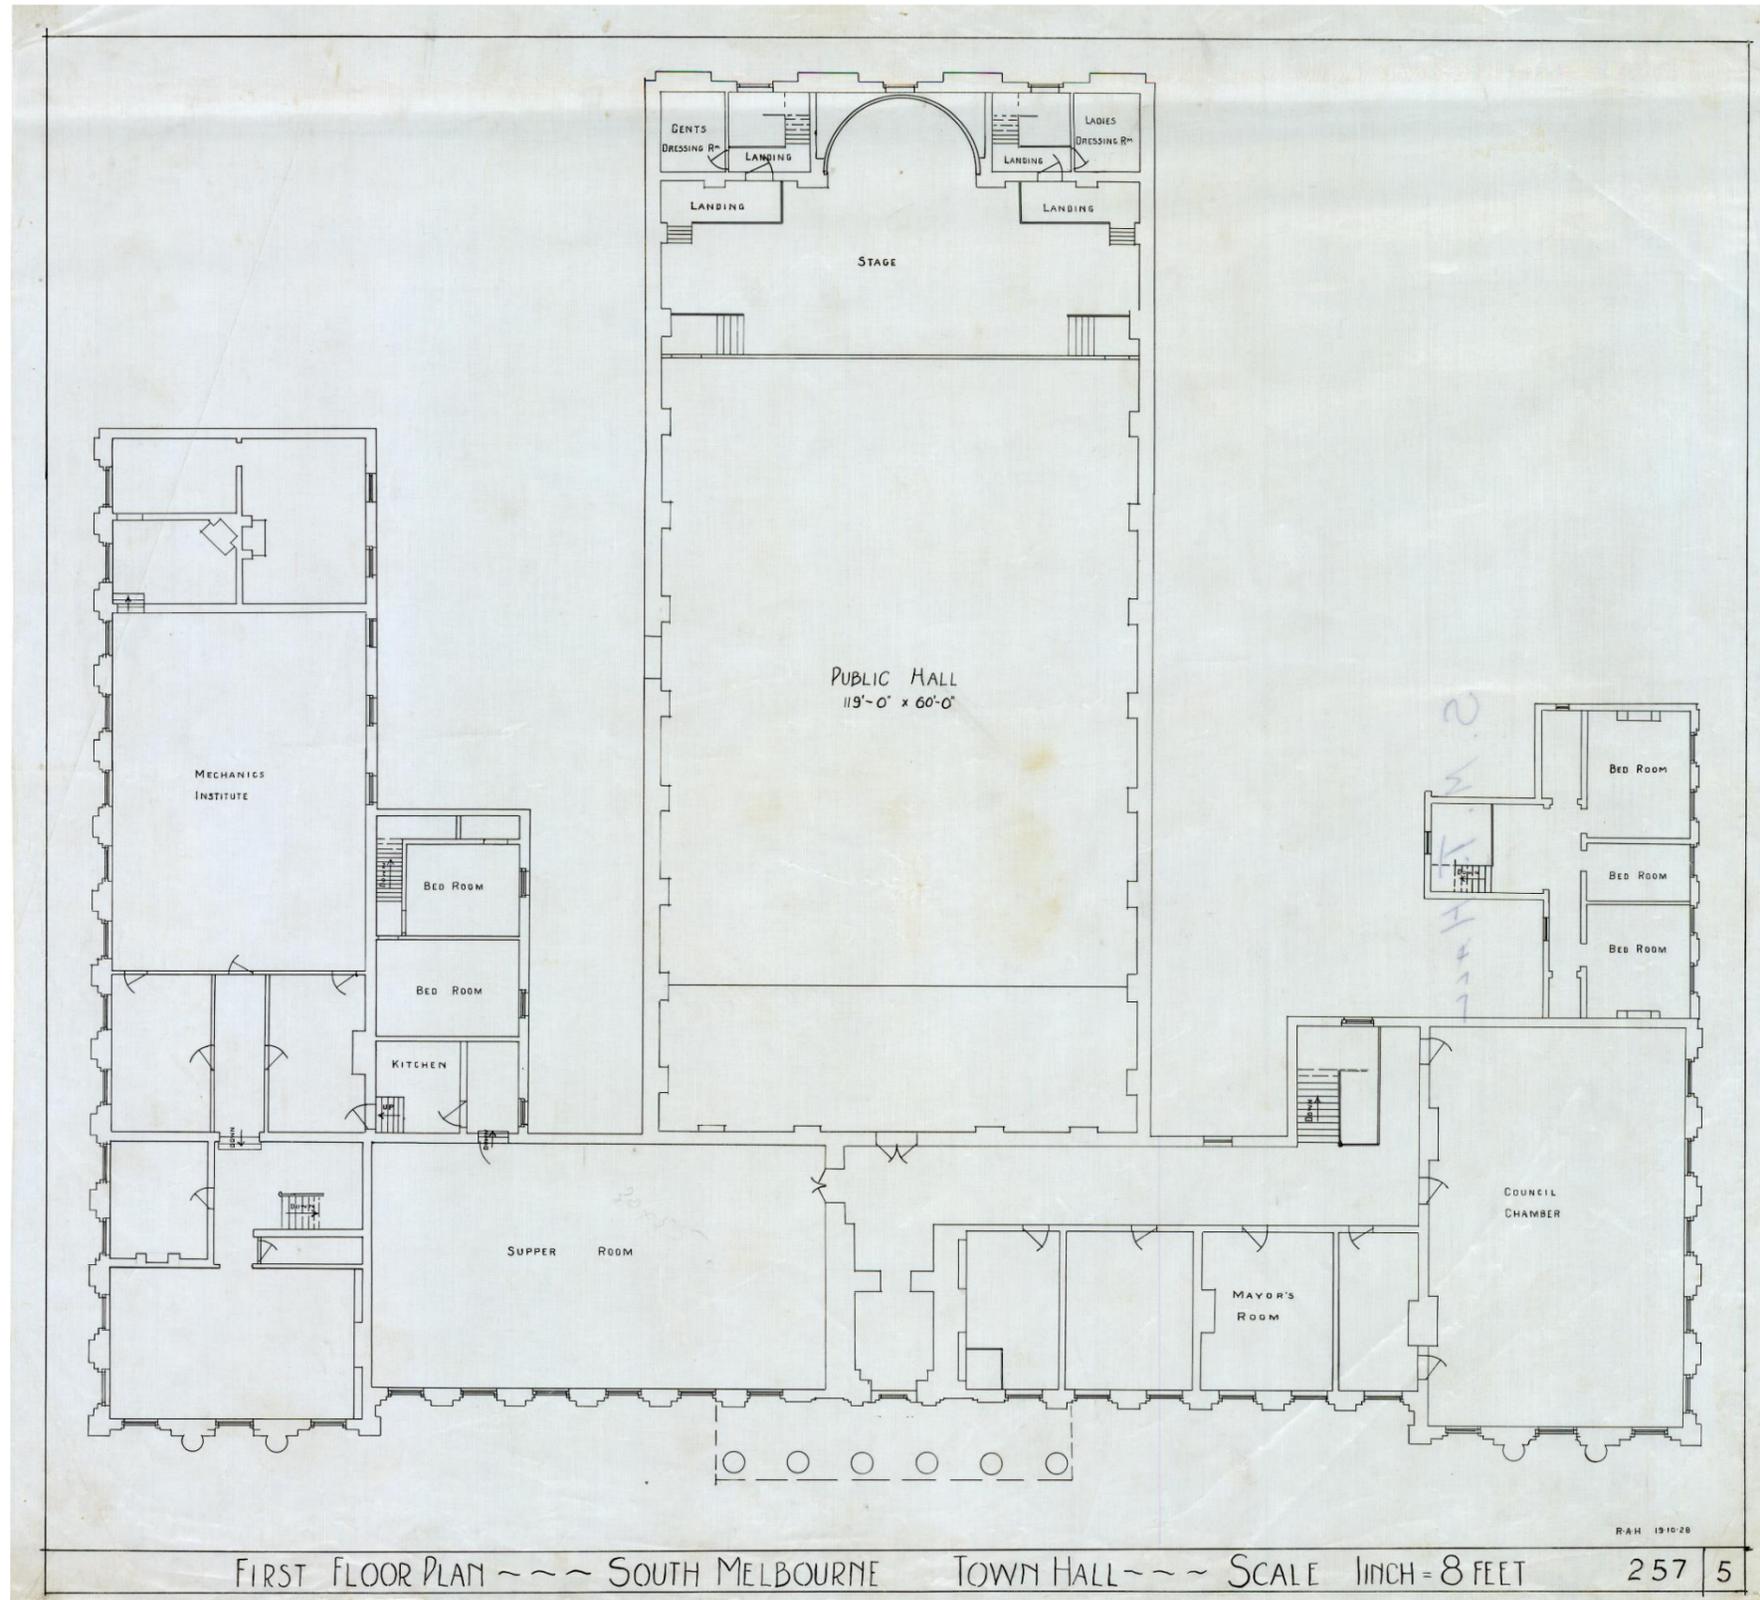
Figure 3 1928 First Floor Plan  
Source: City of Port Phillip

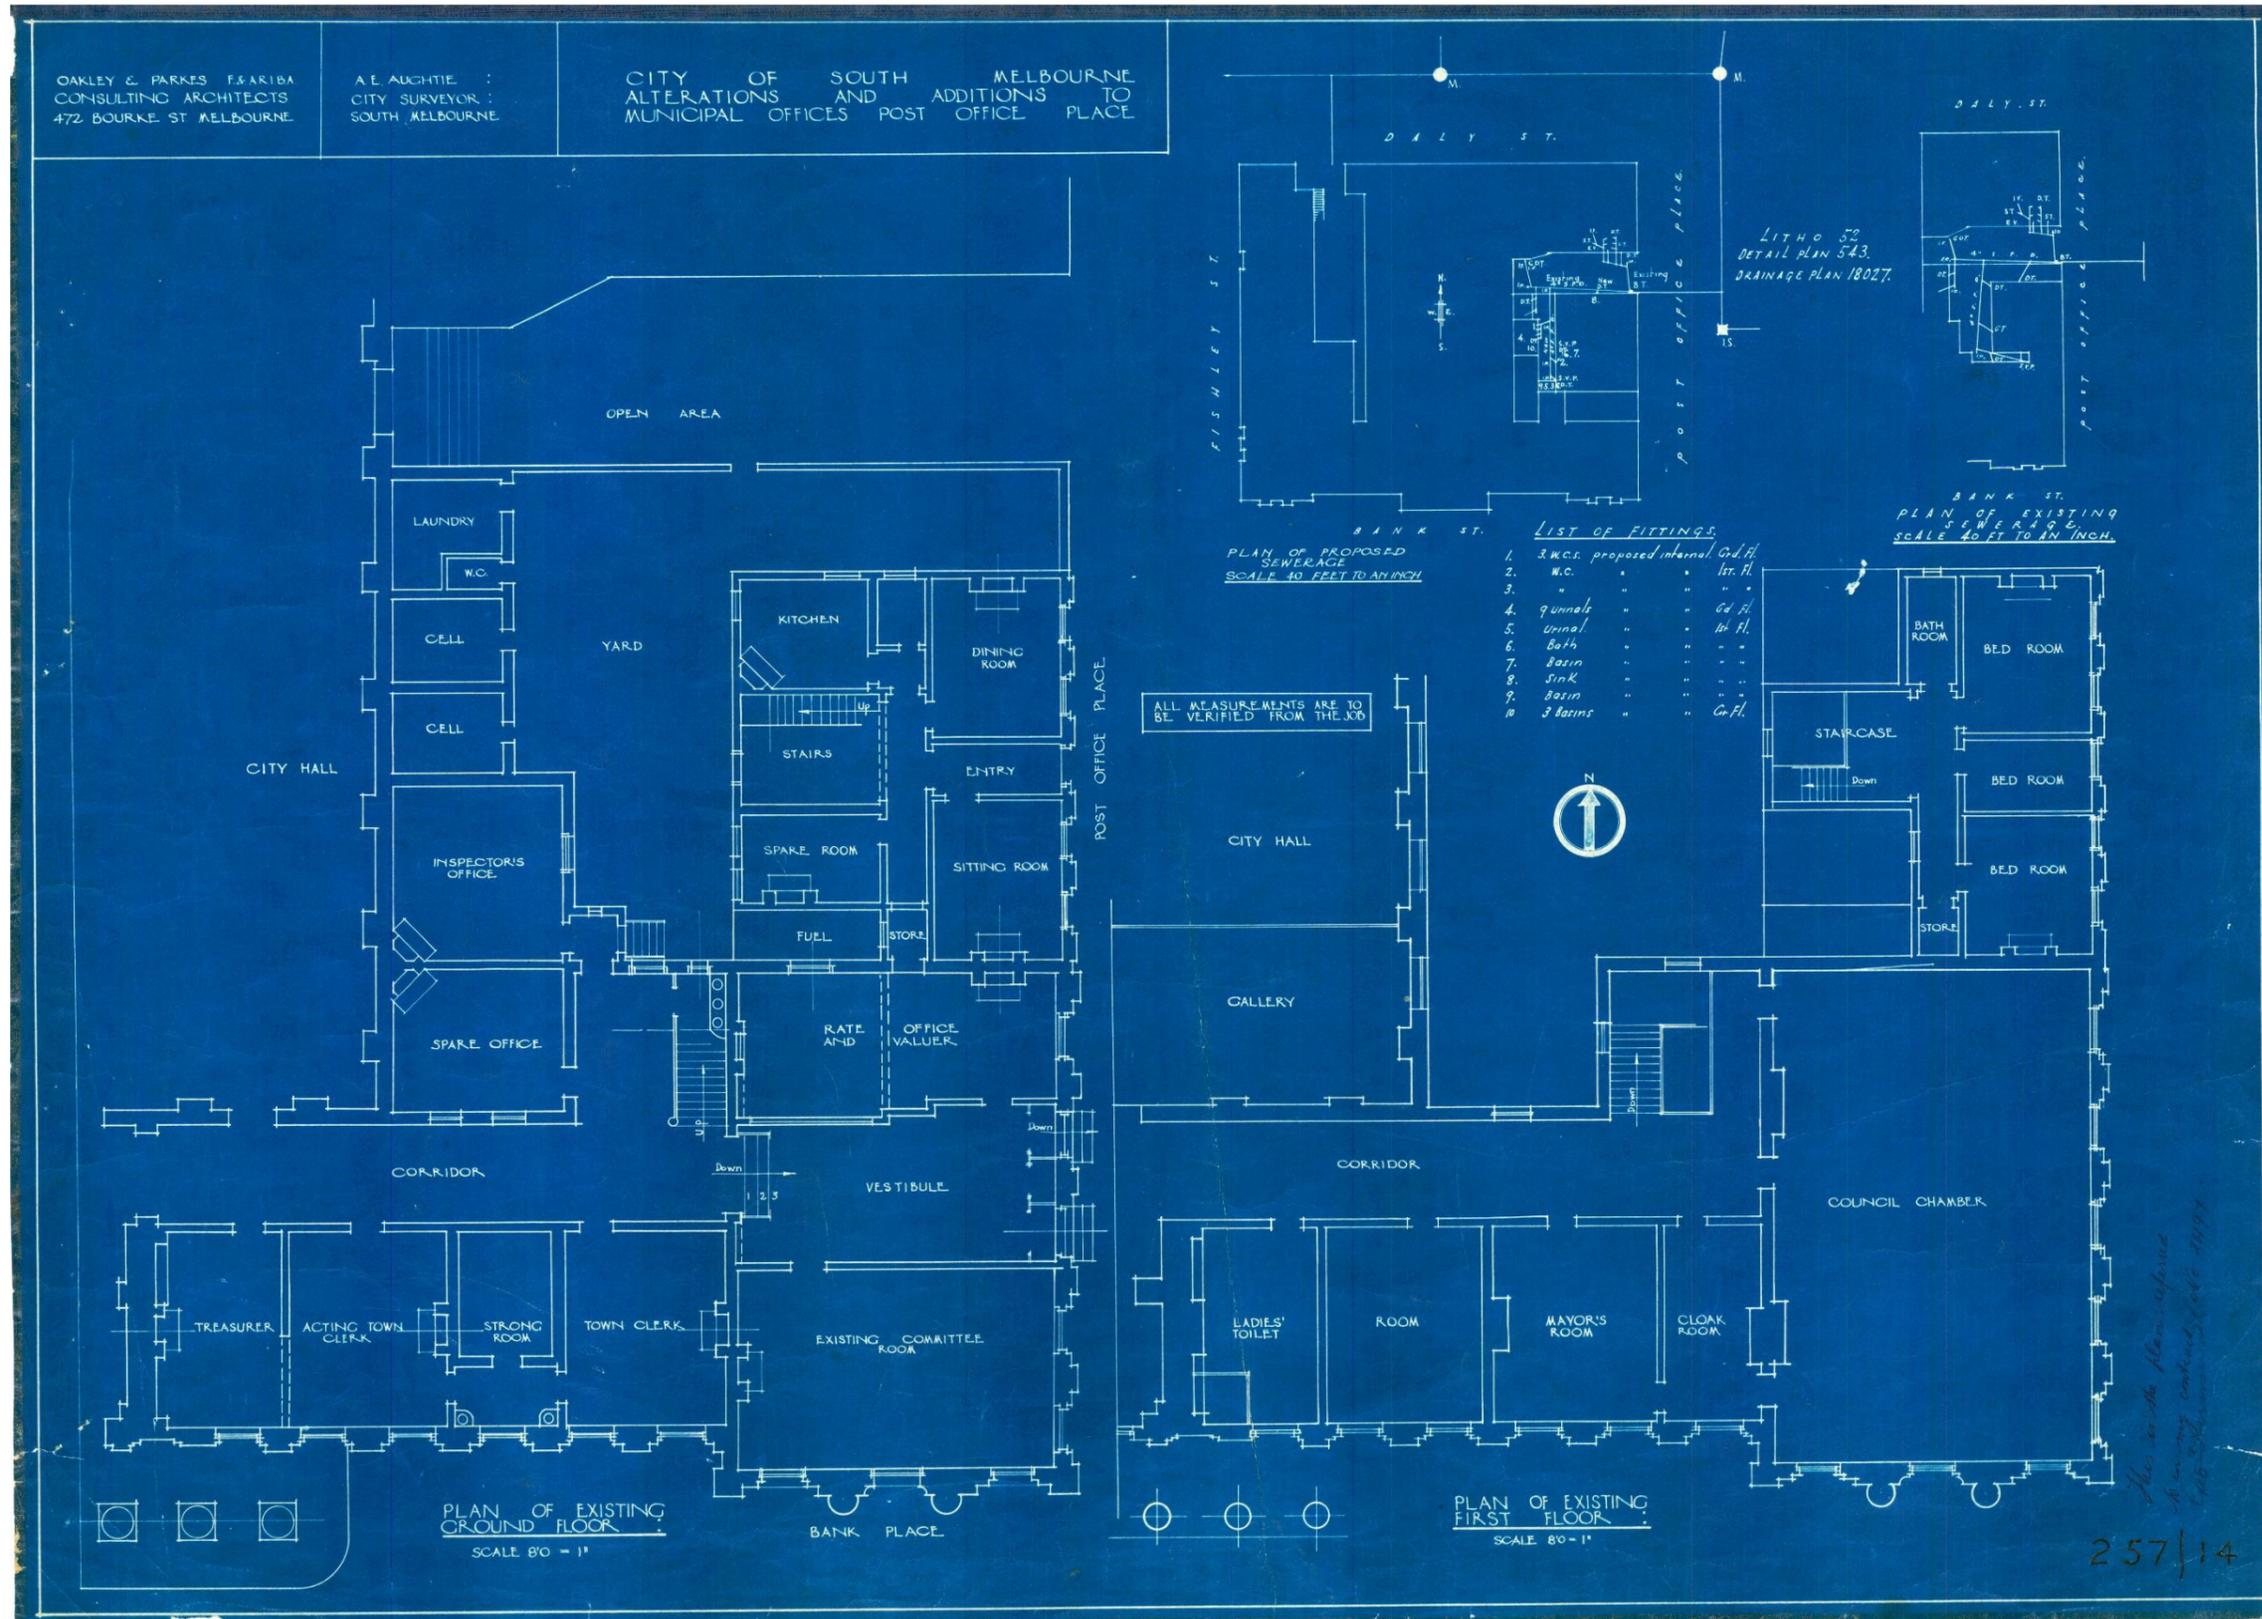
Figure 4 c. 1936 Existing Conditions plans of south-east quadrant of SMTH, prepared prior to reconstruction of the former Postmaster's Residence and other renovations  
Source: City of Port Phillip

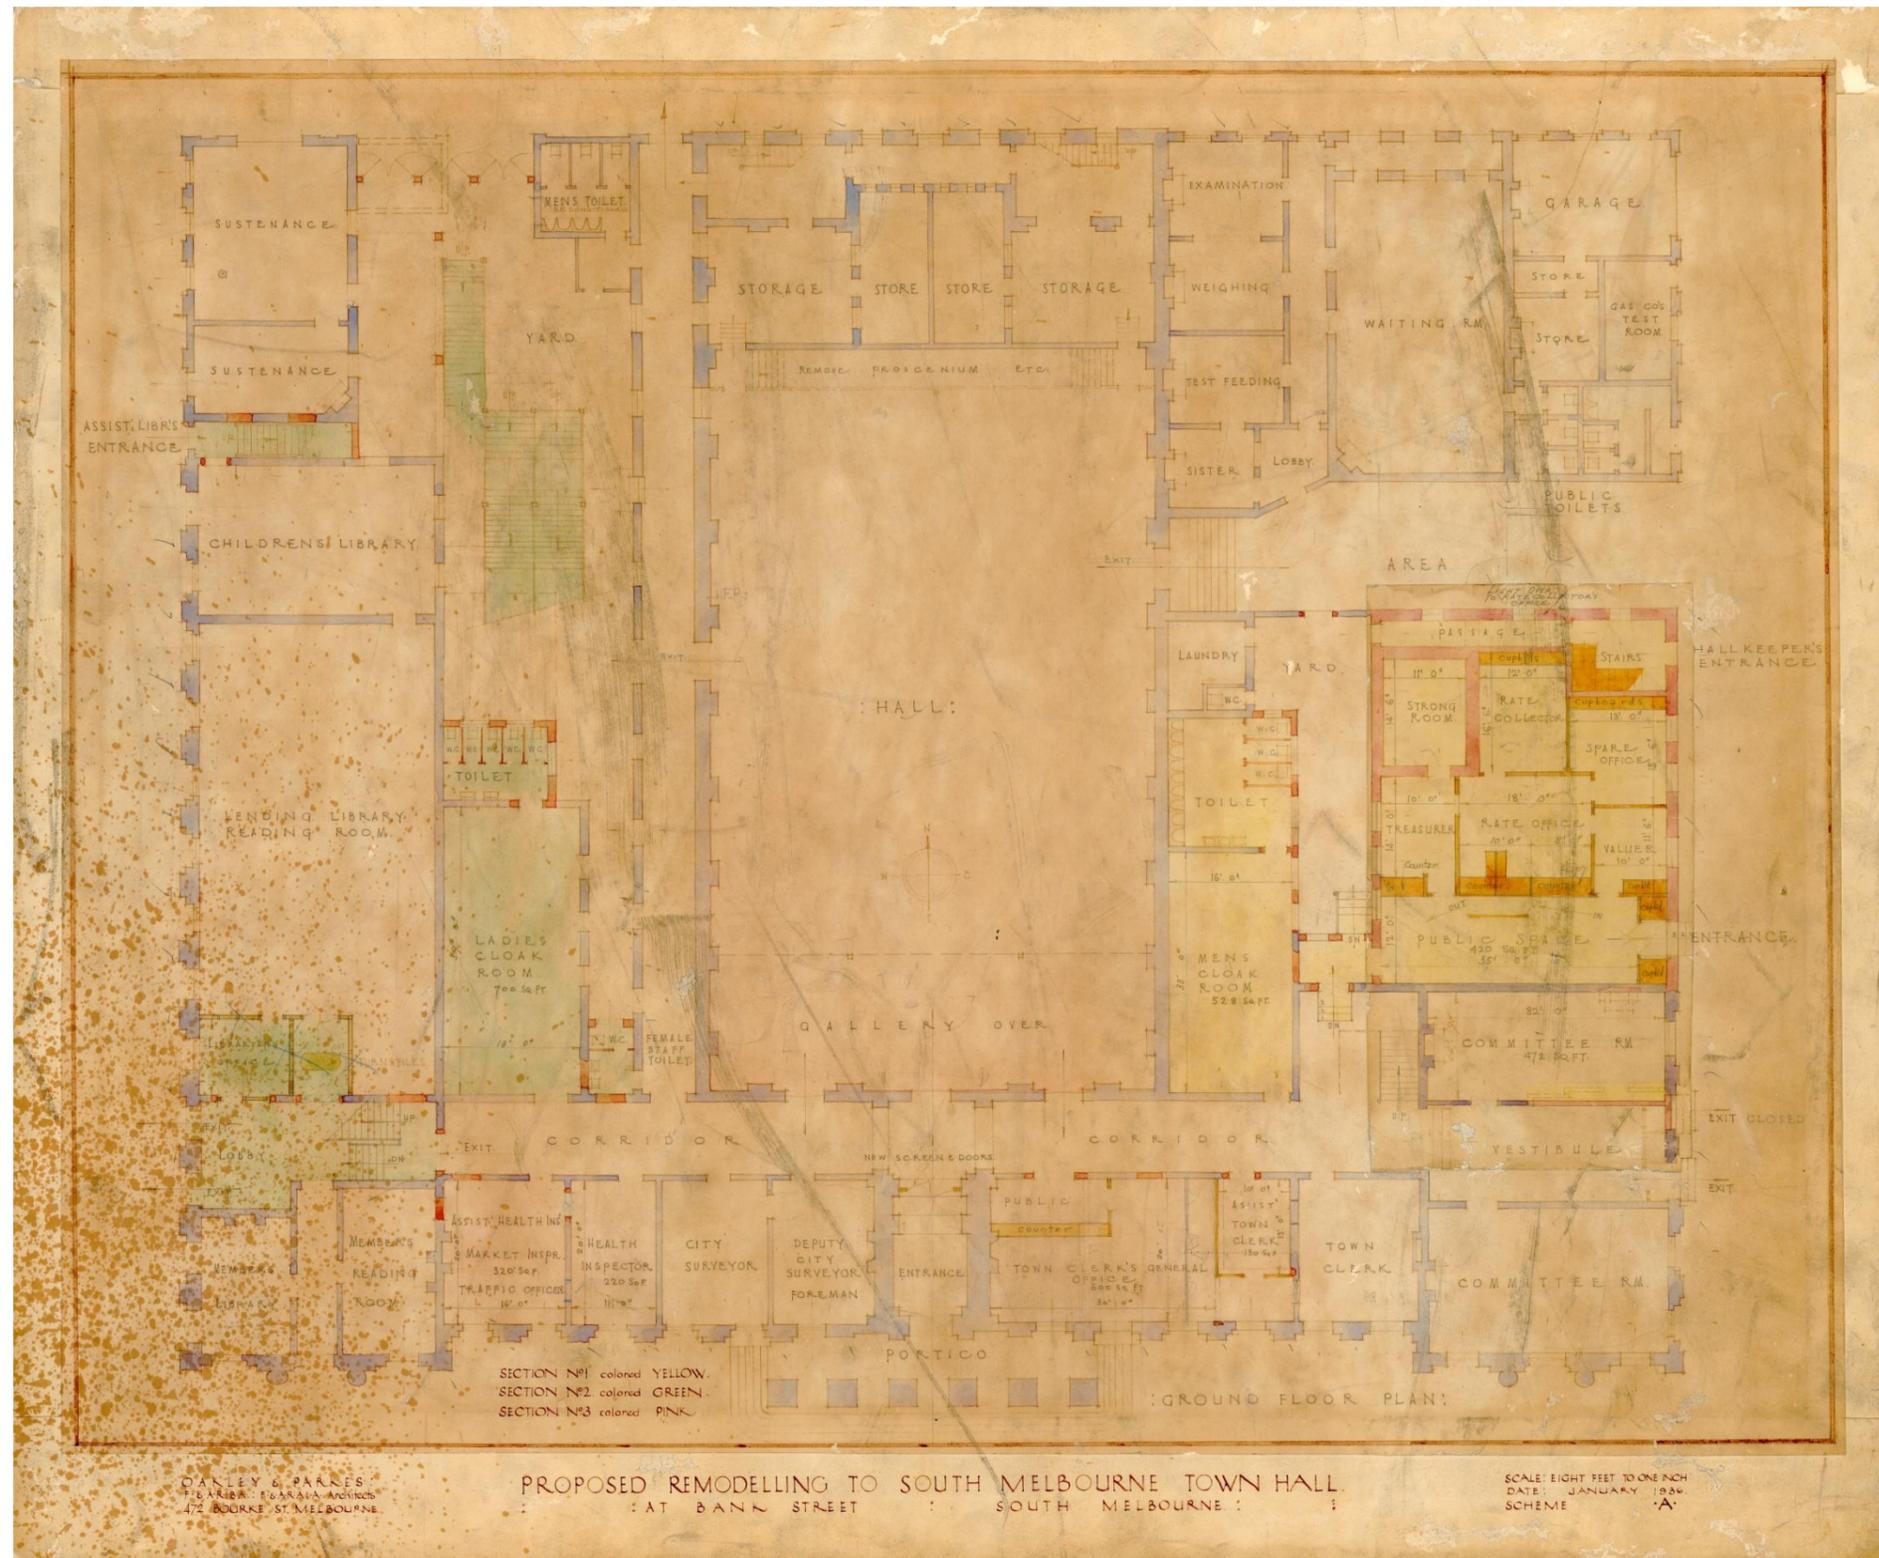
Figure 5 1936 Ground Floor Plan of the Oakley & Parkes-designed remodelling of the South Melbourne Town Hall; new and remodelled rooms and partitions are shown in yellow, green and pink. Source: City of Port Phillip

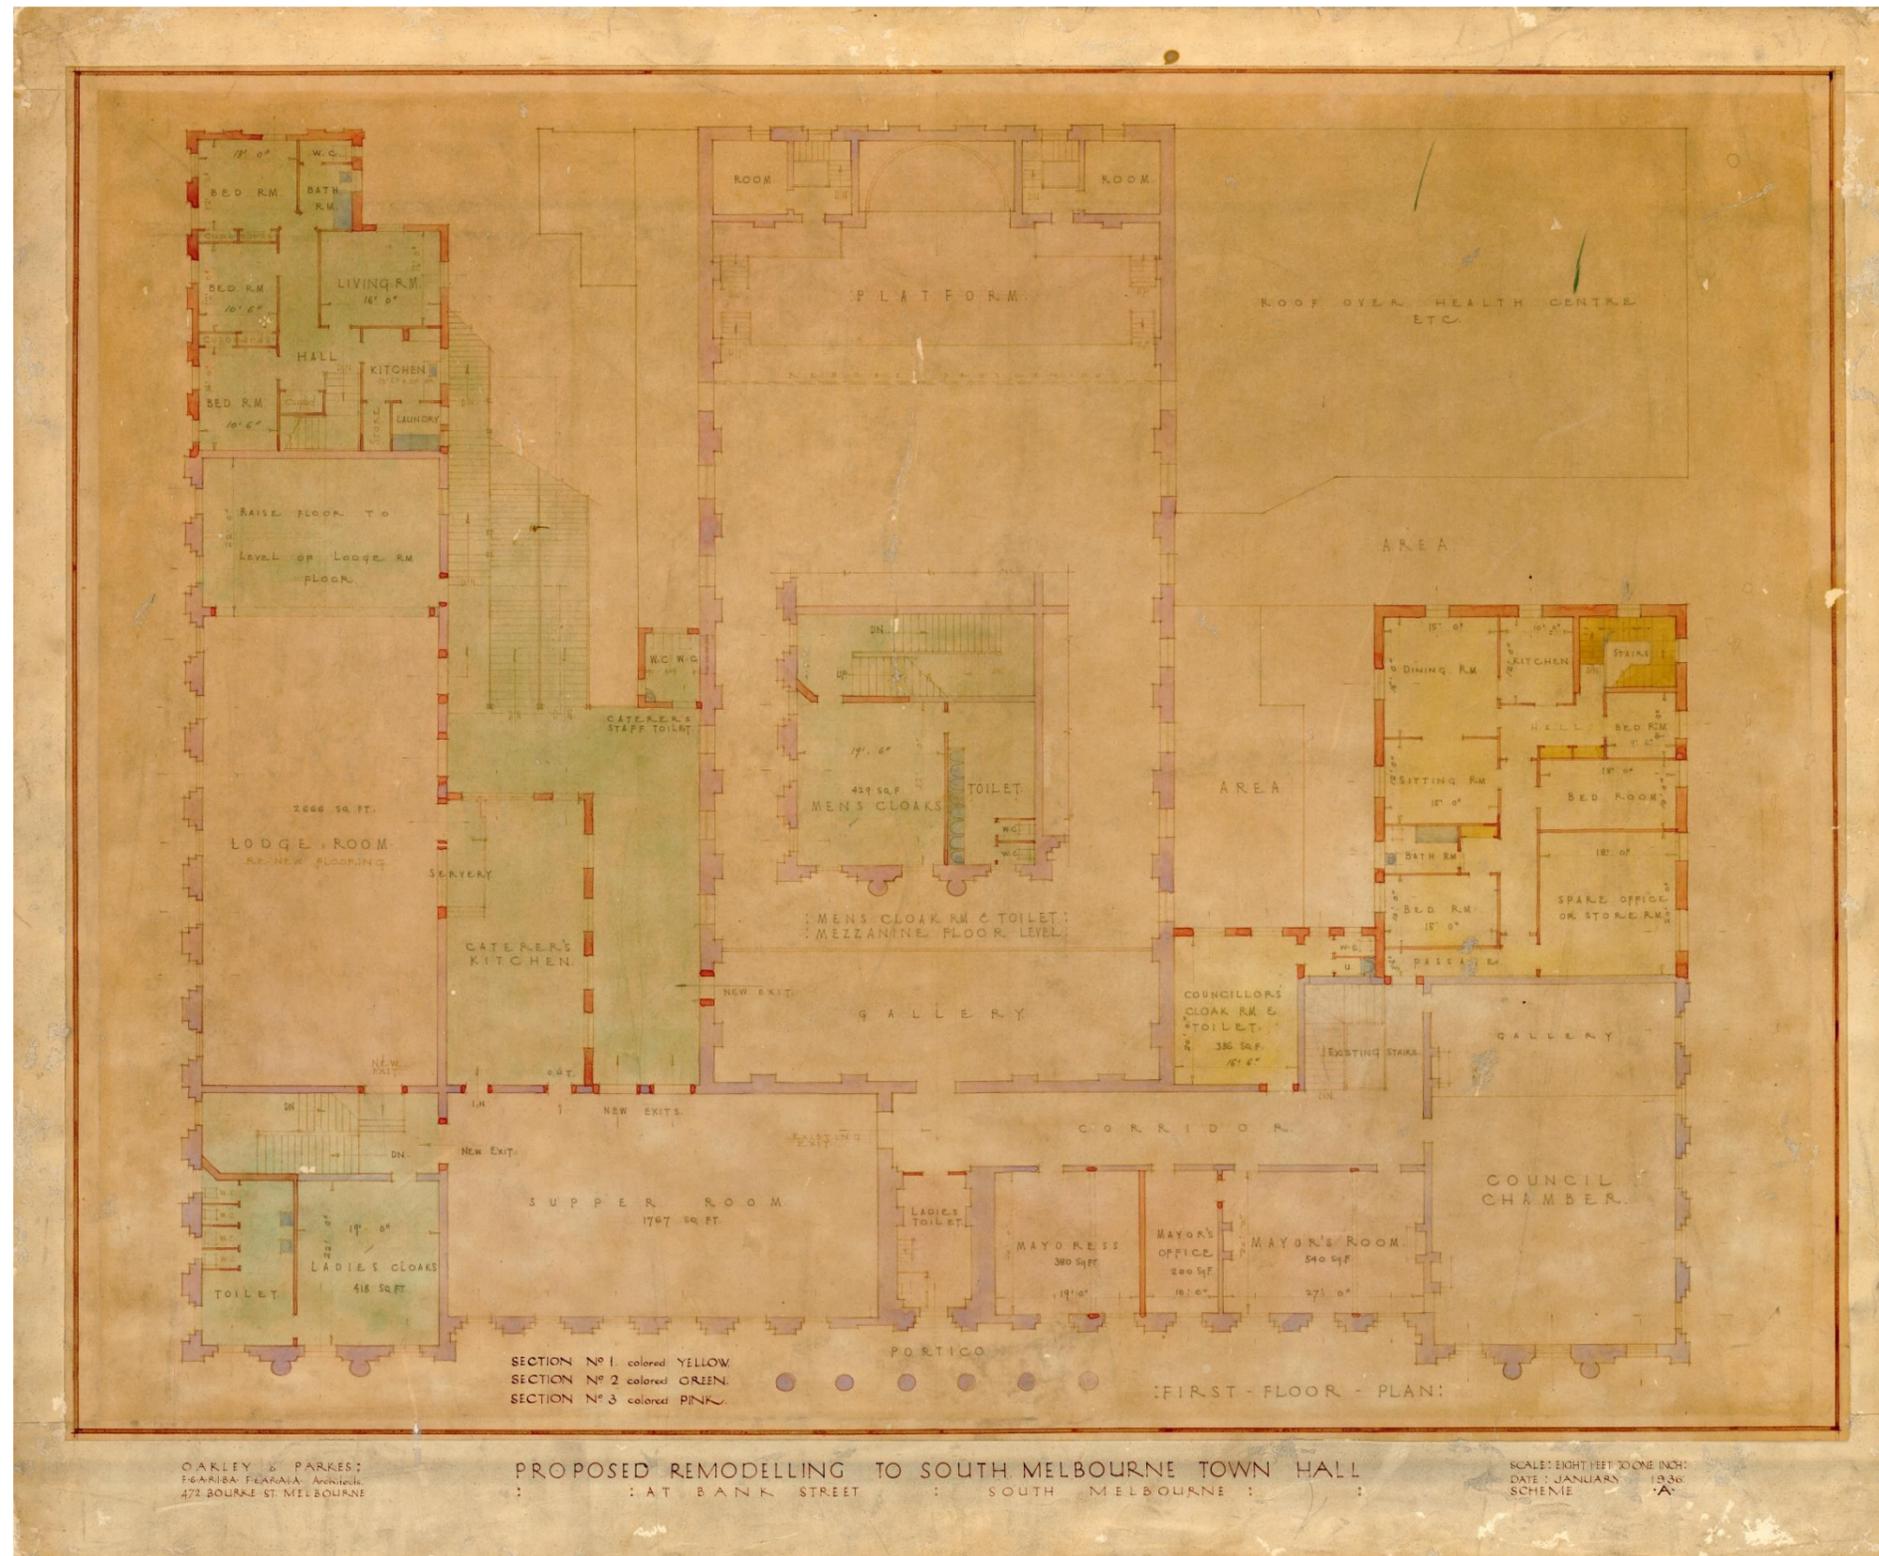
Figure 6 1936 First Floor Plan of the Oakley & Parkes-designed remodelling of the South Melbourne Town Hall; new and remodelled rooms and partitions are shown in yellow, green and pink.  
 Source: City of Port Phillip
