# South Melbourne Town Hall

Conservation Management Plan

208-220 Bank Street, South Melbourne, Victoria

LOVELL CHEN

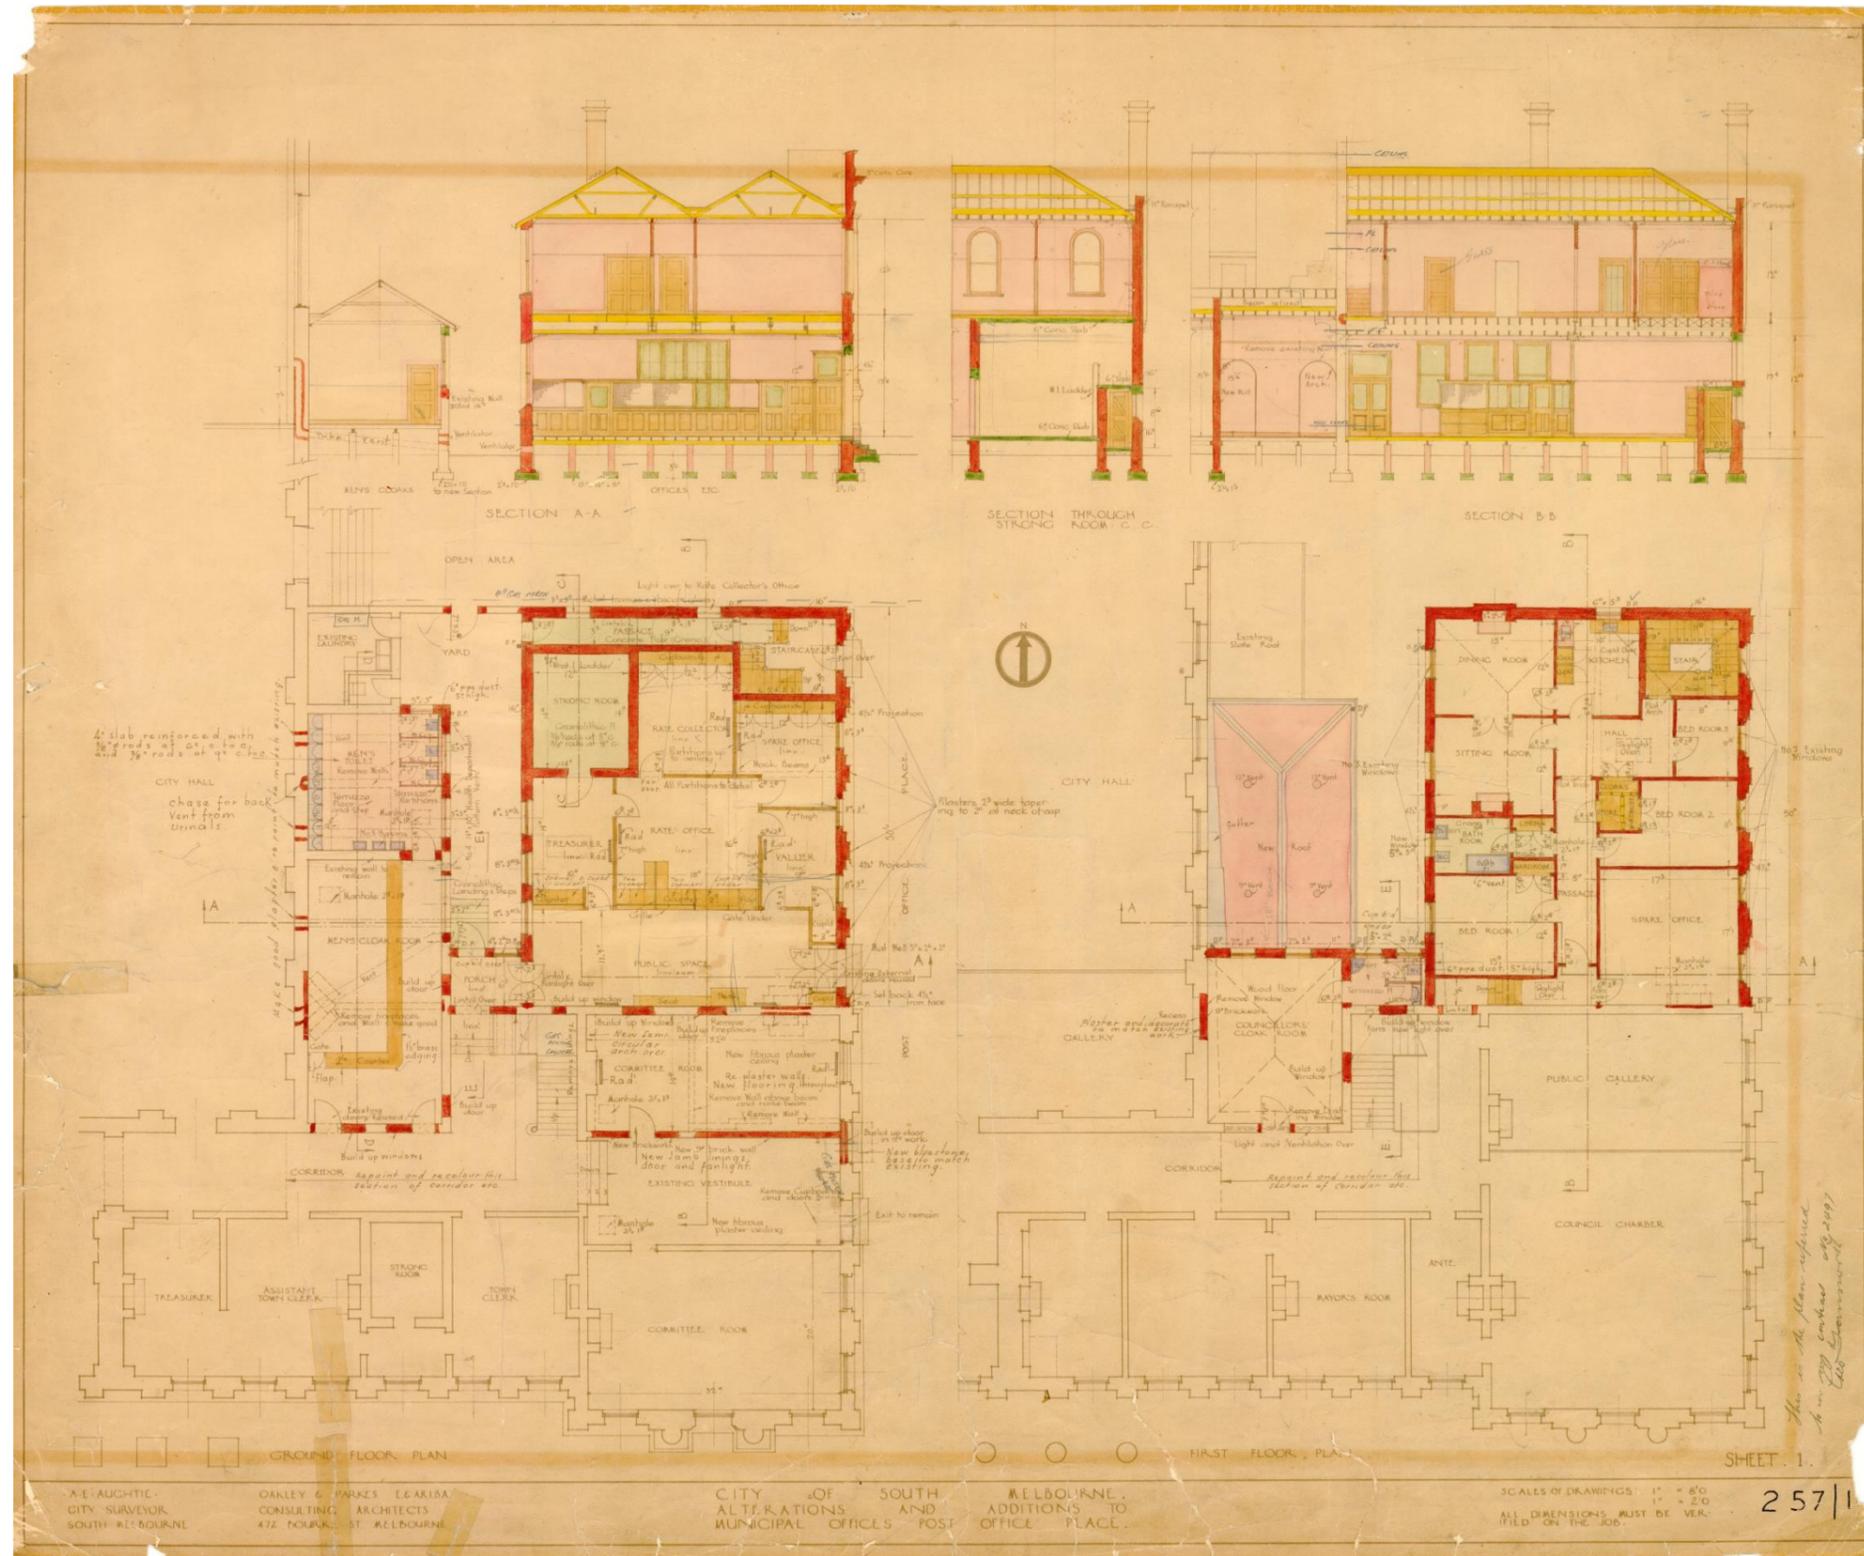
Figure 7 c. 1938 plan by Oakley & Parkes detailing the reconstruction of the former Postmaster's Residence and yard as improved municipal offices (ground) and a hall keeper's flat (first floor)  
 Source: City of Port Phillip

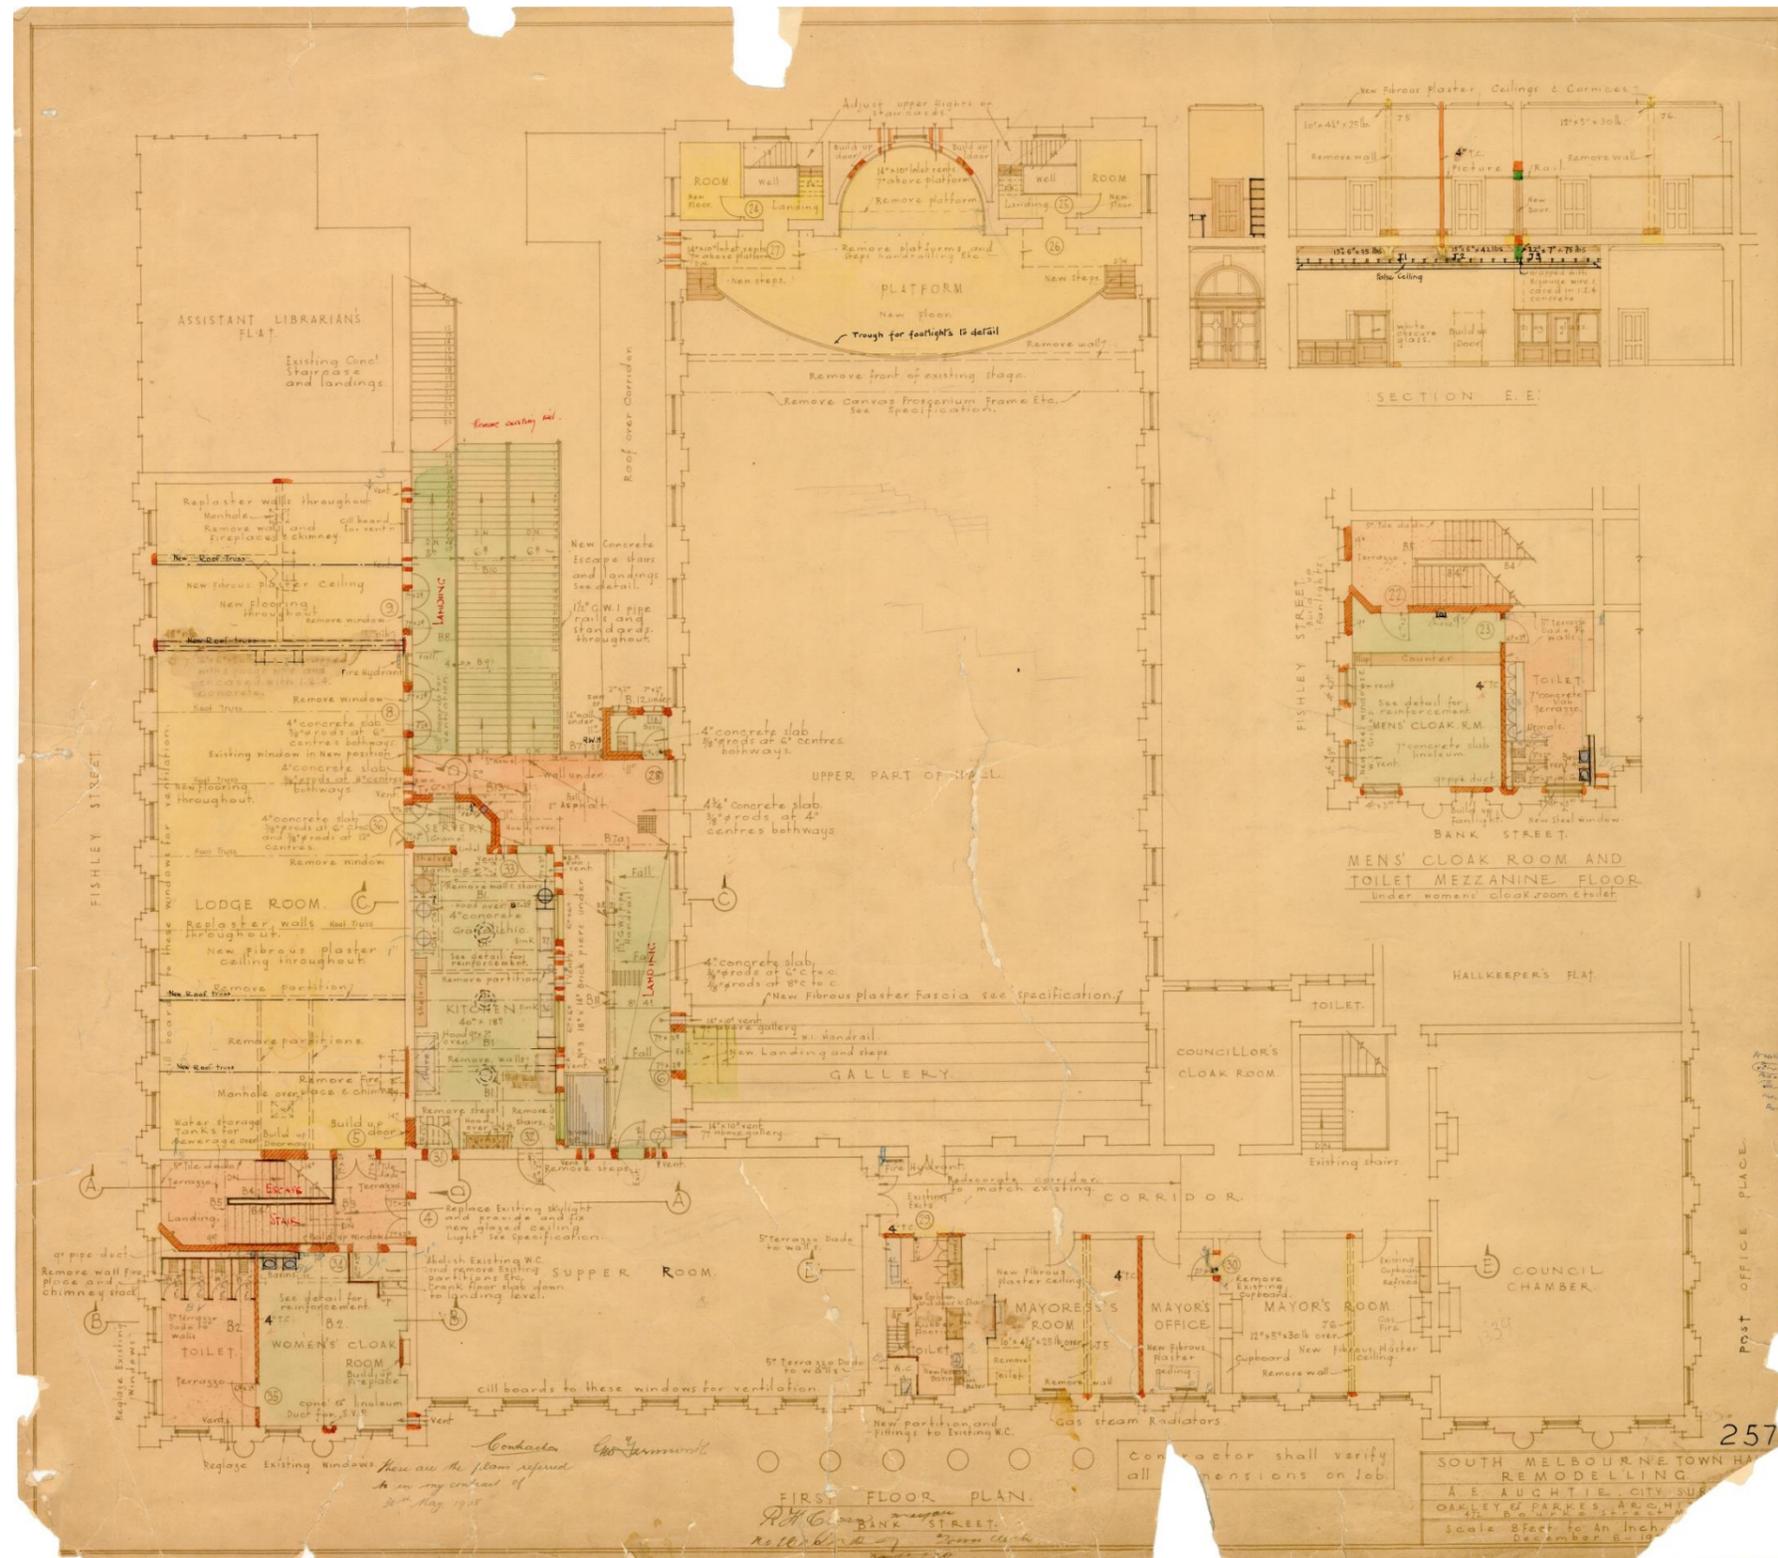
Figure 8 c. 1938 Oakley & Parkes first floor plan detailing renovations of the Main Hall stage and backstage area, mayor's offices, and Lodge Room and attached kitchens and mezzanine amenities  
Source: City of Port Phillip

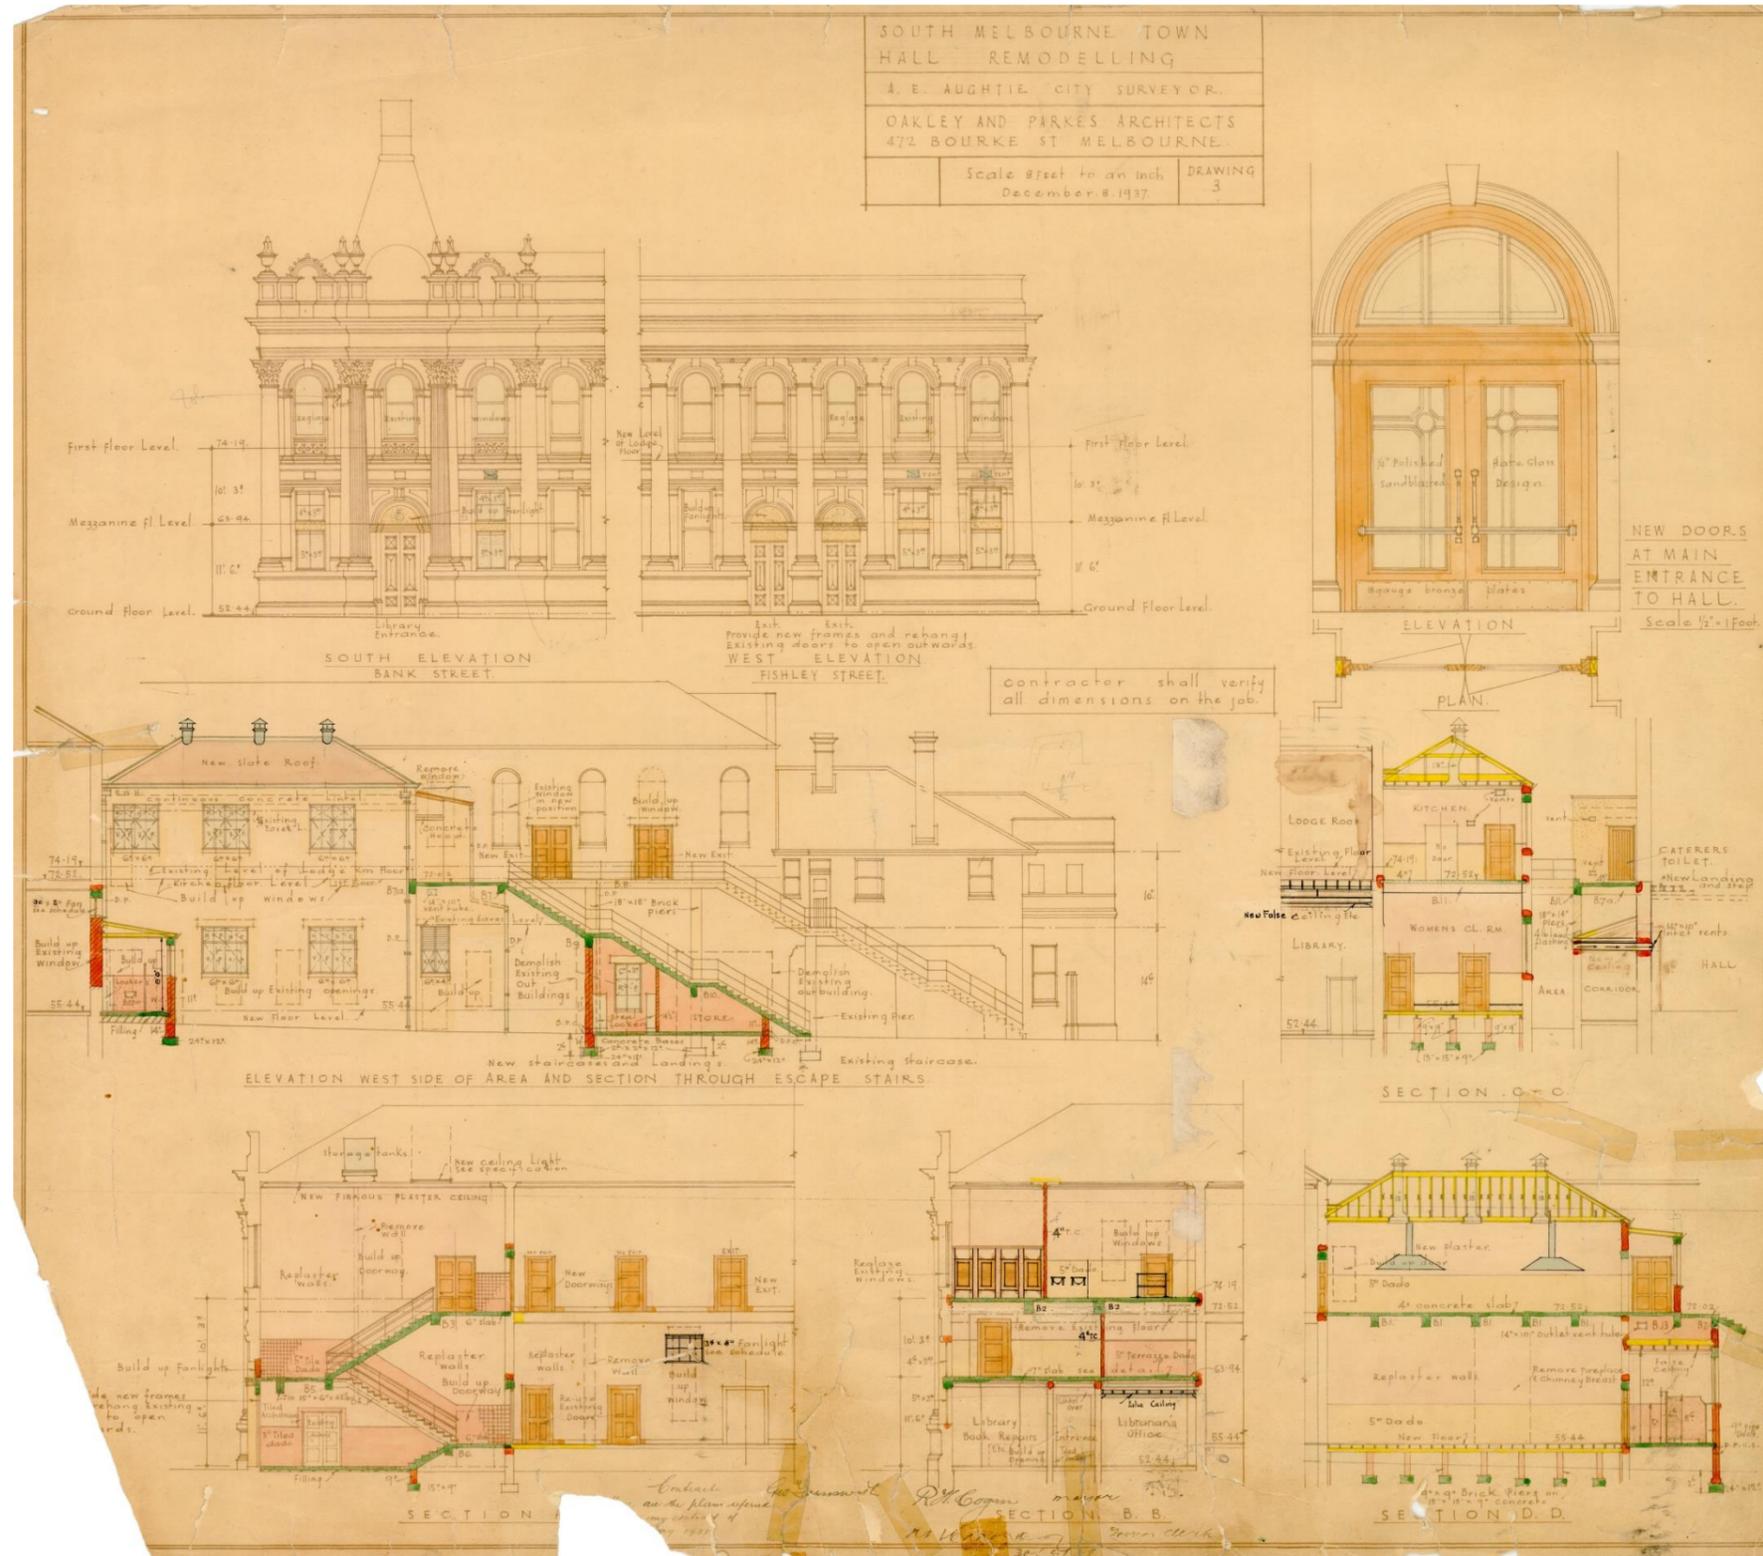
Figure 9 1937 Oakley & Parkes section and elevation drawings detailing various alterations to building access, amenities and kitchen facilities  
Source: City of Port Phillip

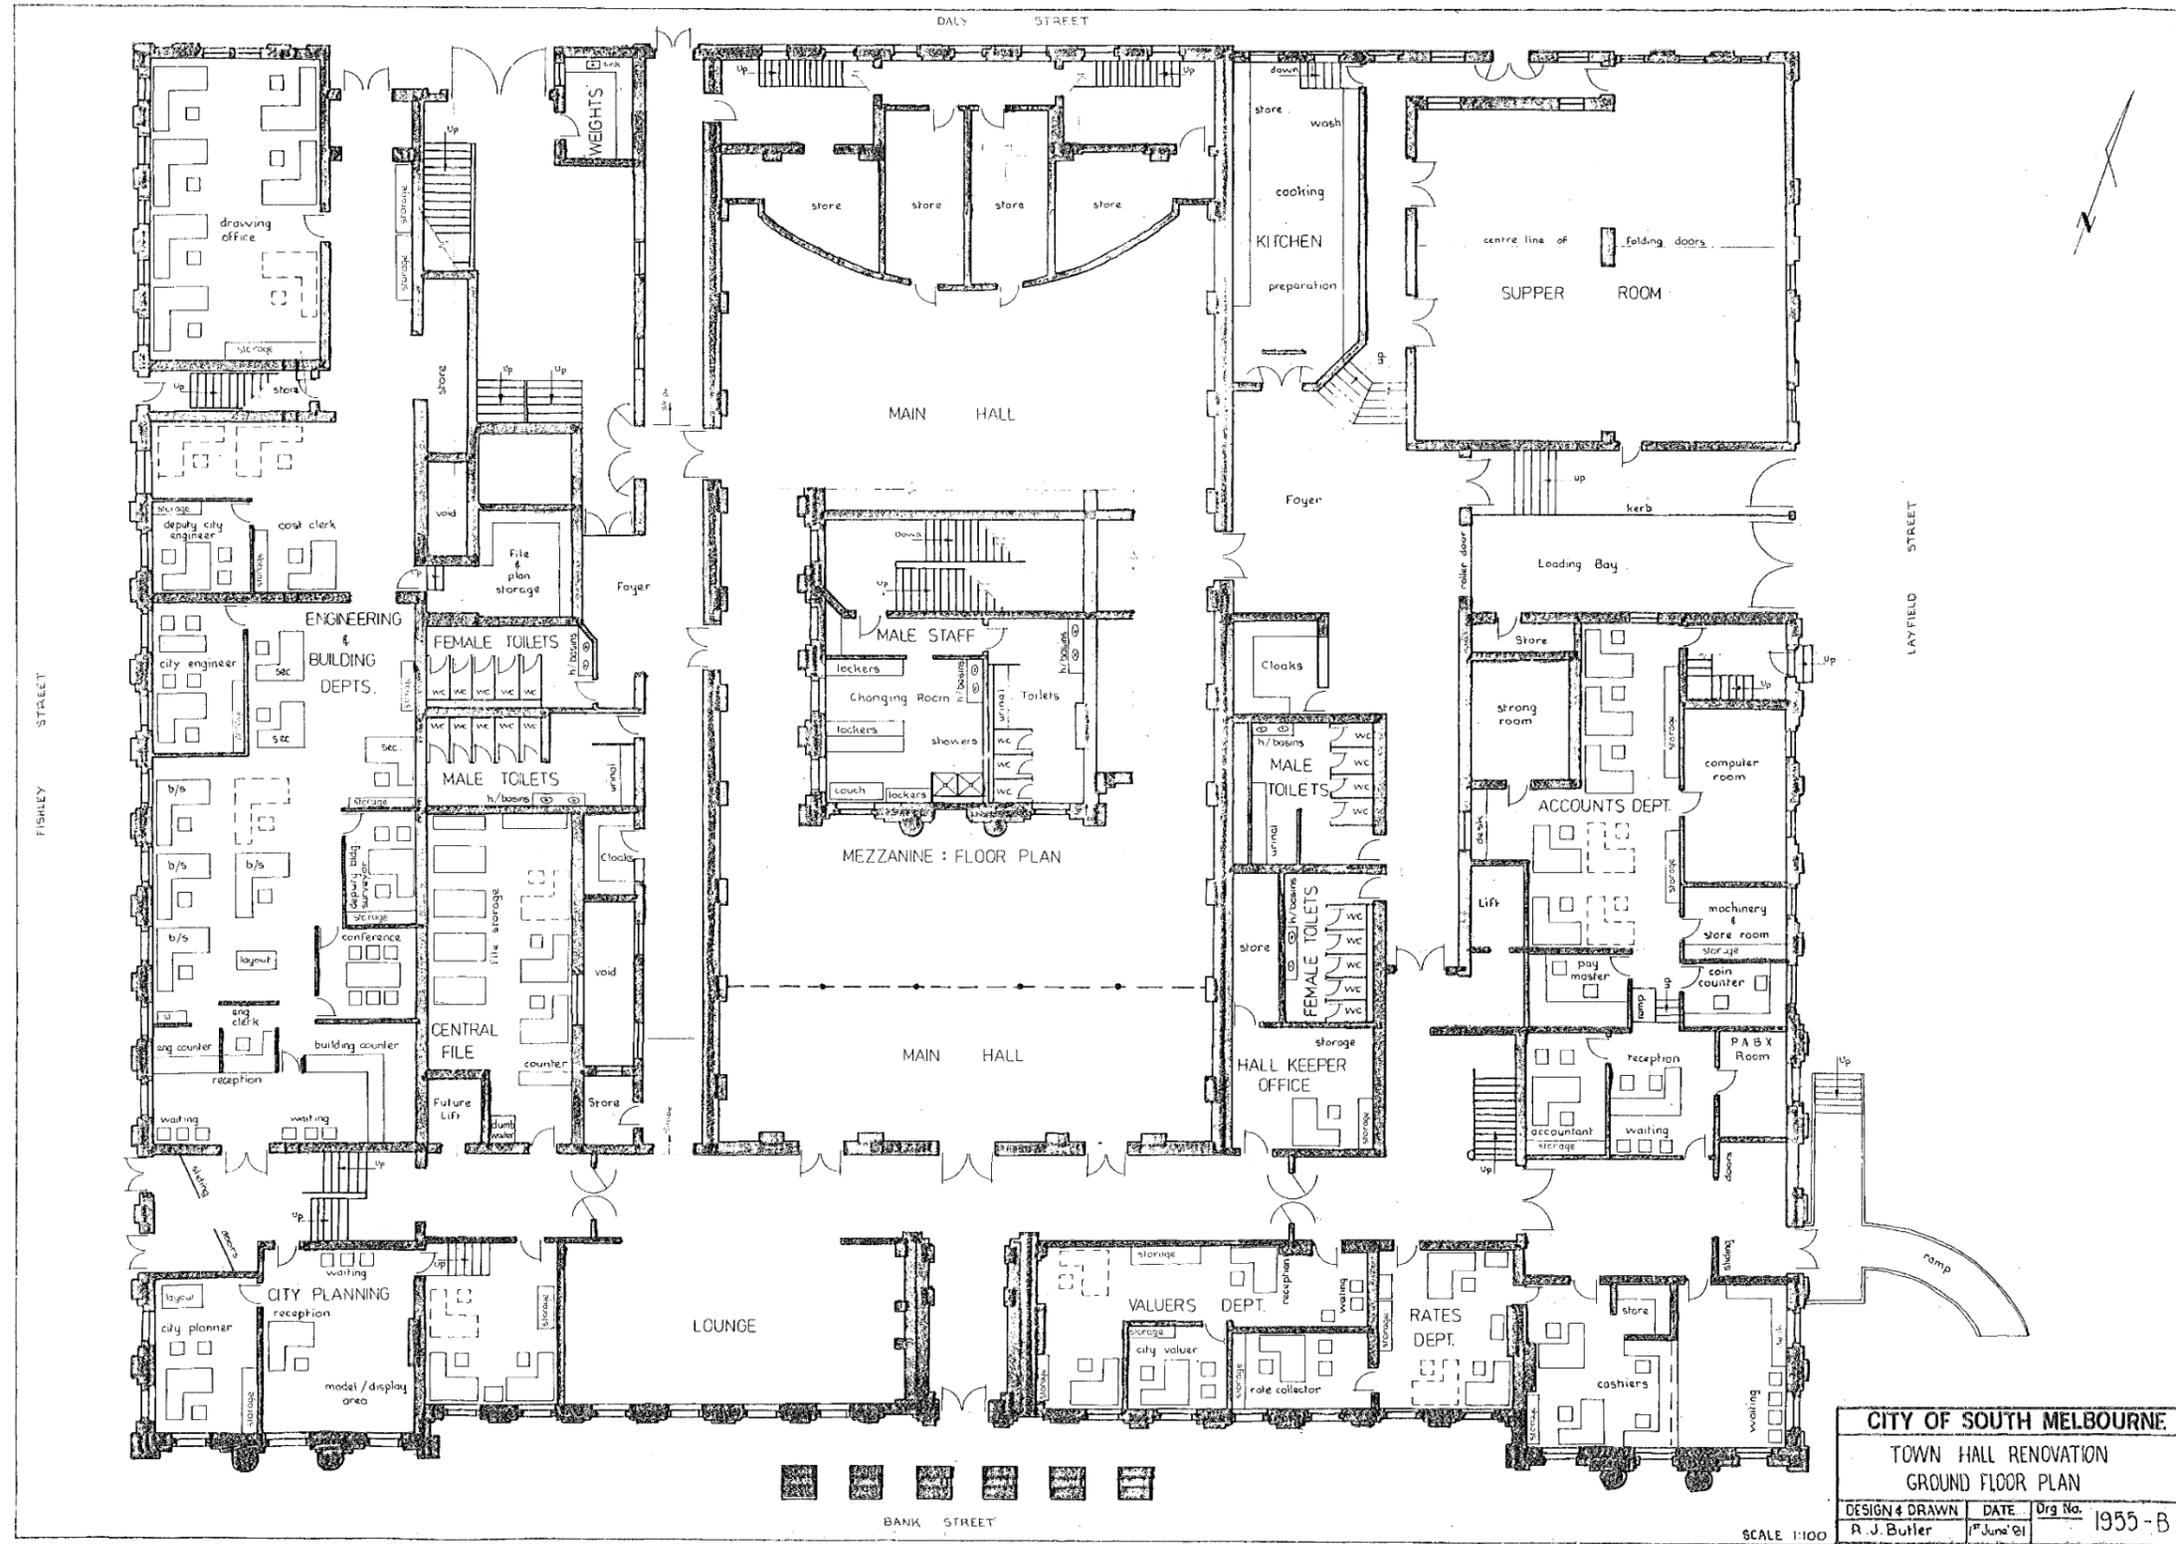
Figure 10 1981 Ground Floor Plan of proposed renovations; while it is believed that the full program of renovations may not have been implemented, some of the layout and elements shown were constructed, either prior to 1981 (i.e. existing conditions) or subsequently  
 Source: City of Port Phillip

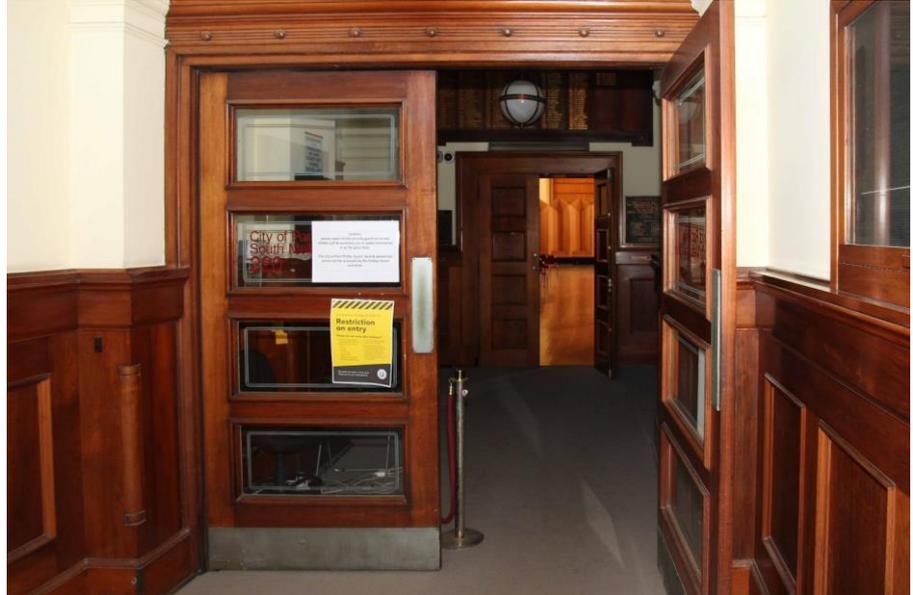
ROOM No. G1  
CofPP 0G.01

1930s double doors to the street frontage with arched highlight over, new door furniture  
1930s blackwood double doors with four glazed panels in each to main corridor G16  
Rendered mouldings around door arches with keystone at top  
1930s blackwood wall panelling to walls  
1930s ceiling decorative central panel and decorative cornice  
Recent central pendent globe light fitting  
Two etched glazing panels in lights over doors with different versions of the South Melbourne crest  
Commemorative plaques

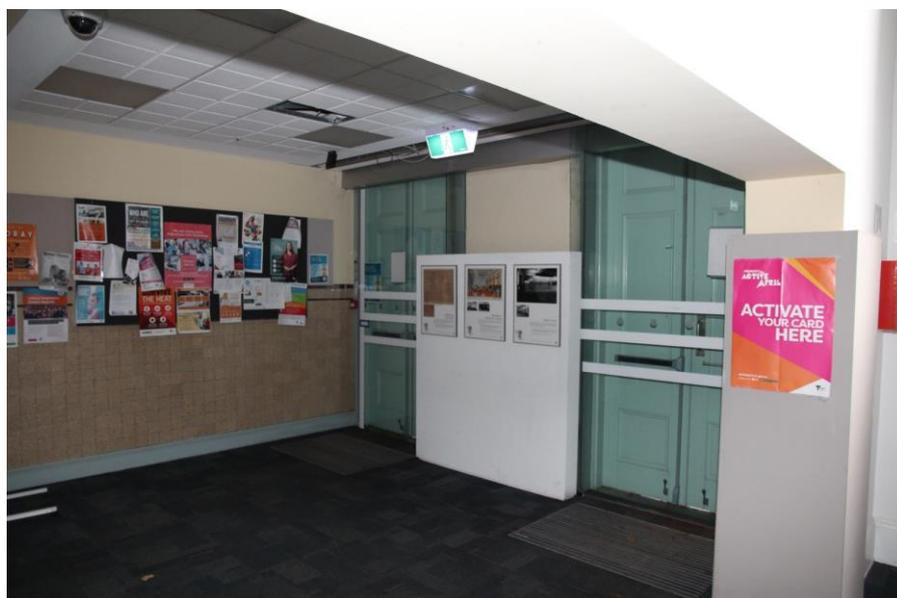
**ROOM No.** G4  
**CofPP** 0G11

The 1930 terrazzo floor is concealed under new floor coverings.  
The tiled wall treatment to tall dado height remains on the south side.  
The stairs are terrazzo-surfaced with a timber rail and decorative wrought-iron-work balustrade.  
Two sets of double panel external doors to Fishley Street have new glass automatic sliding doors fitted internally.  
Flat architraves have raised square corner blocks to the doors to room G3 and Fishley Street.  
A perforated-panel ceiling has been fitted under the mezzanine floor level of the stairs.  
There is a wide opening without doors through to room G5.

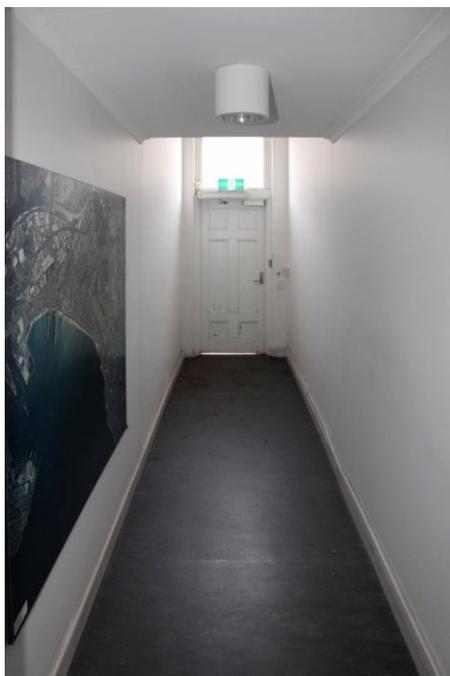
**ROOM No. G7  
CofPP 0G.23**

Originally an open space between the fire station and the Mechanics' Institute. The space was enclosed and a stair added when the first-floor assistant librarian's residence over the original fire station was added in 1936. Staircase removed before 1979, probably for construction of theatrette (G8) in 1951.

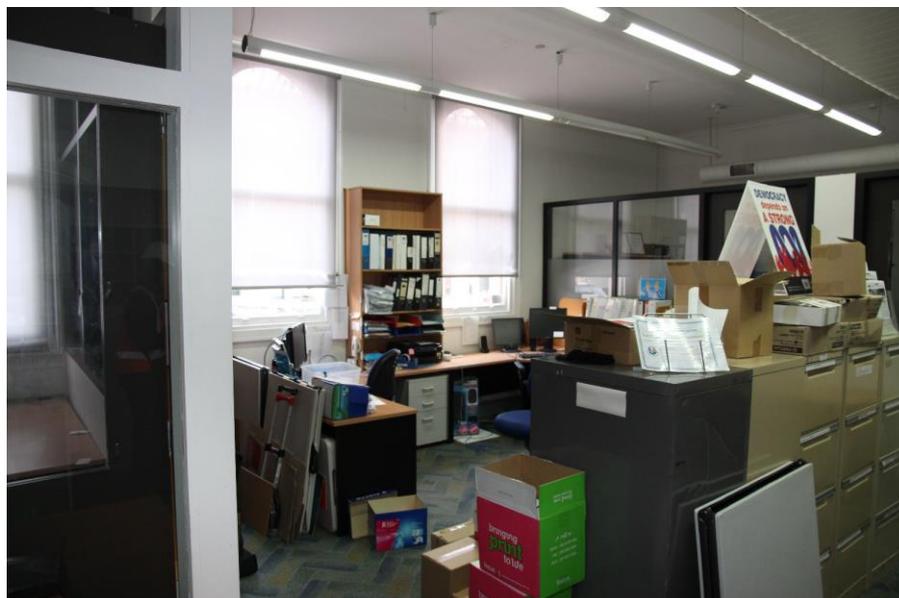
ROOM No. G8  
**CofPP 0G.22, 0G.28, 0G.29, 0G.30,  
0G.31 & 0G.32**

This space started as a reel room/store for the fire brigade. It was then used for council purposes before becoming a sustenance depot in the 1930s. During World War II it was an Air Raid Protection office. A cinderblock wall was added outside the main envelope of the building during this phase of use. Subsequently the space became a lunchroom and girls club venue before being converted into a theatrette in 1951. The expansion of the space to the east for a new entrance probably occurred at this point.

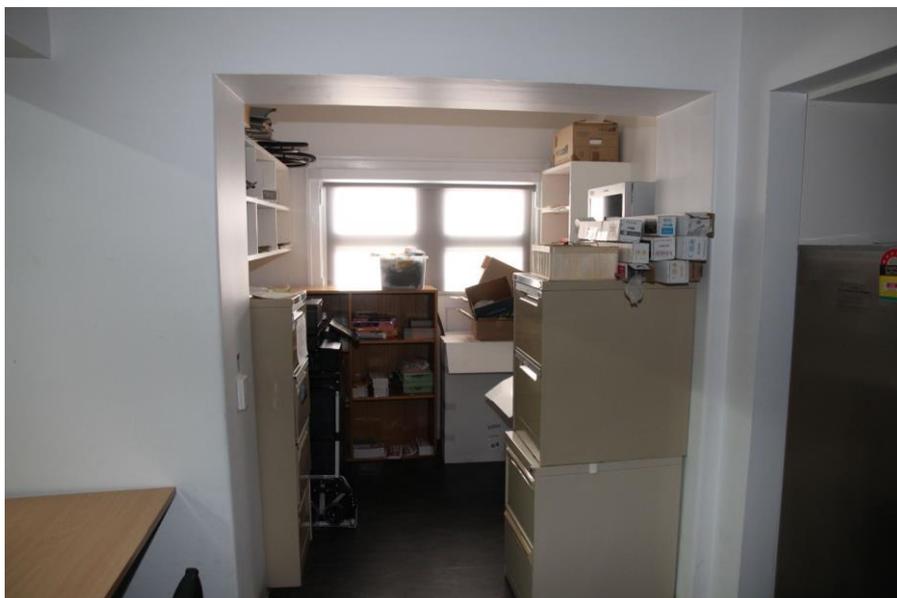
**ROOM No. G9  
CofPP off 0G.33**

There was a bell tower, probably timber, in this space in the 1880s. There was no building here apart from a courtyard wall, probably until the construction of the theatrette in 1951, when this lobby room was built in masonry with stucco external walls and double doors.

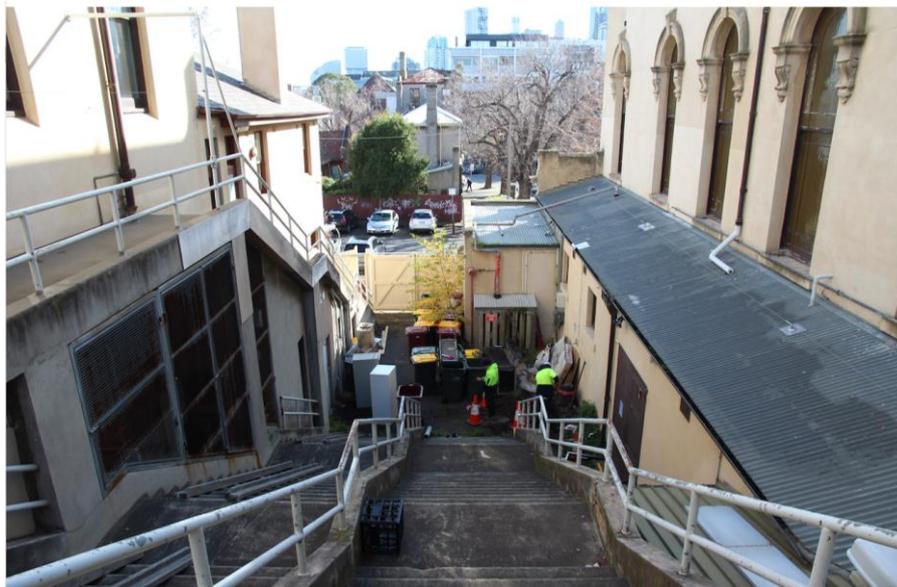
**ROOM No. G10  
CofPP 0G.34**

A service court/yard has been in this location since 1879. The first concrete stairs introduced serviced the assistant librarian's residence built in 1936. The broad sweep of concrete stairs was added in 1938-9 as fire egress for the expanded lodge/supper room on the first floor (F5) as well as the old supper room (F2) and the balcony in the hall (F10).

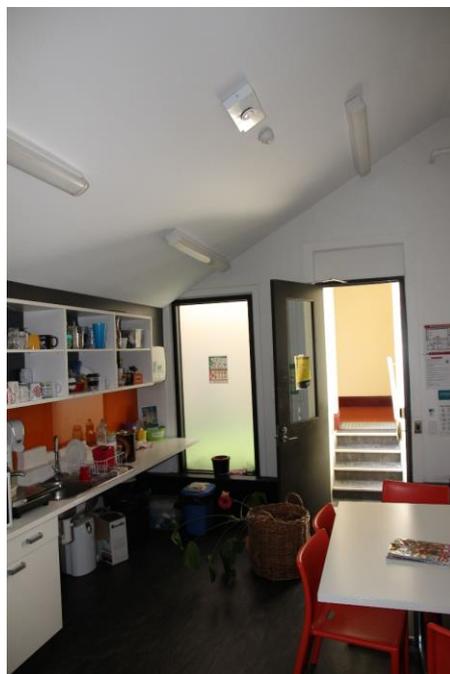
ROOM No. G11  
**CofPP 0G.46 and adjacent spaces  
0G.47, 0G.48, 0G.49 & 0G.50**

When the broad concrete fire stairs were built in 1938-39 a space was created underneath. This was later enclosed, creating a sloping ceiling. Access through to the main north south corridor flanking the hall was added after 1979.

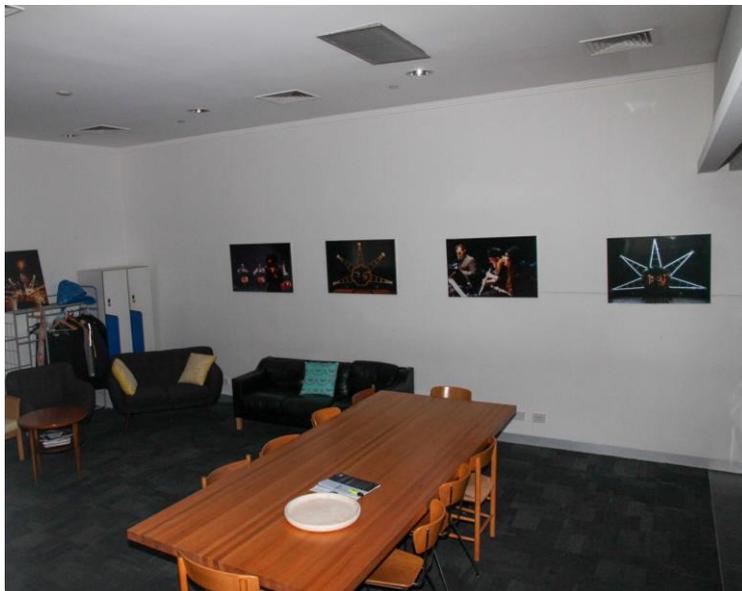
ROOM No. G12  
**CofPP 0G.07 and adjoining spaces  
0G.08, 0G.47, 0G.48, 0G.49, 0G.50,  
0G.52**

From the 1880s a two-storey brick building stood on this footprint, with a kitchen on the ground floor and stairs up to take food to the supper room F2. In the late 1930s the building was comprehensively renovated, with a raised roof and first floor, and the kitchen was moved to the first floor. The ground floor area became a ladies' cloak room and retained that function until at least 1979.

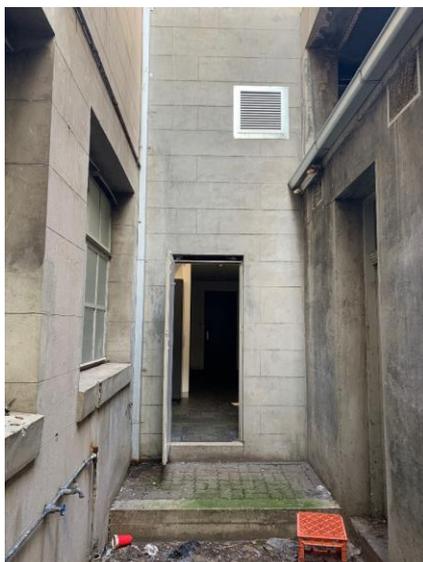
**ROOM No.** G13  
**CofPP** 0G.51

Looking north at ground level

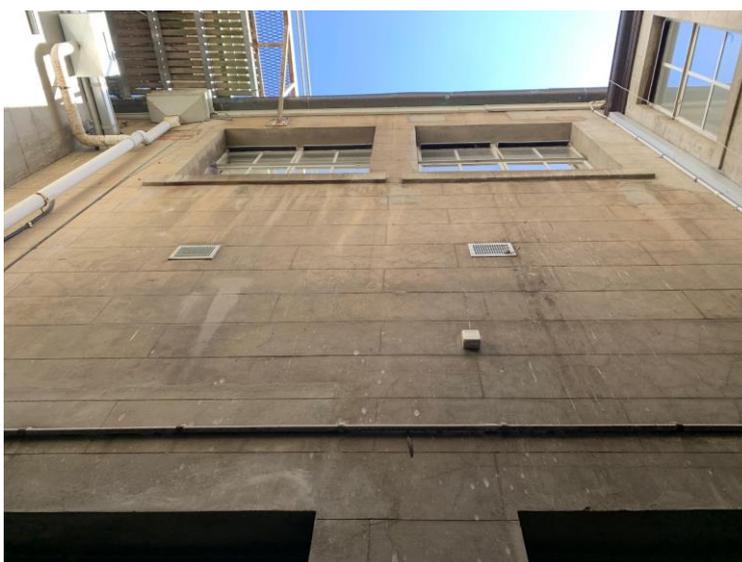
West wall of lightwell

- The 1930s render on the west wall of the lightwell over ground and first floor levels shows crazing. There have been recent patch repairs in a non-matching render

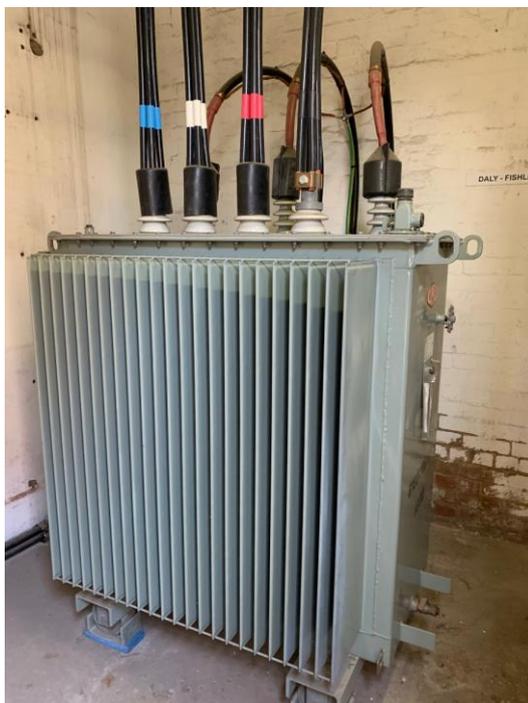
**ROOM No. G14  
CofPP 0G.37**

The north wall formed part of a wall to the courtyard in the original build, evidenced by the brickwork in Colonial bond. Men's toilets had been built in this position by 1904, making use of the courtyard wall, and remained there until the 1970s. The enlarged space was then converted for use as a substation. The outer wall to Daly Street retains plinth, corner pier and a sense of the earlier wall.

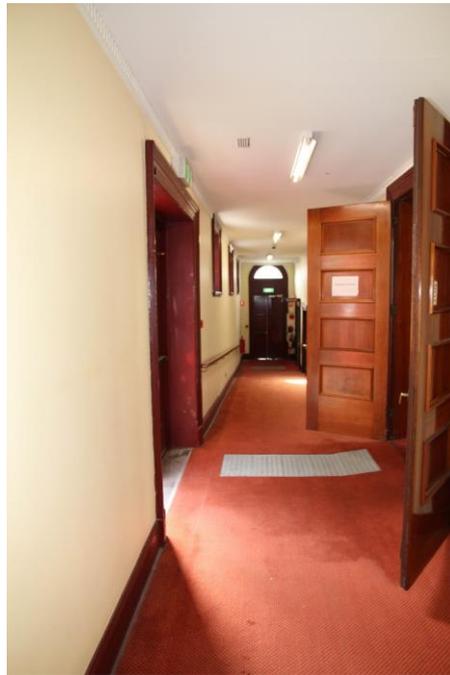
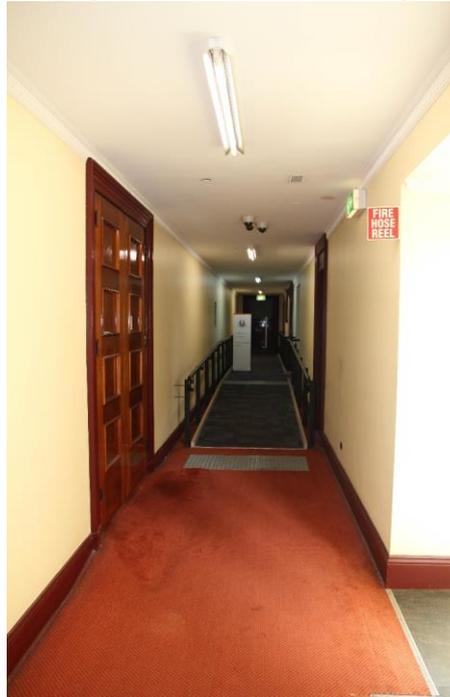
**ROOM No. G15  
CofPP 0G.06**

Looking north from centre of length of corridor, hall on right.

Looking south from centre of length of corridor, hall on left.

- The double doors at ground level to the corridor G15, which has the panels filled in with ply externally, shows weathering to paint and timber externally. Repair doors and repaint to match existing.

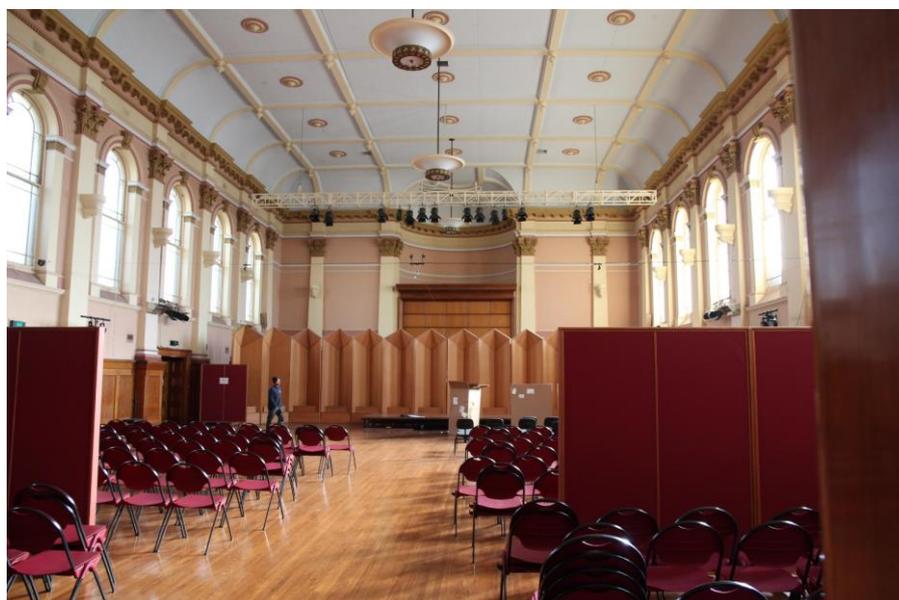
**ROOM No. G17  
CofPP 0G.57**

Victorian clerestory double-hung sash windows with Victorian rendered moulding architraves to the east and west elevations  
Corinthian style pilasters with a substantial door-head-height blackwood panelled dado and stage screen  
Decorative recessed apse to the rear of the stage, intended for the installation of an organ.  
1950s half-height timber screen closing off stage  
Decorative panelled ceiling with remaining areas of acoustic treatment from the 1930s  
Decorative cornice supported on console brackets  
Blackwood panelling to curved outer edge of stage  
Sprung hardwood floor without fixed seating  
Recent crude fittings for stage lighting fixed in sill areas of a number of clerestory windows  
Hanging truss/frame for lighting  
The auditorium has exceptional acoustic qualities, making it a favoured performance and recording venue

- Establish and remove source of moisture causing structural and plaster damage to pilaster at south end of west wall. Establish structural impact of this damage and undertake structural repairs as necessary.

- Investigate failures of lower Acanthus leaf component of console brackets under the main cornice and undertake works to prevent further failure. Repair damaged examples.

- Some top sashes have dropped allowing moisture penetration. Where possible close properly. Undertake repairs as necessary to make full closure possible.

- Monitor minor cracking in plaster work of pilasters, cornices and coved ceiling panels.
- Repair minor damage to cornice upper edge.
- Repair impact damage to timber wall panelling, door reveals, doors, stage surround panelling and stairs to stage. See general works policy.

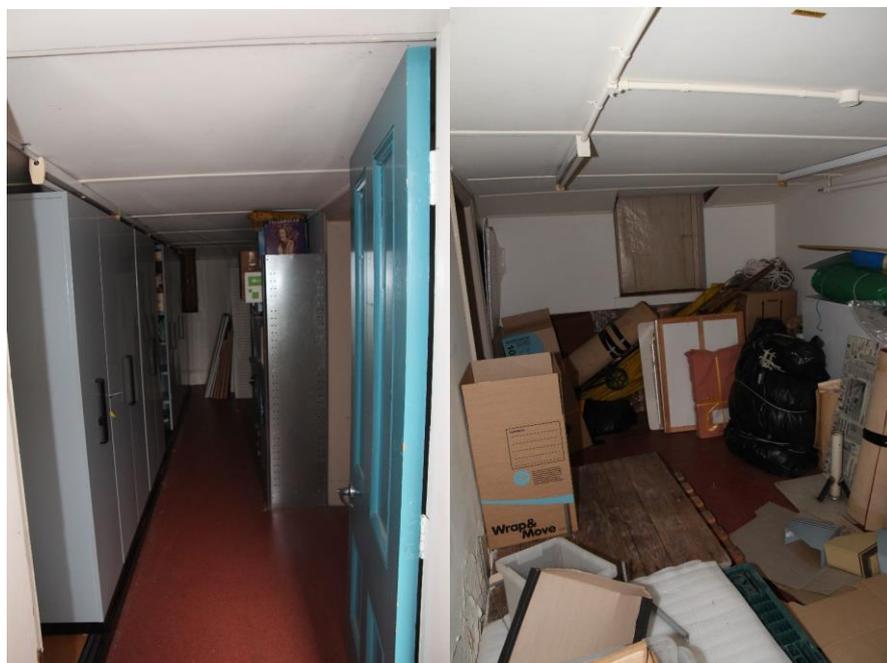
**ROOM No. G18  
CofPP 0G.41, 0G.42**

Early plans indicate that these spaces were originally backstage toilets (central section) accessed via 'retiring rooms' on either side. The retiring rooms were accessed from the staircase lobbies (G19 & G21). They all became storage spaces in the 1930s renovations, with new doors from the passage (G20) into the central storage spaces.

There is a severe dampness problem in these spaces which has necessitated removal of stored material. The cause is being investigated (2020).

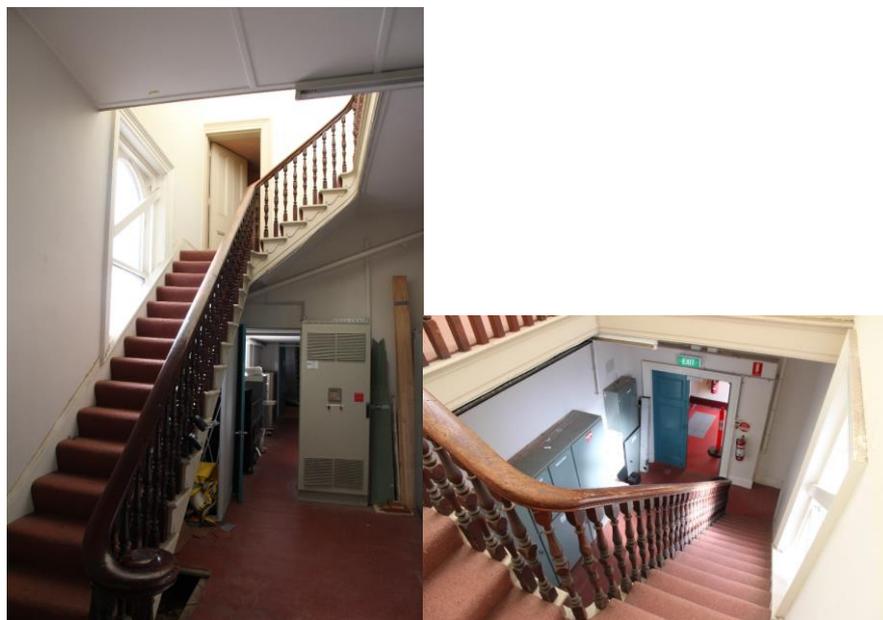
**ROOM No. G19  
CofPP 0G.38**

1930s style double doors with Victorian architraves and stops to corridor G15

- Install replacement baluster in the bottom volute of the staircase balustrade.
- Repaint handrail of the balustrade.
- Monitor plaster cracking high on the west wall.

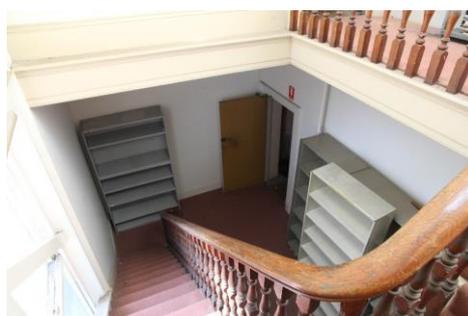
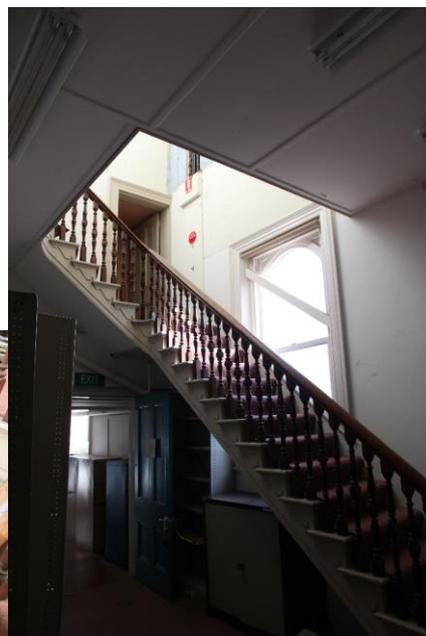
**ROOM No. G21  
CofPP 0G.43**

Victorian stair with turned balustrade up to room M6 (ex F23)  
Victorian double hung window with decorative arched glazing treatment, Victorian architraves and sill as a large highlight to the stair  
Victorian double hung window, half blocked by stair, to Daly Street  
Victorian door with part Victorian architrave to stage M5 (ex F22) from first landing  
Recent ceilings to upper and lower levels  
Recent fire and other services exposed  
Victorian style door to G20 (ex G32)  
Wall light with small baked enamel shade to stair

- Fix loose baluster under volute at base of stair balustrade.
- Restore plasterwork over exposed old power ducts within north wall.
- Monitor minor plaster cracking high on east wall.

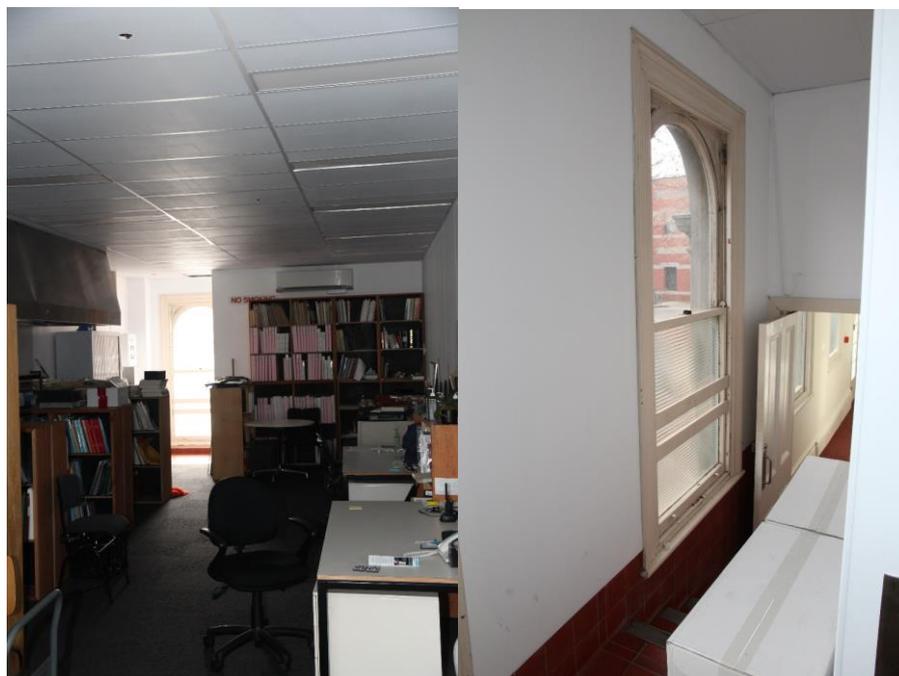
**ROOM No. G22  
CofPP 0G.80**

This space was originally a series of 4 small rooms for the police station, each with a fireplace and a doorway to the corridor (G29). These rooms remained though to the era of use by the Baby Health Centre, although in the late 1930s the wall between the northern two rooms was largely removed. In the 1990s renovations the kitchen was created to serve functions in the hall, and the floor level was correspondingly raised to that of the lobby area (G23) and hall. Most of the kitchen fittings and fixtures were subsequently removed.
