# South Melbourne Town Hall

Conservation Management Plan

208-220 Bank Street, South Melbourne, Victoria

LOVELL CHEN

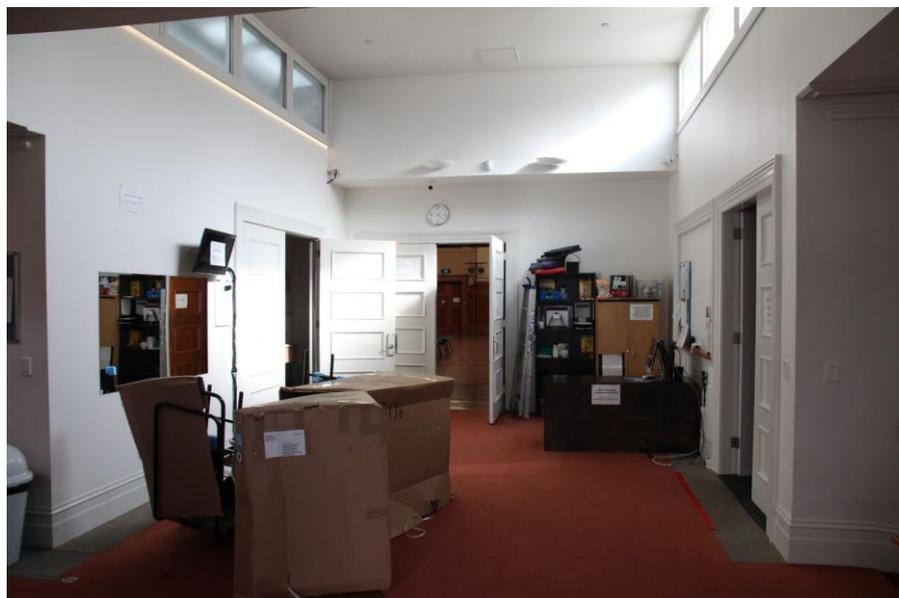
**ROOM No. G23  
CofPP 0G.79**

Originally part of an external service yard with open-air stair egress from the auditorium created c1918. The space was enclosed, and the floor raised to hall level in the 1990s.  
1930s or later four panel double doors to auditorium G17  
Recent matching style double doors to former kitchen servery room G22 & G24  
Victorian architraves with large steps to the auditorium doorway  
Victorian architraves and some recent Victorian-style architraves to door openings  
Recent high ceiling with recessed or surface mounted services  
Recent clerestory windows to the north and south walls  
Broad clear opening to new loading dock room G33

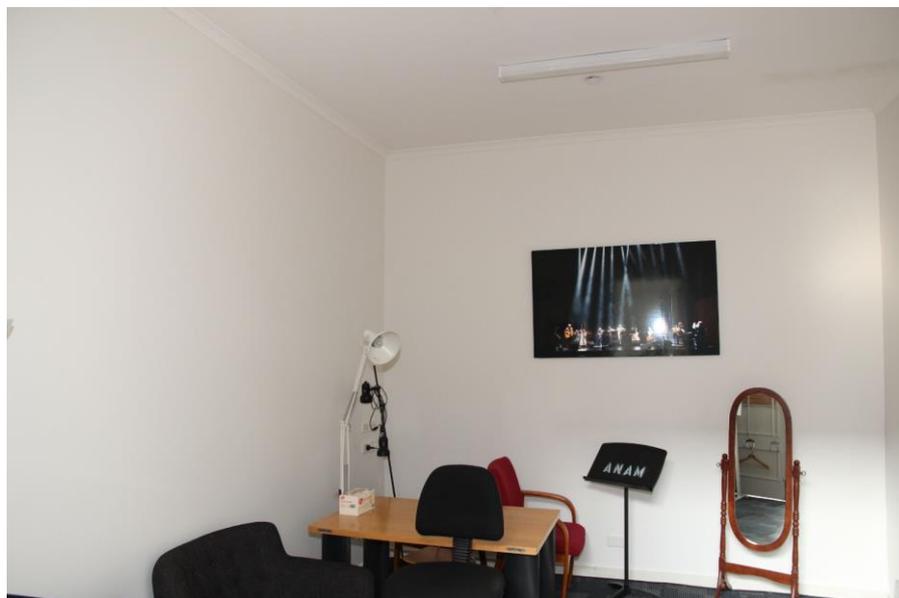
**ROOM No. G24  
CofPP 0G.80**

This room is on the same footprint as the bluestone-walled police cells of the original build. The cells had probably been removed by the 1920s. A slate-roofed laundry had been built here before 1936. The laundry remained in the late 1930s renovations.

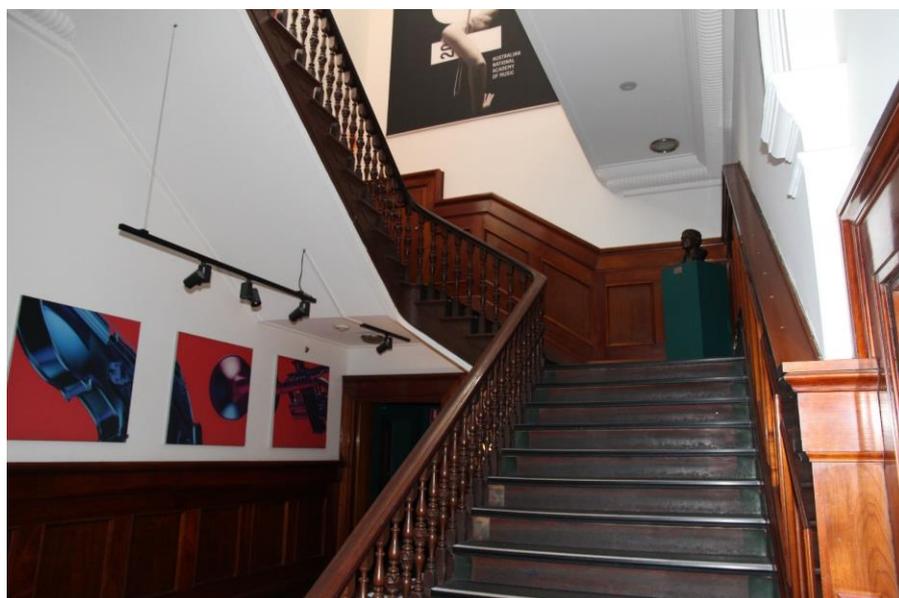
**ROOM No. G27  
CofPP 0G.68**

Curved Victorian staircase with timber balustrade and turned balusters  
1930s blackwood wall panelling  
1930s ornate cornice to match main passages (G16)  
Victorian door to underside of stairs

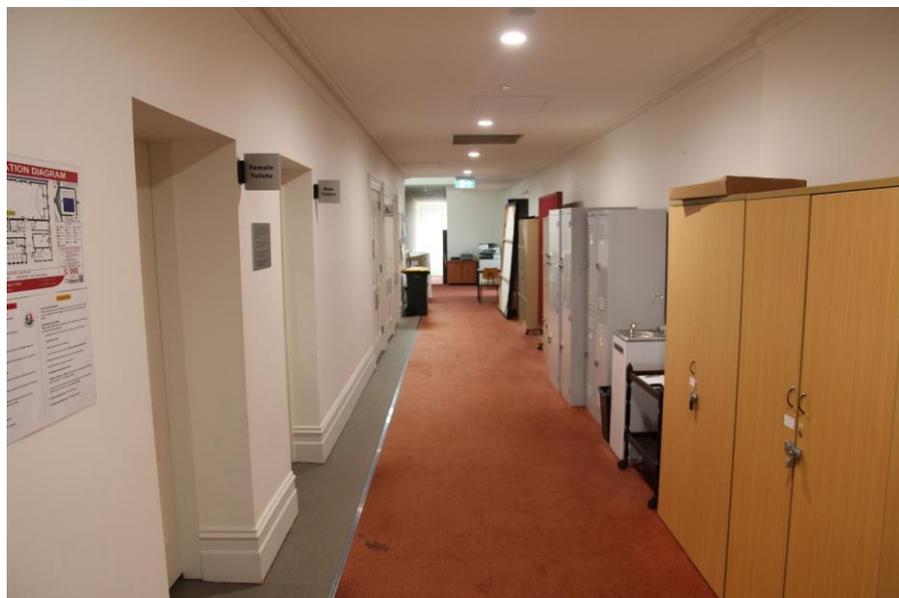
ROOM No. G28  
CofPP 0G.73, 0G.74, 0G.75, 0G.76,  
0G.77 & 0G.78

The current corridor was part of the post-office yard in the original building and remained open yard space in the 1930s renovations. It was subsequently enclosed and the floor level raised to main Town Hall ground floor level. The toilets occupy a space originally occupied by some of the police cells and the yard which serviced them. In the 1930s renovations this space became toilets and cloakroom - the wall separating the toilets and corridor was an external wall.

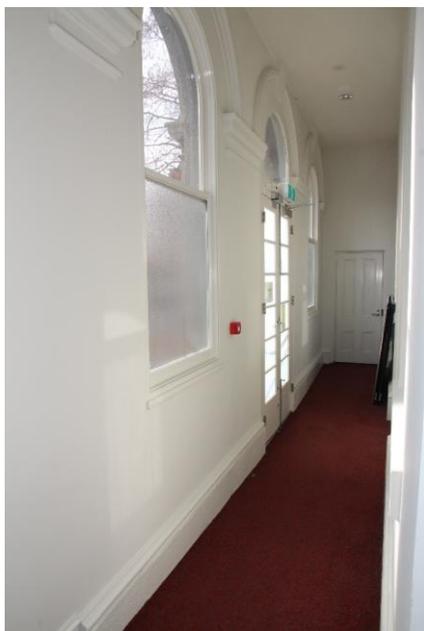
**ROOM No. G30  
North of CofPP 0G.84**

Originally a loggia with three arched openings to the street, and a central double doorway for public entry to the courtroom. There was also a door on the west to the police station and a door on the east to the police residence. The arrangement survived through the Baby Health Centre era of use.

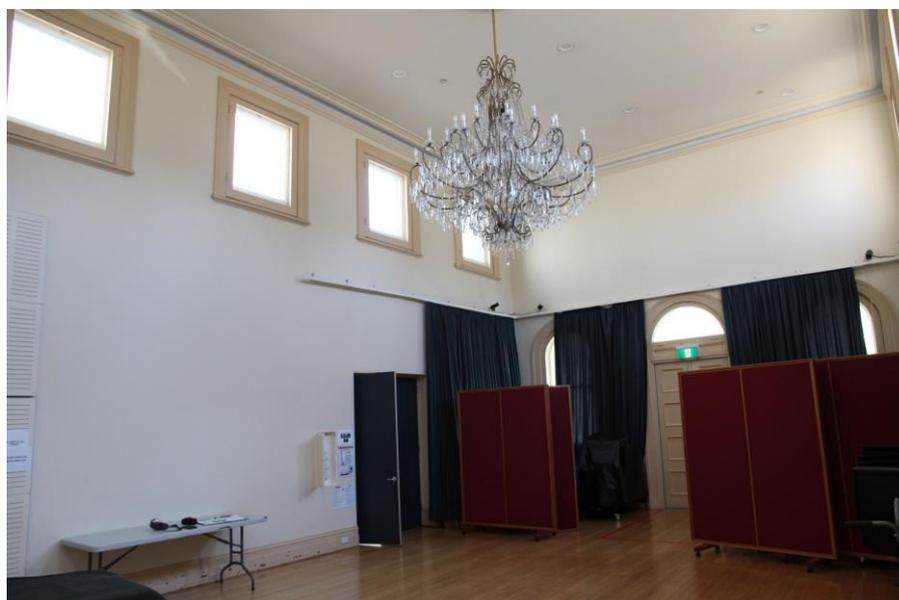
**ROOM No. G31  
CofPP 0G.84**

This space has always been a single room but has changed in its relationships to the adjoining spaces. The original central public doorway on the north remains. On the west, the original doorway to the police station remains, although enlarged to a double door. The door to the police station corridor from the dock in the courtroom was removed in the 1990s renovations. The fireplace in the southwest corner has been removed. On the south, the doorway to the magistrate's room was removed by the 1930s (along with the magistrate's room).

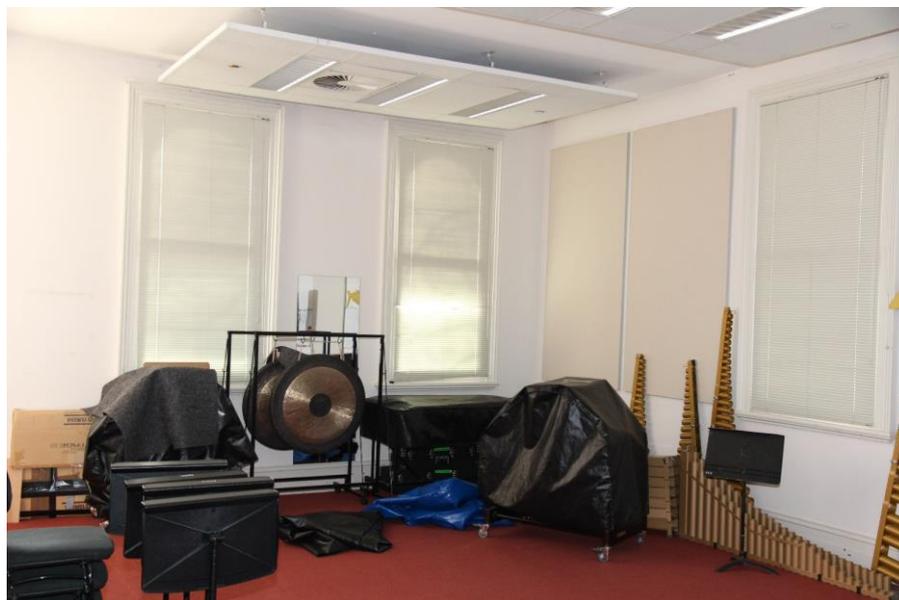
**ROOM No. G32  
CofPP 0G.85, 0G.86, 0G.87 & 0G.88**

Originally the five rooms and small courtyard of the police quarters. After the police left in the 1920s, the north end was converted to a garage with garage door to the east. The central part was a store and gas company's test room with a door to the east, and the southern end became public toilets, also with a door to the east. Subsequently the garage door and two other doors on the east facade were returned to windows. The west wall was largely opened up between 1979 and 1995, which also entailed removal of fireplaces. This wall was later rebuilt.

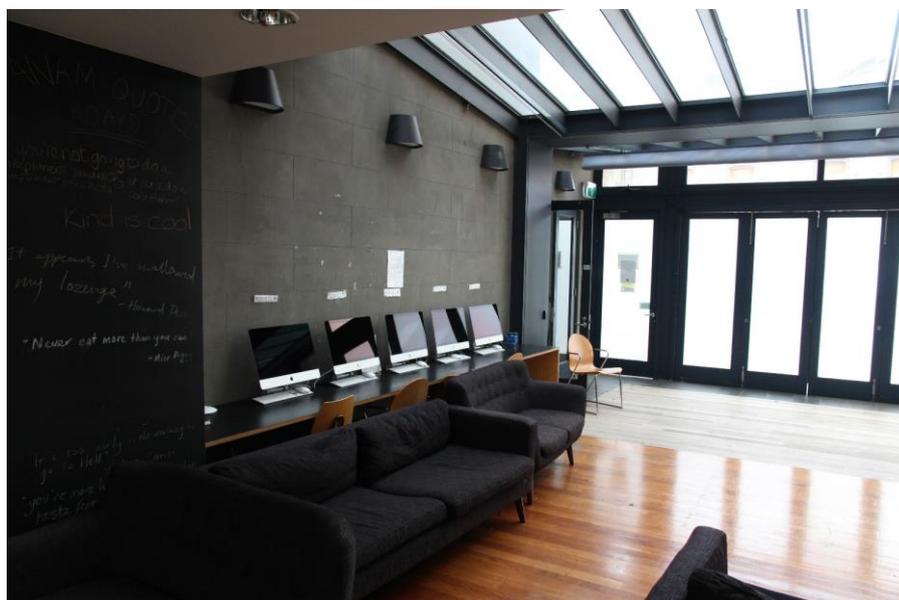
**ROOM No. G33  
CofPP 0G.89**

This space was occupied by the magistrate's room and a service court in the original 1879 build. The magistrates' room was removed, probably by 1918 when additional fire egress was provided from the hall. The yard then became part of the public egress from the hall, as well as providing access to the public toilets on the north side.

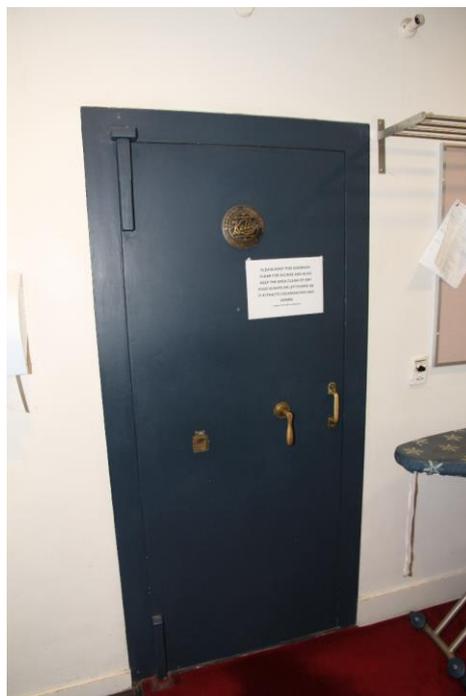
**ROOM No. G34  
CofPP 0G.92**

This strongroom was built in the late 1930s renovations as part of the new rates office.

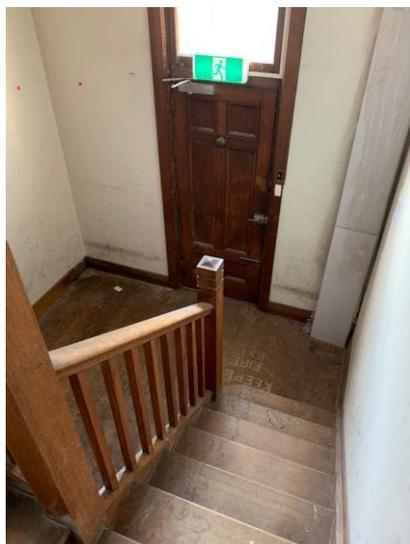
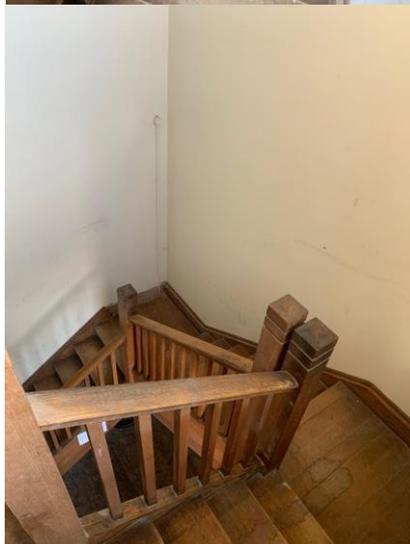
**ROOM No. G35**  
CofPP OG.106

Constructed in the 1938-9 renovations to give access to the hallkeeper's flat on the first floor and largely unaltered since then.

The original door to the corridor on the northern edge of the building (part G36) which was observed in the 1995 CMP is now closed over.

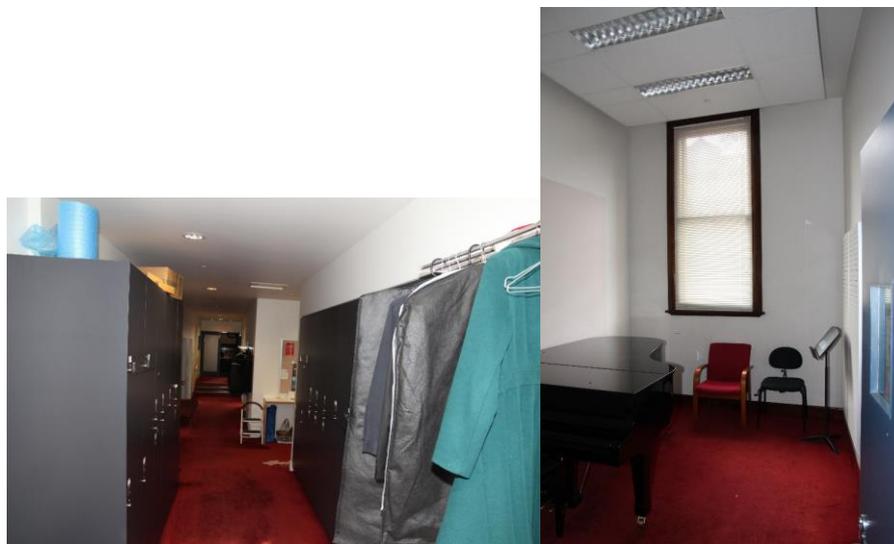
ROOM No. G36  
**CofPP 0G.90, 0G.91, 0G.93, 0G.94,  
 0G.95, 0G.97 & 0G.98**

This space incorporates the majority of the floor area of the rates office built in the late 1930s. The rates offices appears to have been planned with large spans supporting the floor above to allow flexibility of office arrangements.

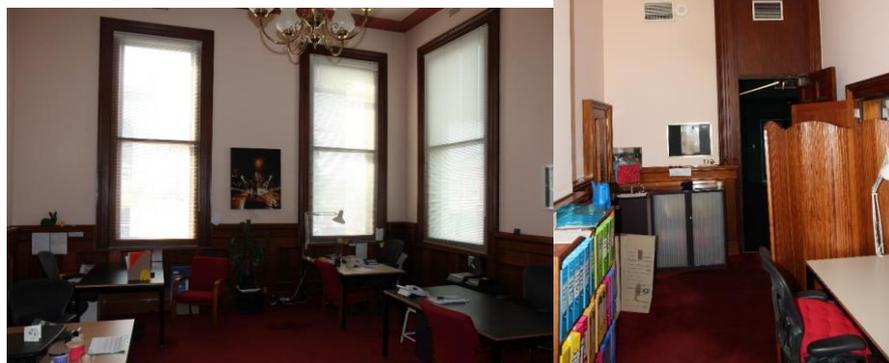
**CofPP 0G.104 & 0G.105**

Originally a single space being the “General Office” of the Post and Telegraph office, with a large formal entrance on the south and a central door on the north leading into a central corridor serving smaller offices. A fireplace was located on the west wall. Before the late 1930s renovations the space had become a committee room, with the central north doorway filled in and a new door opened to its west. By 1979 the floor level had been raised to match the main Town Hall ground floor level, and the space had been divided in two as per its current layout, functioning as the town clerk’s office.

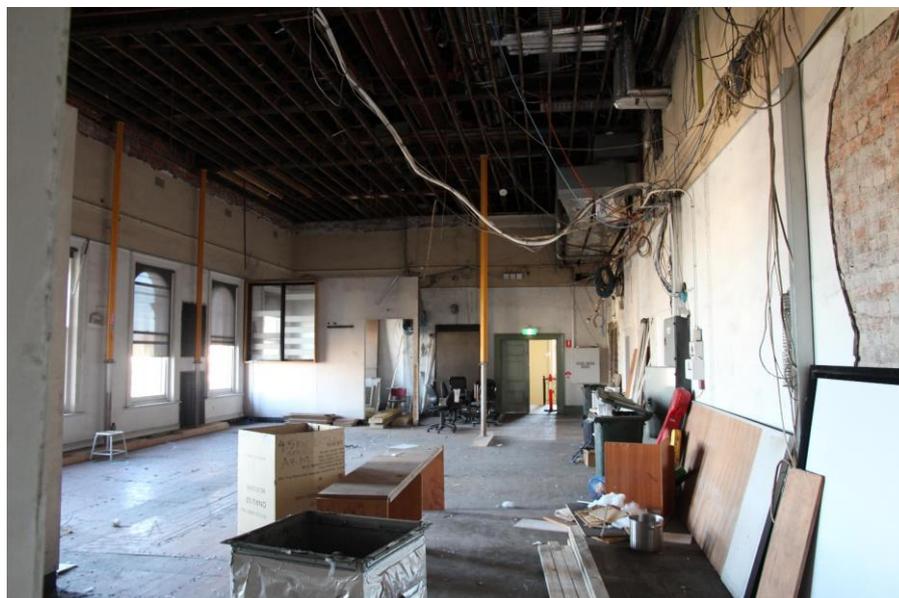
**CofPP 01.29, 01.30, 01.32, 01.33, 01.34 & 01.05**

This was the original 'refreshment room' with the public exit to the corridor (G11) on the west, and a service exit to the kitchen block at the east end of the north wall. The space was renamed in the late 1930s as the 'supper room'. In the late 1930s renovations, additional exits were created to the west into the new staircase and to the north to the fire escape stairs in the northern courtyard. From the 1970s it was variously partitioned into smaller spaces.

The suspended ceiling of this room and the original lathe and plaster ceiling above have been removed because of partial failure of the trusses and water entry.

Failures in the trusses and truss bearing plates have caused dropping of the truss bottom chords and water damage.

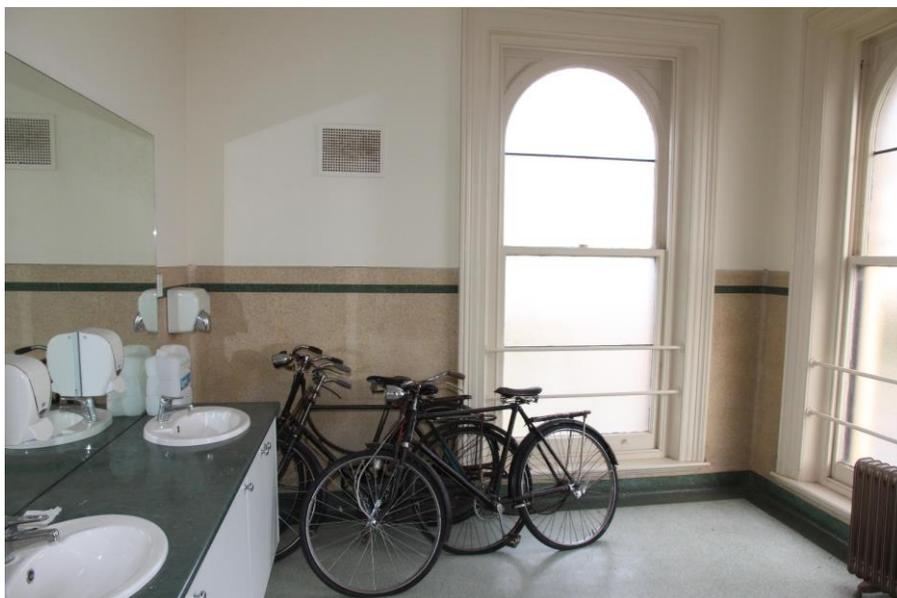
**ROOM No. F3  
CofPP 01.02, 01.03, 01.04**

This space was created in the 1930 renovations, with the floor raised to accommodate the mezzanine level below, hence the window sills are at floor level.

Three double hung windows with Victorian architraves to Bank Street  
Glazing to these windows has been replaced with obscure glass and now has horizontal glazing bars

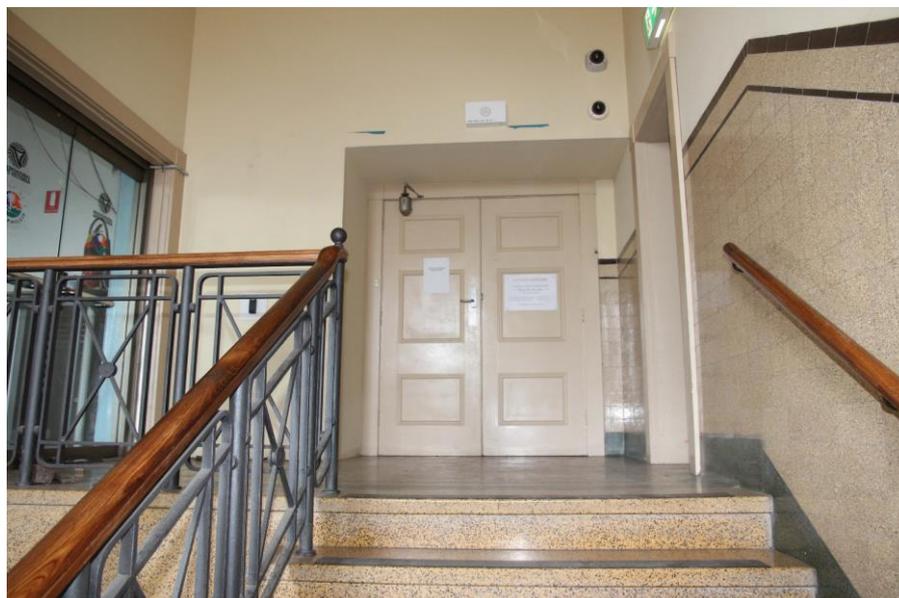
**ROOM No. F4  
CofPP 01.01**

This is a new reinforced concrete staircase added in the late 1930s renovations, with new doors through to the supper room.

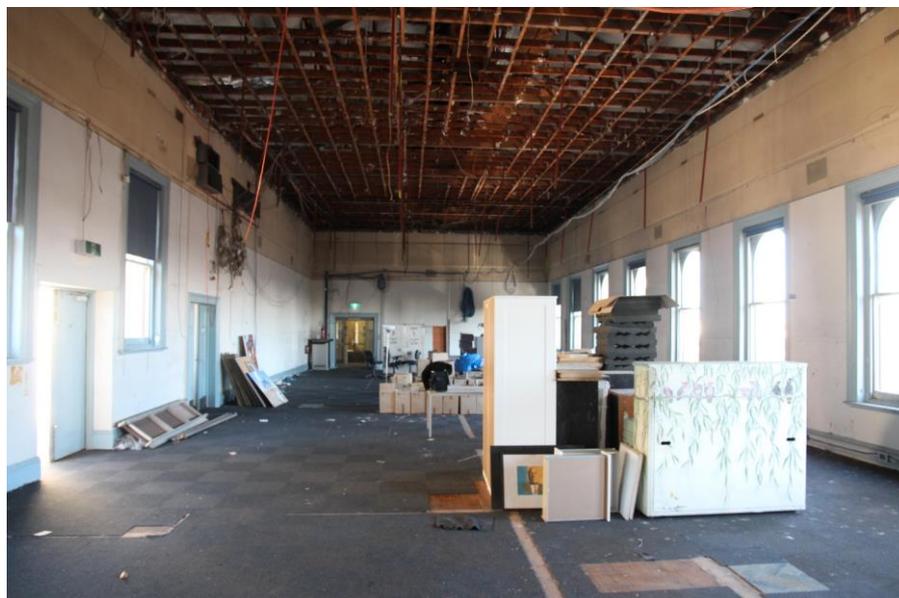
**CofPP 01.06, 01.07, 01.08, 01.09, 01.10,  
01.12, 01.13 & 01.14**

This large space was originally separated into three parts. The central section, with raked ceiling and painted trusses, was initially a reading room for the Mechanics' Institute before becoming a meeting room when the free reading room replaced the meeting room on the ground floor. At the south end was a central corridor and rooms on either side, including a 'Members Room' for Mechanics' Institute subscribers. At the north end were anterooms (a couple of steps down), and a narrow staircase to the ground floor. In the early twentieth century the north end spaces became part of the first assistant librarian's residence then baby health centre in 1920.

The suspended ceiling of this space has recently been removed to allow investigation of potential truss failure.

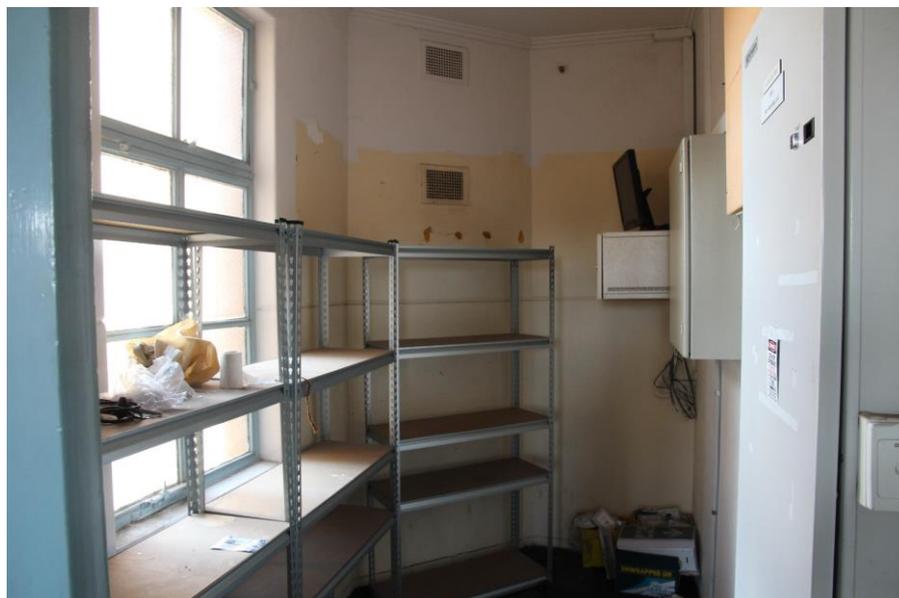
**ROOM No. F6  
CofPP 01.11**

This room was created as a servery in the 1930s and was intermediate between the canteen/kitchen F7 and the supper room F5.

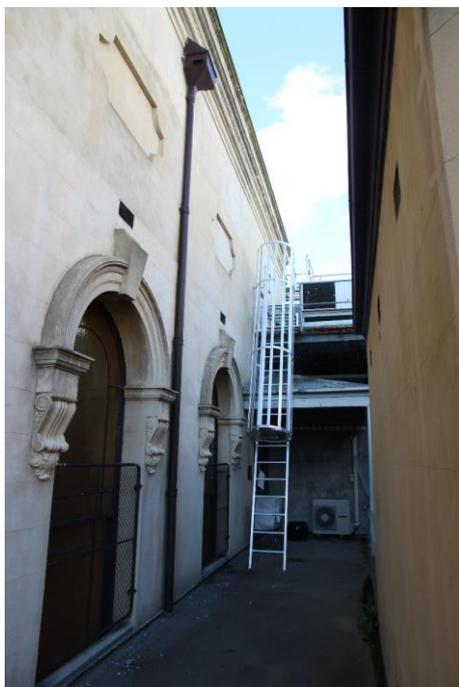
ROOM No. F8  
**CofPP not numbered**

External concrete walkway added in the late 1930s renovations providing egress to the south courtyard from the supper rooms F2 and F5, and the balcony F10. There is no longer access to the supper room F2.

Various air-conditioning services installed at this level  
Now also provides access to roof walkways

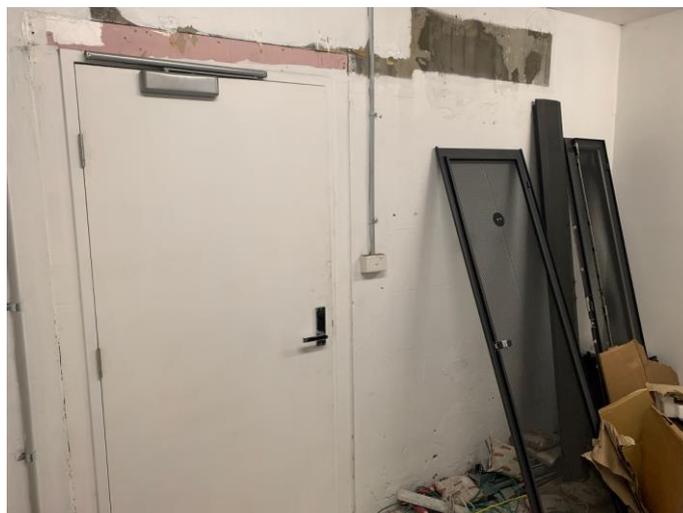
**ROOM No. F9  
CofPP 01.31**

South wall with former exit from supper room (F2)

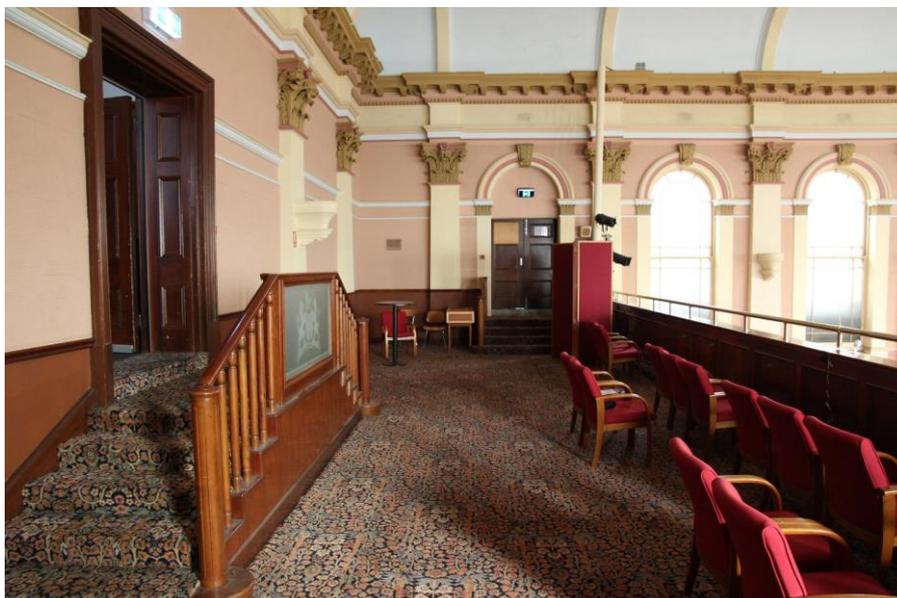
**ROOM No. F10  
CofPP 01.36**

In the late 1930s renovations, the balcony gained an additional fire exit on the west side.

- Deterioration/damage to plasterwork, including loss of sections of top edge of cornice, recommendations are as for Auditorium G17.
- Water seeping in at base of western double doors. Examine source of moisture, improve weather seal.

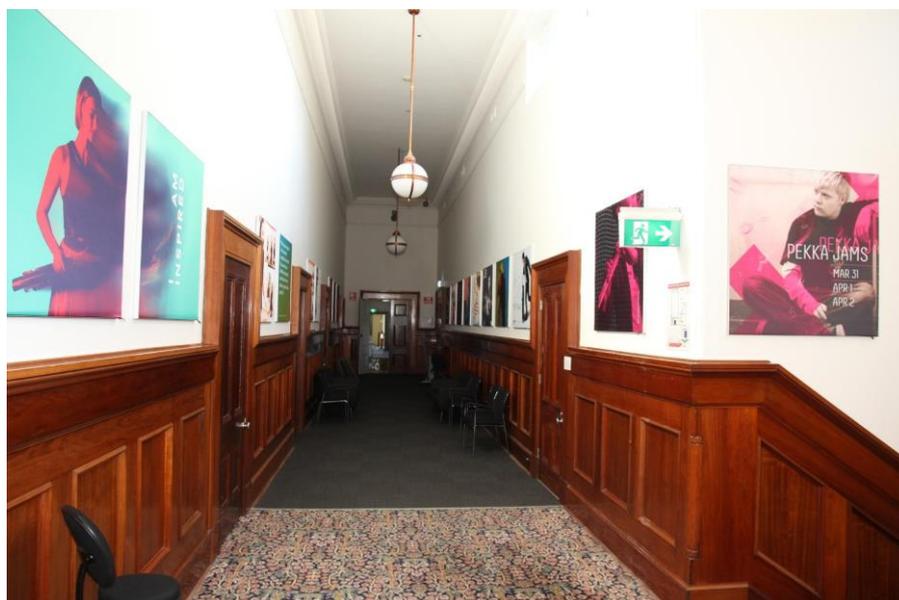
**ROOM No. F11  
CofPP 01.35**

1930s blackwood wall panelling  
 1930s ornate cornices  
 High ceiling, flush mounted services and high picture rail  
 1930s steel clerestory windows with no architraves on southern wall  
 1930s doors to balcony F10  
 Victorian doors, some with deep panelled reveals, to rooms F1, F12, F15, F16, F17 and F18. Impact damage to door reveals and doors particularly prevalent here.  
 1930s wide architraves with stops to all doors  
 Recent pendent globe feature lighting  
 Framed portraits of Councillors removed and replaced with posters  
 Carpet design matches room F12, F15, F16, F17 and F18

- The doorways, doors and panelling on the south side of this corridor display particularly severe examples of impact damage.

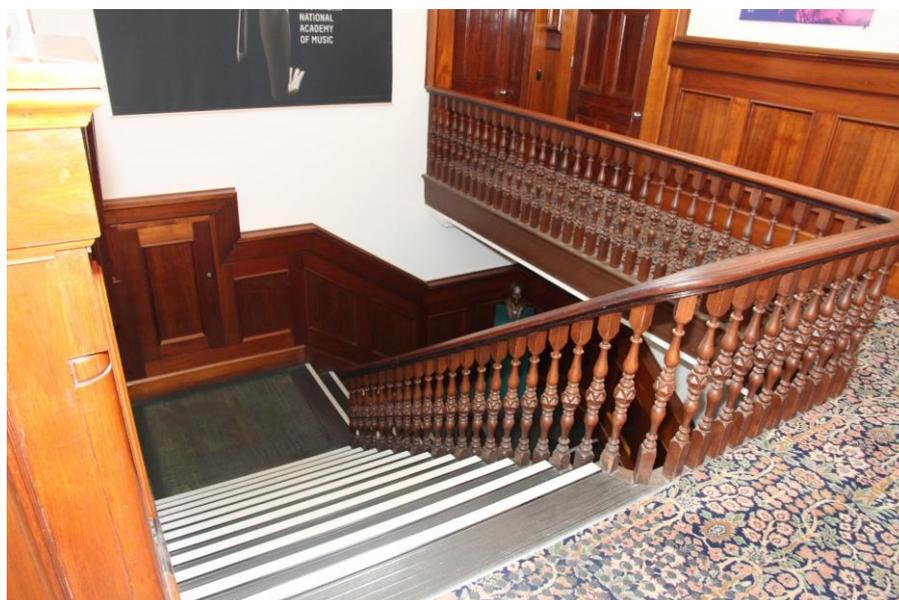
**CofPP upper part of 0G.68**

Upper level of stair from G27.  
Timber balustrade with turned balusters.  
Blackwood paneling to walls  
Aluminium and rubber stair tread coverings.

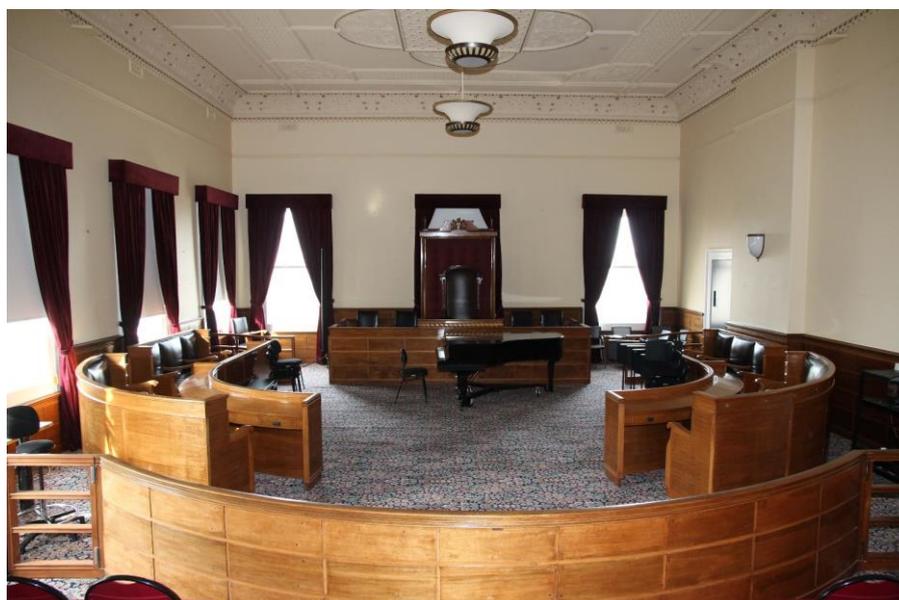
**ROOM No. F15  
CofPP 01.45**

The council chamber was comprehensively renovated in the late 1930s renovation works. Several detailed reports have been done specifically for this room and are available from City of Port Phillip.

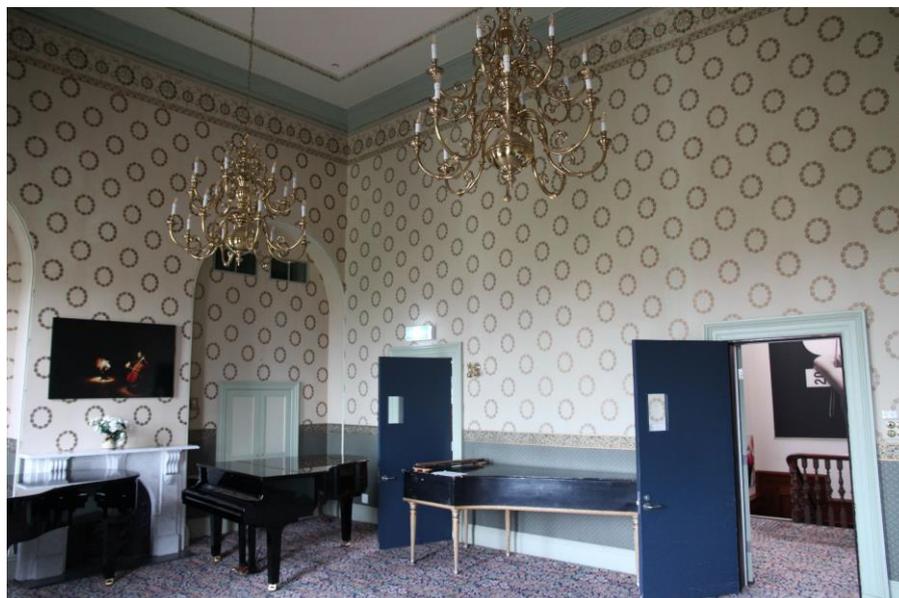
**ROOM No. F16  
CofPP 01.44**

In the original layout, the space between the council chamber and the tower was divided into four spaces – a small anteroom to the council chamber, the mayor's room, and two spaces which original descriptions suggest were committee rooms. In the late 1930s renovations walls were removed and added and the anteroom became part of a larger mayor's room adjacent to the council chamber (F16), a small mayor's office (F17) and a mayoress's room (F18).

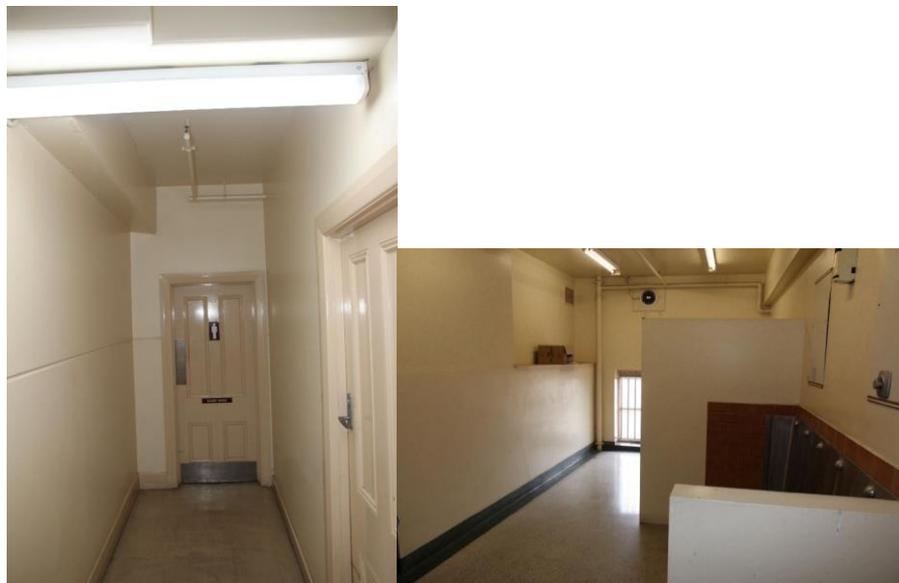
**CofPP** tbc

This mezzanine level with concrete floor was introduced in the late 1930s renovations, as evidenced by the floor level being at half height of the original ground floor windows.

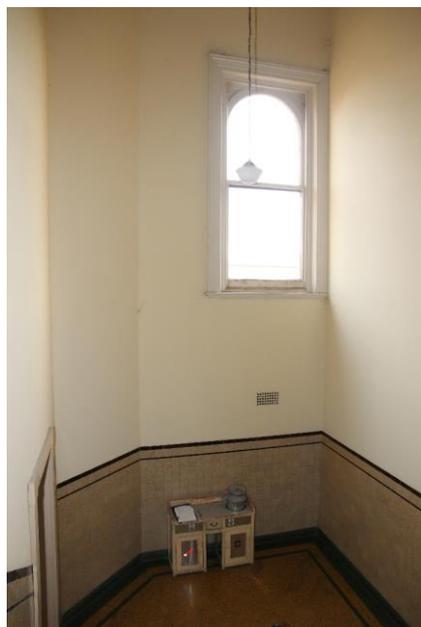
ROOM No. M2  
**COPP ?**

This staircase with its lobbies and landings was introduced in the late 1930s renovations.

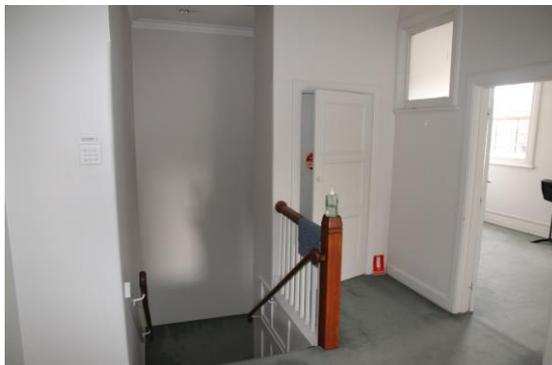
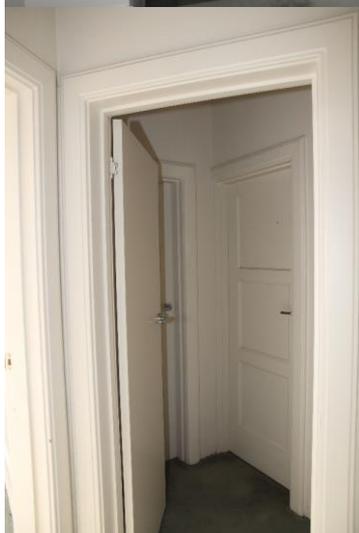
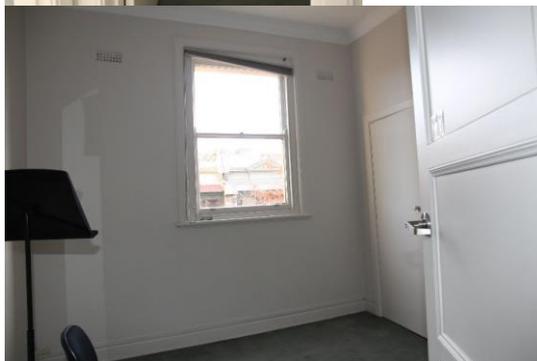
**CofPP 01.15, 01.16, 01.17, 01.18, 01.19,  
01.20, 01.21, 01.22, 01.23, 01.4 & 01.25**

In 1936 these rooms were added over the former fire brigade station to accommodate the assistant librarian. The formerly open space between the former fire station and the former Mechanics' Institute was filled in for a staircase for the flat, with access from the west.

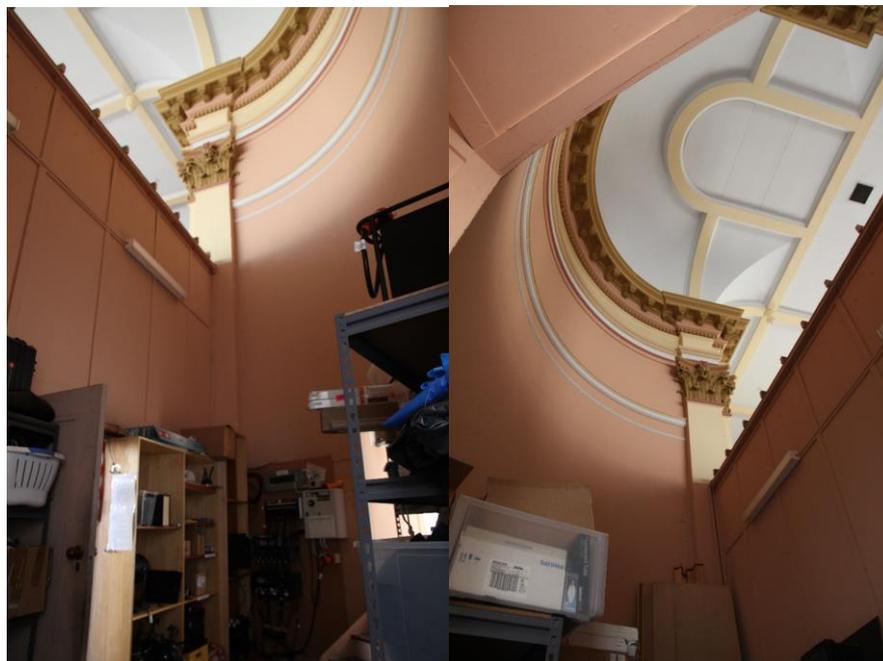
**ROOM No. M5  
COPP ?**

This semi-circular plan space was created in the original build to accommodate an organ. It was retained in the late 1930s renovations, but with a timber screen to the hall and the floor level changed to suit the new stage.

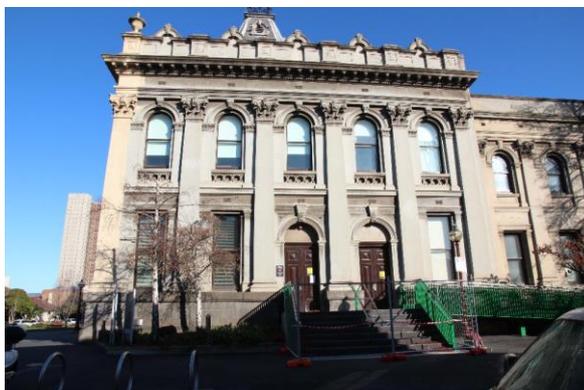
East facade

The eastern facade of this block did not undergo renovation in late 1990s. The urns on the parapet have not been replaced. The main alterations to this facade over the years have been in terms of position and placement of entrances. The original single entrance was central to the facade. At some point another entrance was created in the bay to the right, which was subsequently filled in and then recently opened again. The arched lights above the doors are filled in.

The eastern facade of this block did not undergo recent renovation like the south facade. This facade would benefit from a general maintenance program for the stucco work, similar to that previously done to the other facades of this block. The following non-urgent problems were observed on this facade:

- The stucco generally has crazing.
- There is some erosion of the Acanthus leaf brackets under the cornice.
- There is some cracking and moss/lichen growth on the top parts of the cornice
- Small losses of stucco edges generally
- Remove horizontal steel strut from southern most ground-floor window.

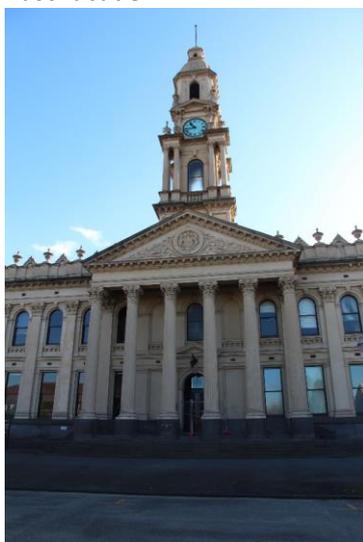
South facade

The majority of the exterior of this block remains close to its original 1879 configuration. Extensive conservation and reconstruction works were undertaken to the southern and western facades and roof of this block in the late 1990s, including replacement of the mansards and urns which had been removed in 1945.

- The jointing of the bluestone steps around the central portico of the south facade is eroded in parts allowing growth of weeds. This erosion will be progressive. The joints should be cleaned out and renewed with lime putty.
- The upper steps in the central entrance are worn and may not be compliant with current standards.
- There is thin plate-like exfoliation of the bluestone plinth in a number of areas. This is probably a side-effect of producing the original picked finish of the faces of the stone and is unlikely to lead to more substantial damage.
- Damage to corners of bluestone bases to portico columns. This may be impact damage. Refer to general policy for impact damage.

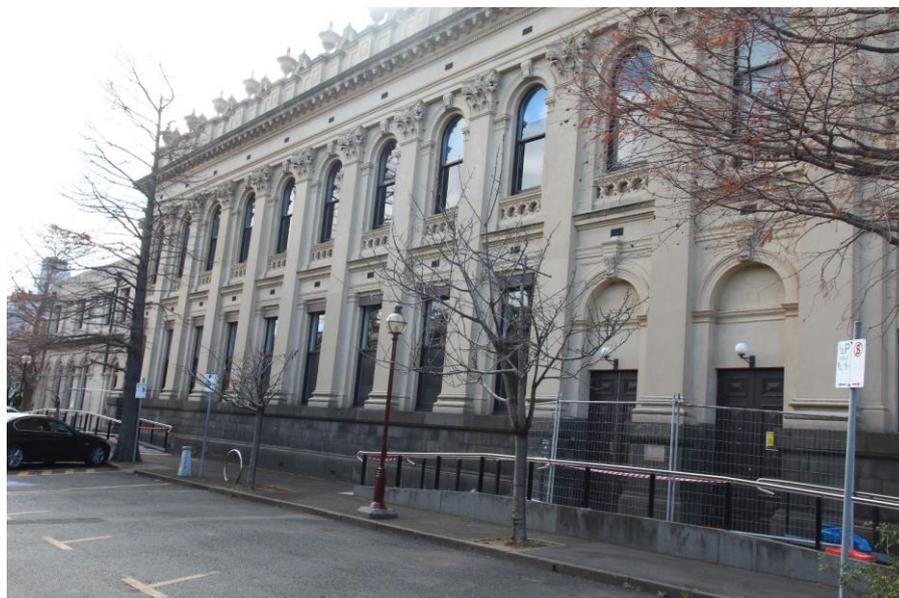
Originally the Mechanics Institute, this building's facade was continuous with the west portion of the town offices, with the same architectural treatment. There were originally three entrances. On the south facade the doorway led to a stairway to the first floor Mechanic's institute reading room (later meeting room). The two doorways on the north end of the west facade and one at the southern end of the west facade serviced the original meeting room (later public and children's libraries). The arched lights above the two southern doors in the west facade have been filled in.

- The timber windows generally, and particularly the upper windows, are subject to extreme weathering, with damage to timber, putty and paintwork. This is most urgent for the upper windows on the west and east sides.

There is thin plate-like exfoliation of the bluestone plinth in a number of areas. This is probably a side-effect of producing the original picked finish of the faces of the stone and is unlikely to lead to more substantial damage.
