CITY OF PORT PHILLIP ELECTRICAL LINE CLEARANCE MANAGEMENT PLAN 2025-2026

VERSION 2.1 – 25 FEBRUARY 2026

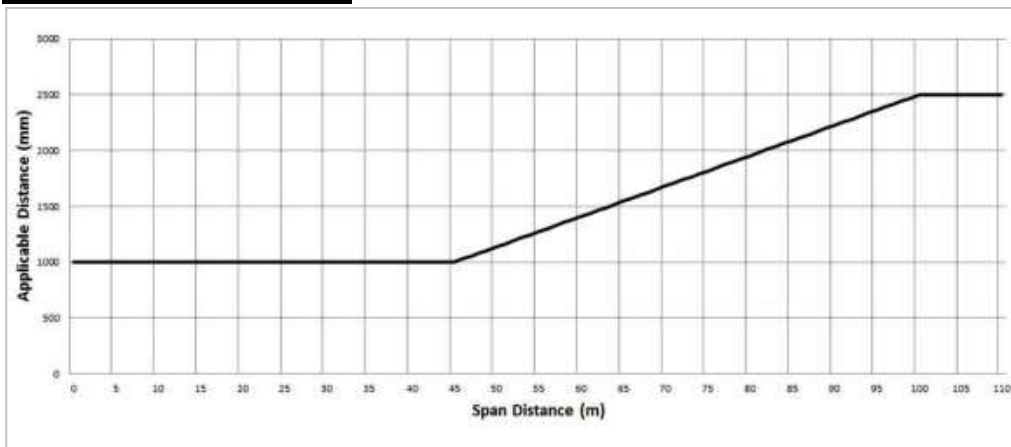
Graph 2: Uninsulated Low Voltage Electric Line in Low Bushfire Risk Area

The formula by which the applicable distance for the middle two thirds of a span of uninsulated low voltage electric line in a low bushfire risk area is calculated is as follows:

- a) if the span distance is less than or equal to 45 metres the applicable distance equals 1000 millimetres; or
- b) if the span distance is greater than 45 metres and less than or equal to 100 metres the applicable distance is calculated in accordance with the following expression – $1000 + ((\text{span distance minus } 45) \text{ multiplied by } (1500 \text{ divided by } 55))$; or
- c) if the span distance is greater than 100 metres the applicable distance equals 2500 millimetres.

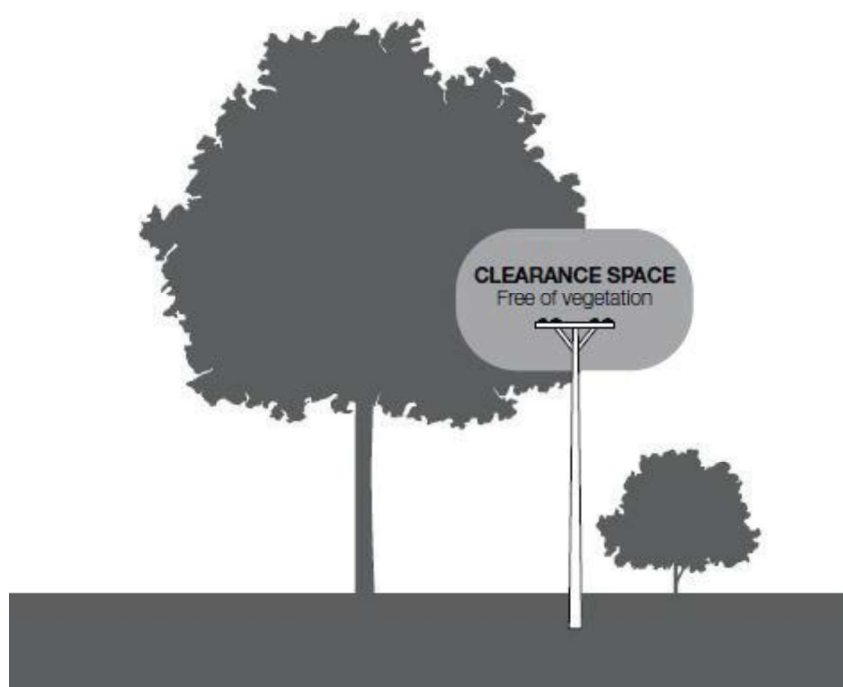
Figure 4 – Uninsulated Low Voltage Electric Line in a Low Bushfire Risk Area (NOT TO SCALE)
 Clause 25, Graph 2

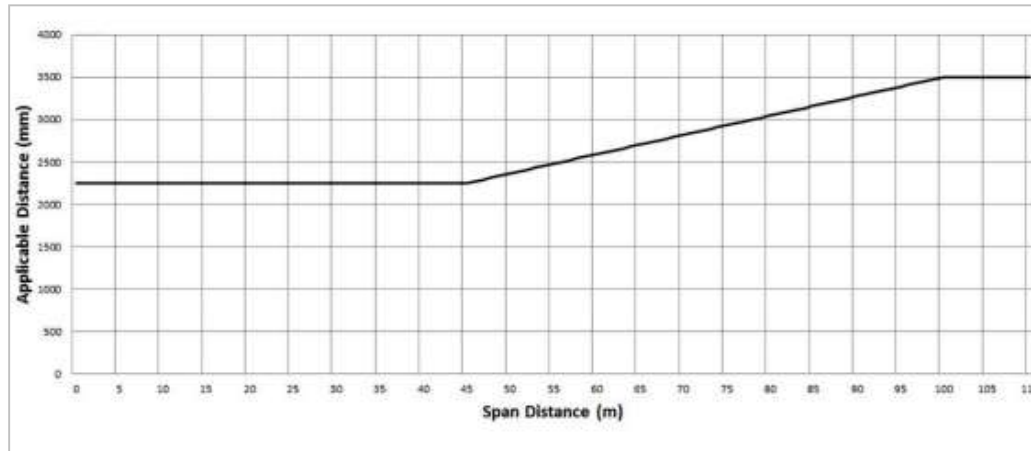
Graph 4: Uninsulated 66,000 Volt Electric Line in Low Bushfire Risk Area

The formula by which the applicable distance for the middle two thirds of a span of uninsulated 66,000 volt electric line in a low bushfire risk area is calculated is as follows:

- a) if the span distance is less than or equal to 45 metres the applicable distance equals 2250 millimetres; or
- b) if the span distance is greater than 45 metres and less than or equal to 100 metres the distance calculated in accordance with the following expression
 $2250 + ((\text{span distance minus } 45) \text{ multiplied by } (1250 \text{ divided by } 55));$ or
- c) if the span distance is greater than 100 metres the applicable distance equals 3500 millimetres.

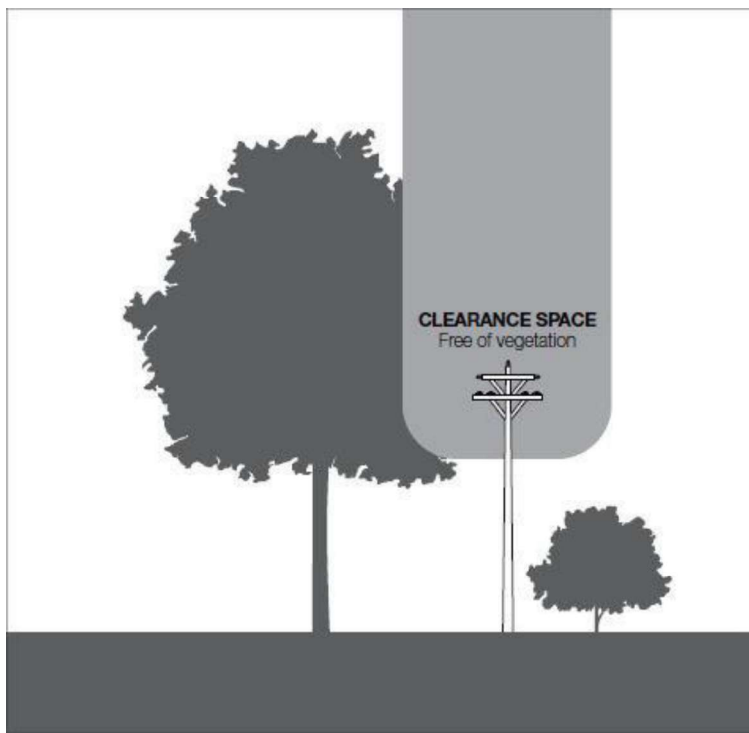
Figure 5 – Uninsulated 66 000 Volt Electric Line in a Low Bushfire Risk Area and Uninsulated Electric Line in a Hazardous Bushfire Risk Area (NOT TO SCALE)
 Clauses 27, 28 and 29, Graphs 4, 5 and 6
