# CITY OF PORT PHILLIP ELECTRICAL LINE CLEARANCE MANAGEMENT PLAN 2025-2026

VERSION 2.0 – 29 JANUARY 2026

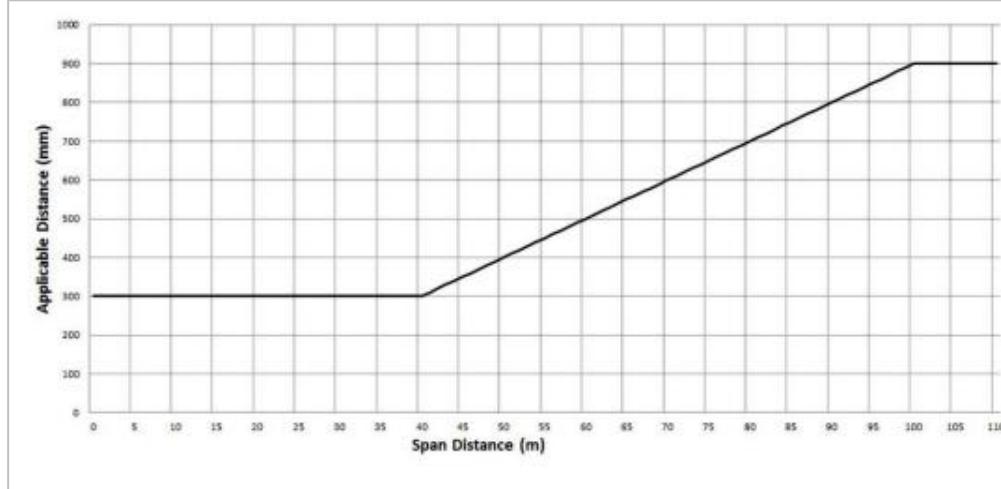
Graph 1: Insulated Electric Lines in all Areas

The formula by which the applicable distance, for the middle two thirds of a span of an insulated electric line in all areas, is calculated is as follows:

- if the span distance is less than or equal to 40 metres the applicable distance equals 300 millimetres; or
- if the span distance is greater than 40 metres and less than or equal to 100 metres – the applicable distance is calculated in accordance with the following expression –

$$300 + ((\text{span distance} - 40) \text{ multiplied by } 10); \text{ or}$$
- if the span distance is greater than 100 metres the applicable distance equals 900 millimetres.

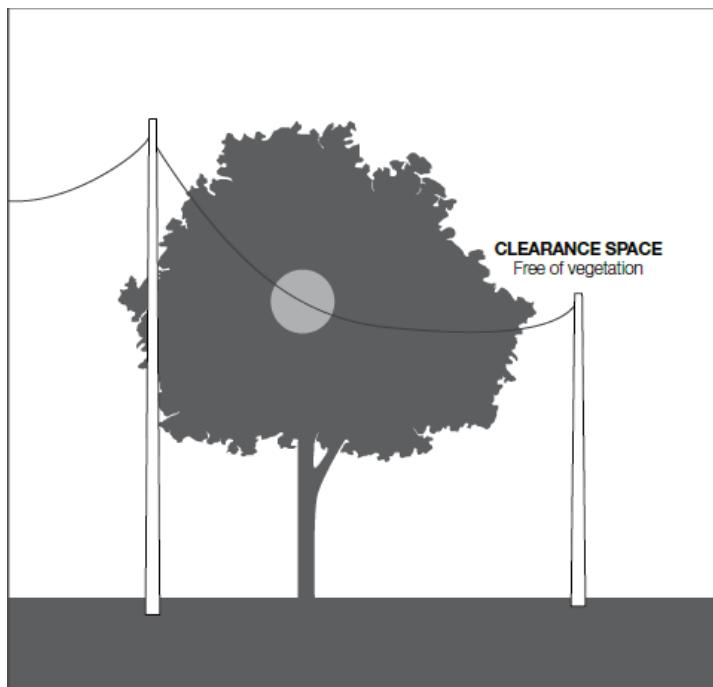
Figure 2 – Insulated Electric Lines in All Areas (NOT TO SCALE)  
 Clause 24, Graph 1

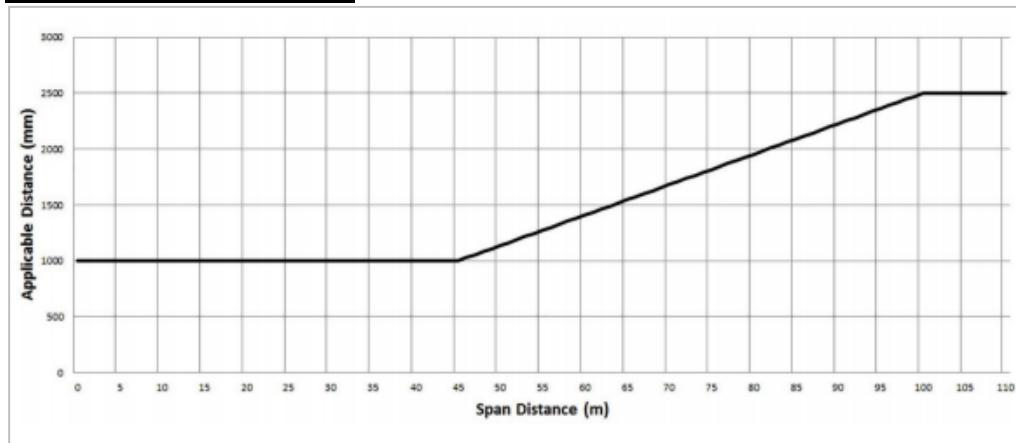
Graph 2: Uninsulated Low Voltage Electric Line in Low Bushfire Risk Area

The formula by which the applicable distance for the middle two thirds of a span of uninsulated low voltage electric line in a low bushfire risk area is calculated is as follows:

- if the span distance is less than or equal to 45 metres the applicable distance equals 1000 millimetres; or
- if the span distance is greater than 45 metres and less than or equal to 100 metres the applicable distance is calculated in accordance with the following expression –

$$1000 + ((\text{span distance} - 45) \text{ multiplied by } (1500 \text{ divided by } 55));$$
 or
- if the span distance is greater than 100 metres the applicable distance equals 2500 millimetres.

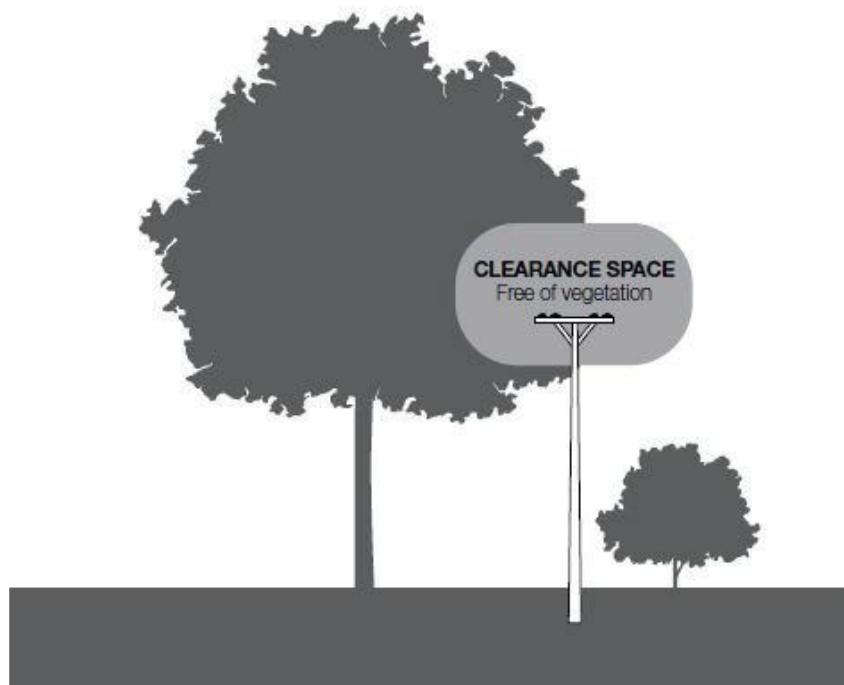
Figure 4 – Uninsulated Low Voltage Electric Line in a Low Bushfire Risk Area (NOT TO SCALE)  
 Clause 25, Graph 2

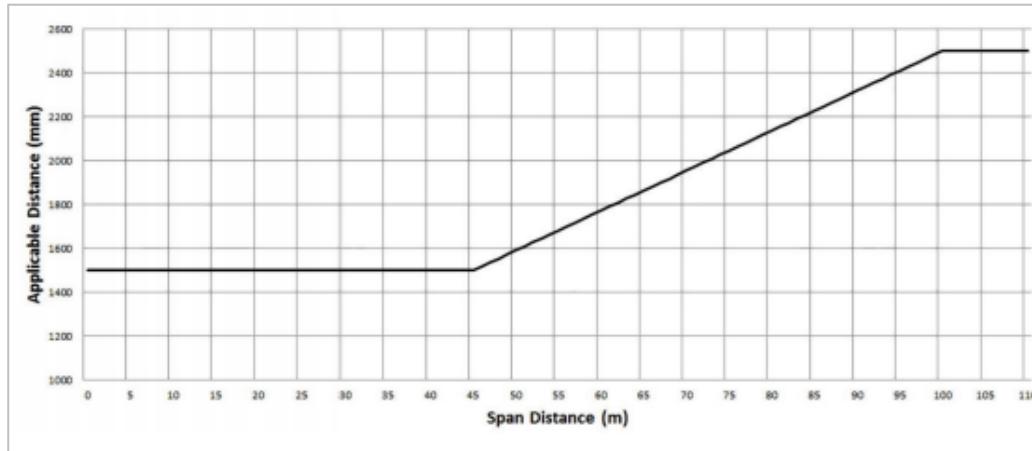
Graph 3: Uninsulated HV Electric Line (other than a 66,000 volt electric line) in LBRA

The formula by which the applicable distance for the middle two thirds of a span of uninsulated high voltage electric line (other than a 66,000 volt electric line) in a low bushfire risk area is calculated is as follows:

- if the span distance is less than or equal to 45 metres the applicable distance equals 1500 millimetres; or
- if the span distance is greater than 45 metres and less than or equal to 100 metres, the applicable distance is calculated in accordance with the following expression –  $1500 + ((\text{span distance minus 45}) \text{ multiplied by } (1000 \text{ divided by } 55))$ ; or
- if the span distance is greater than 100 metres the applicable distance equals 2500 millimetres.

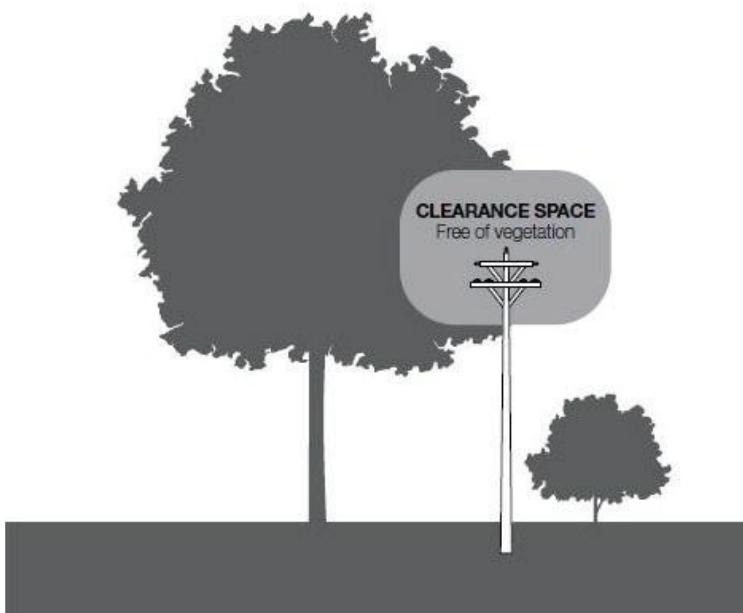
Figure 3 – Insulated Electric Lines in All Areas and Uninsulated High Voltage Electric Lines (Other Than 66 000 Volt Electric Lines) in Low Bushfire Risk Areas (NOT TO SCALE)  
Clauses 24 and 26, Graphs 1 and 3

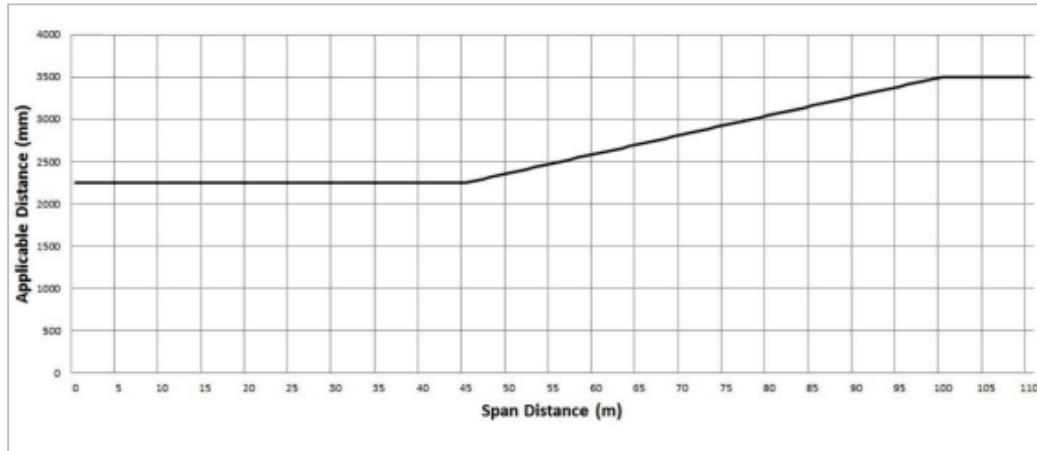
Graph 4: Uninsulated 66,000 Volt Electric Line in Low Bushfire Risk Area

The formula by which the applicable distance for the middle two thirds of a span of uninsulated 66,000 volt electric line in a low bushfire risk area is calculated is as follows:

- if the span distance is less than or equal to 45 metres the applicable distance equals 2250 millimetres; or
- if the span distance is greater than 45 metres and less than or equal to 100 metres the distance calculated in accordance with the following expression

$$2250 + ((\text{span distance} - 45) \text{ multiplied by } (1250 \text{ divided by } 55));$$
 or
- if the span distance is greater than 100 metres the applicable distance equals 3500 millimetres.

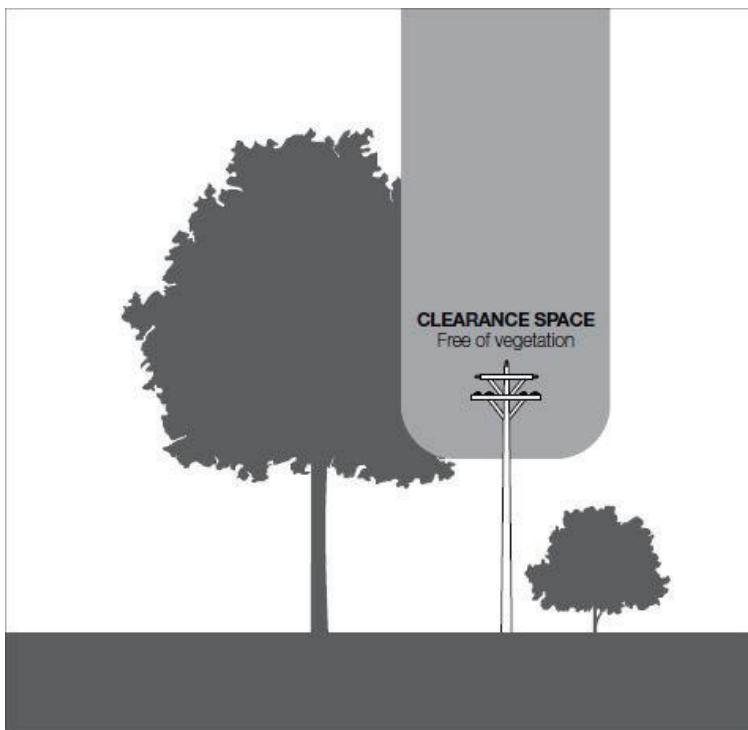
Figure 5 – Uninsulated 66 000 Volt Electric Line in a Low Bushfire Risk Area and Uninsulated Electric Line in a Hazardous Bushfire Risk Area (NOT TO SCALE)  
 Clauses 27, 28 and 29, Graphs 4, 5 and 6
