# CITY OF PORT PHILLIP ELECTRIC LINE CLEARANCE MANAGEMENT PLAN 2026-2027

VERSION 1.1 – 1 JULY 2026

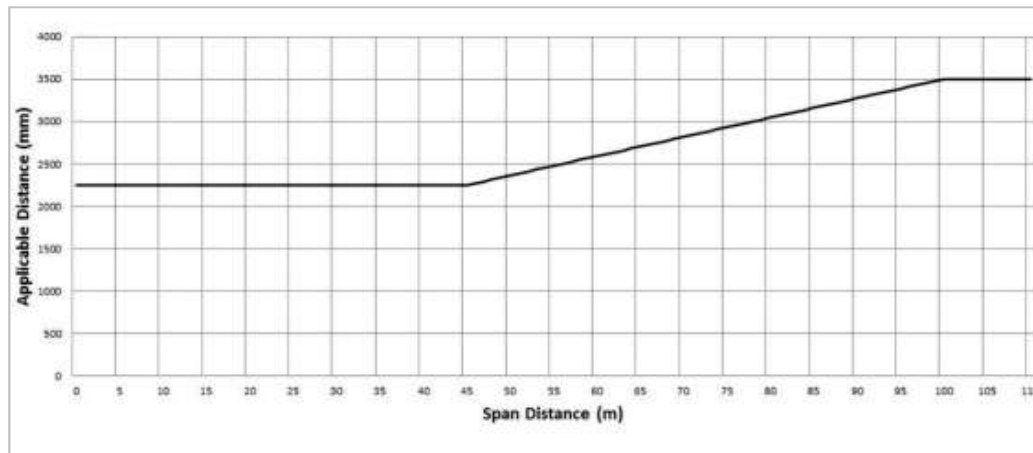
Graph 4: Uninsulated 66,000 Volt Electric Line in Low Bushfire Risk Area

The formula by which the applicable distance for the middle two thirds of a span of uninsulated 66,000 volt electric line in a low bushfire risk area is calculated is as follows:

- if the span distance is less than or equal to 45 metres the applicable distance equals 2250 millimetres; or
- if the span distance is greater than 45 metres and less than or equal to 100 metres the distance calculated in accordance with the following expression

$$2250 + ((\text{span distance minus } 45) \text{ multiplied by } (1250 \text{ divided by } 55)); \text{ or}$$
- if the span distance is greater than 100 metres the applicable distance equals 3500 millimetres.

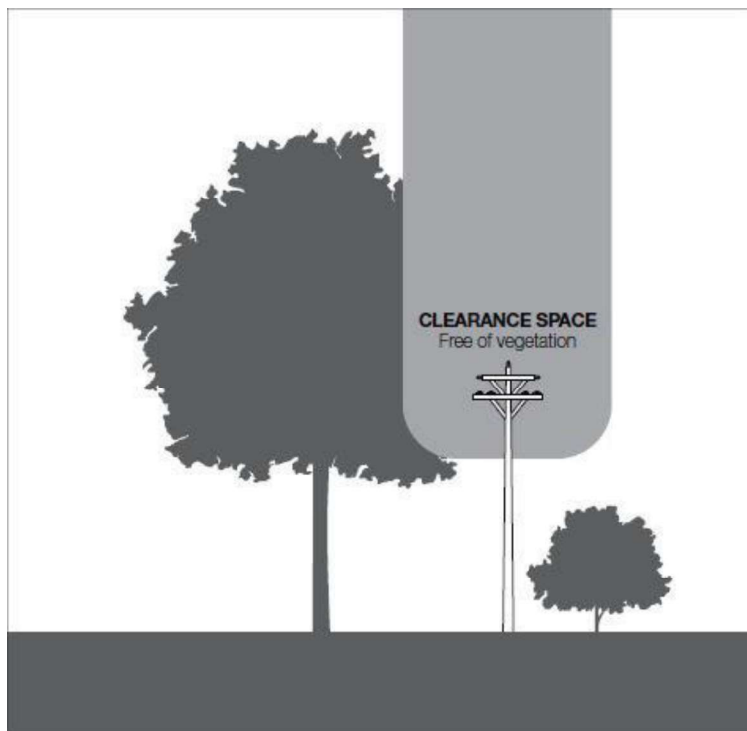
Figure 5 – Uninsulated 66 000 Volt Electric Line in a Low Bushfire Risk Area and Uninsulated Electric Line in a Hazardous Bushfire Risk Area (NOT TO SCALE)  
 Clauses 27, 28 and 29, Graphs 4, 5 and 6
