SOUTH MELBOURNE TOWN HALL ROOF STRUCTURE ASSESSMENT

Prepared for City of Port Phillip

December 2020

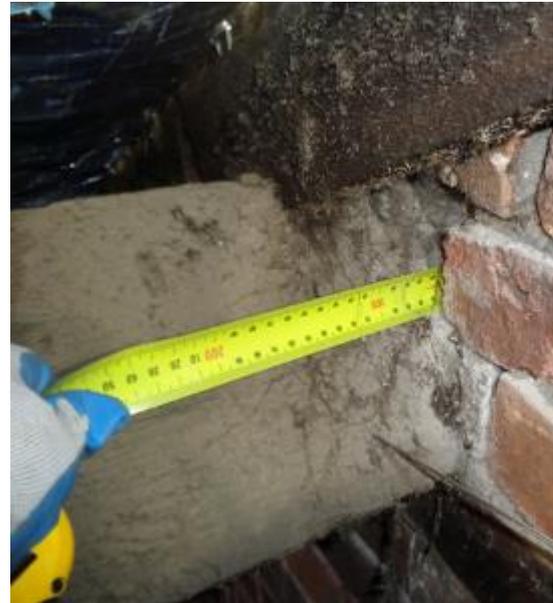
Figure 2: Underpurlin pulled out of wall

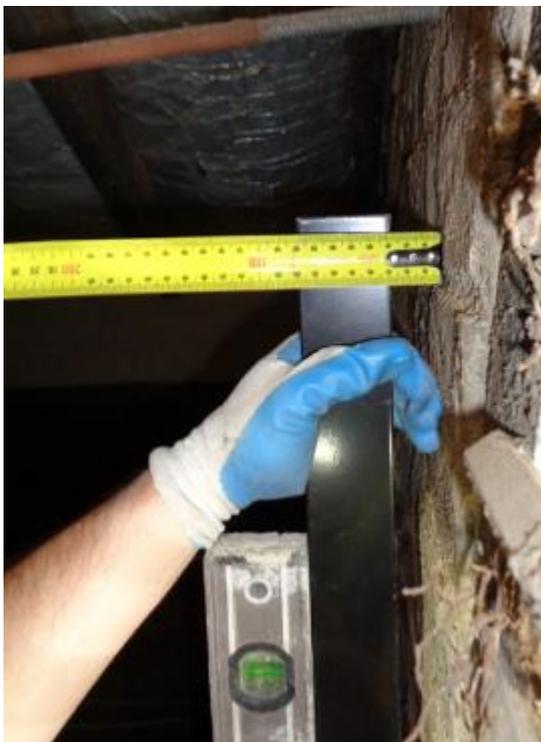
Figure 7: Plumb measurement on north gable

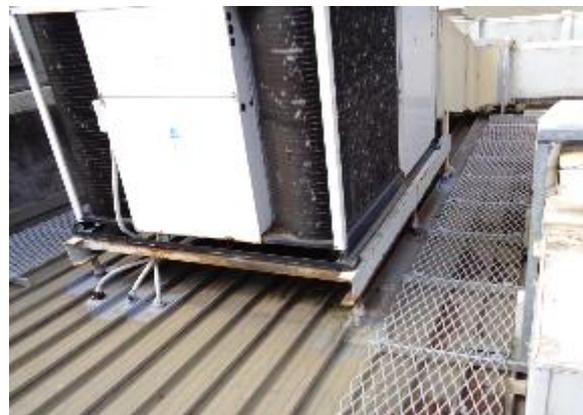
Figure 9: AC plant over G38

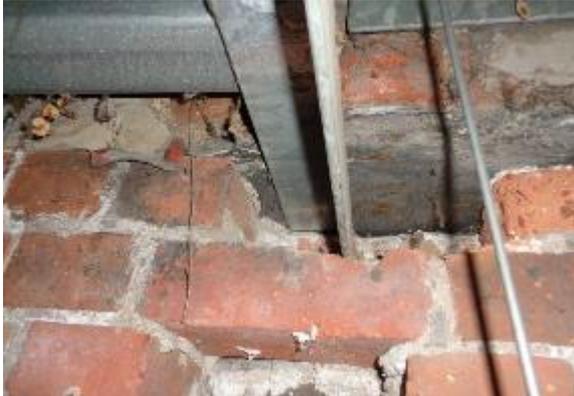
Figure 10: Raker between G35 and G37 supported by a brick

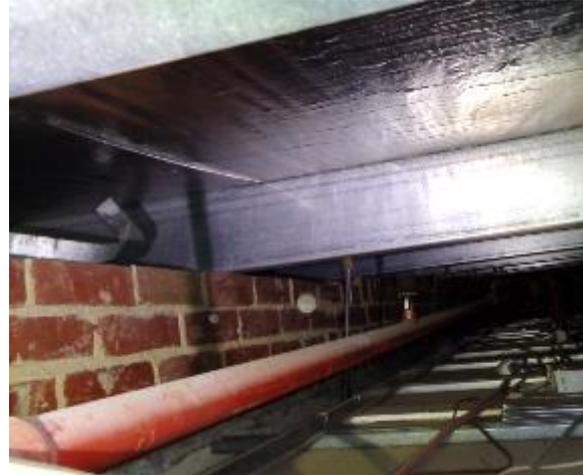
Figure 11: Purlins between G34 and G35 supported on the brick wall. Wall restraint unclear.

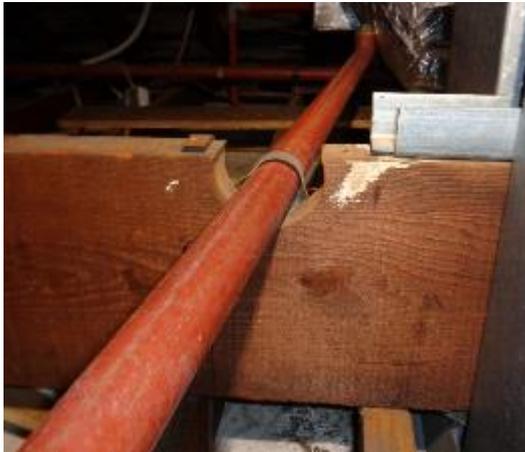
- 1) The hanging beam has had the top notched out of it to allow for the installation of the fire service; and
- 2) When the ceiling AC duct was installed, the ceiling joists were cut and trimmed for the duct including the pine trimmer. Unfortunately, the ceiling joist was not securely fixed to the trimmer.

Figure 12: Ceiling joist hanger cut for fire service Figure 13: Ceiling joist not fixed to pine trimmer

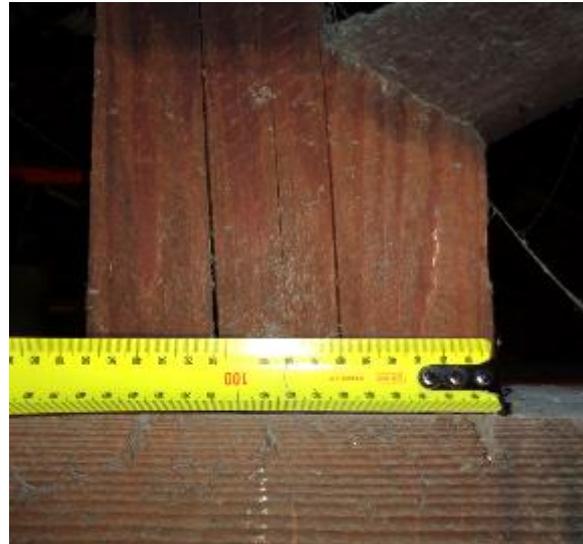
Figure 18: Vertical Splits in the queen post RT2.3

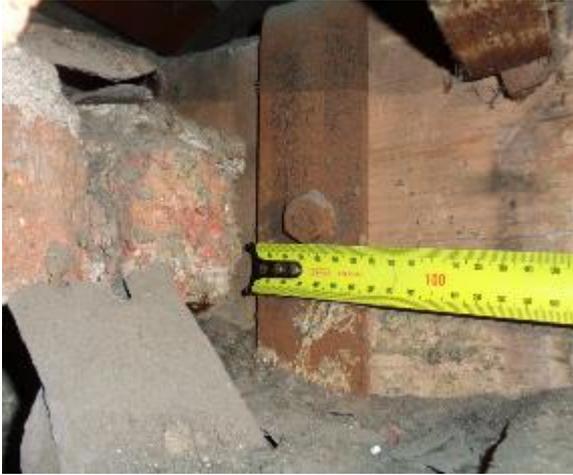
Figure 19: Anchor detail at RT8.4

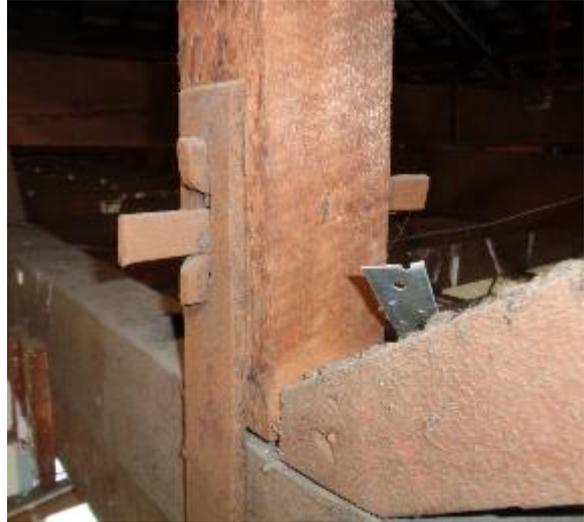
- 4) As shown in the photographs there is a gap between the bottom of the queen post and the top of the bottom chord. This gap can range from a few millimetres up to around 10mm. In each instance the connections were closely inspected to see if the connection had started to fail similarly to the one in room F2. No signs of any of the connections failing was observed. It is most likely that some of the timber used in the manufacture of the trusses was greener than in others. The radial shrinkage of the timber has left a gap in the joint. This is not considered an issue as the joint is in tension and unlikely to close up.

Figure 20: Truss RT8.7 queen post to Bottom chord connection

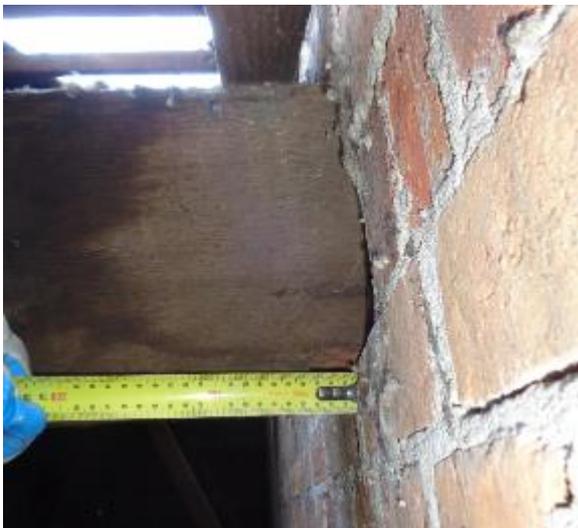
Figure 23: Underpurlin seating in brick wall

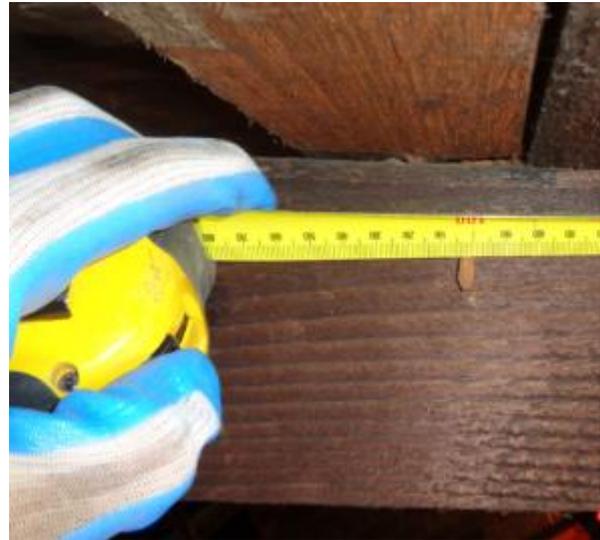
Figure 33: Typical nail diameter

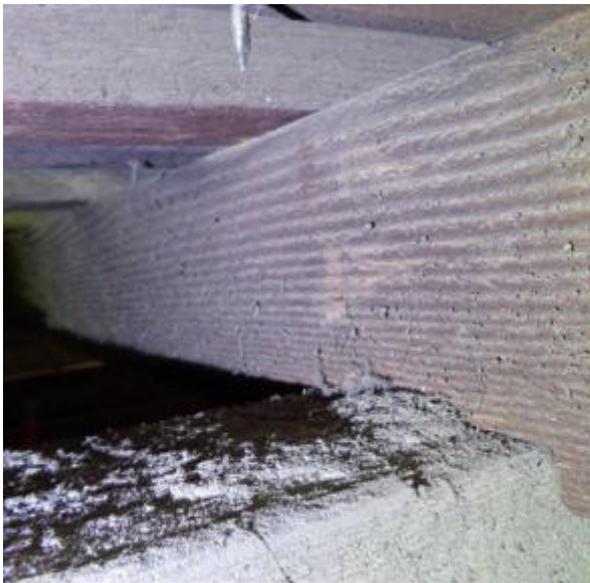
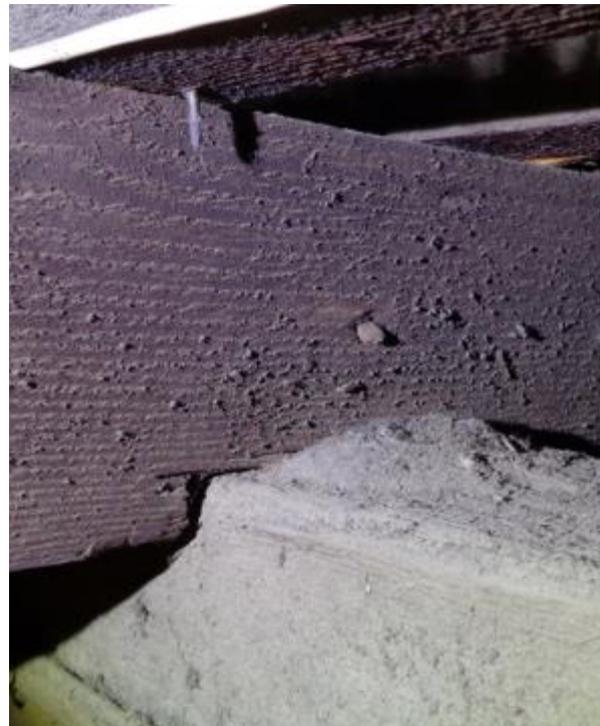
Figure 34: Typical rafter nail to underpurlin

Figure 35: Typical rafter nail to underpurlin

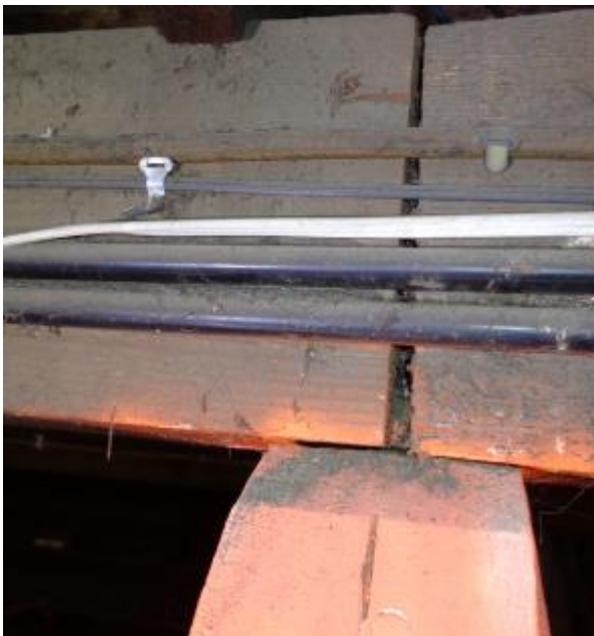
To tie the underpurlins to the trusses it appears that two skew nails have been used. At the Northern end of the Main Hall (at least), due to the trusses dropping, the underpurlins have come away from the trusses and there is no connection between the underpurlin and the truss.

For underpurlins at 2.0m centres and trusses at 3.0m centres, the ultimate wind uplift force is estimated to be 5.1kN. The weight of the roof is estimated in the order of 1.1kN leaving a estimated required tie down force of 4.0kN. The two number skew nails, where intact, are not sufficient to resist this force.

Figure 37: No fixing between underpurlin and truss at top chord

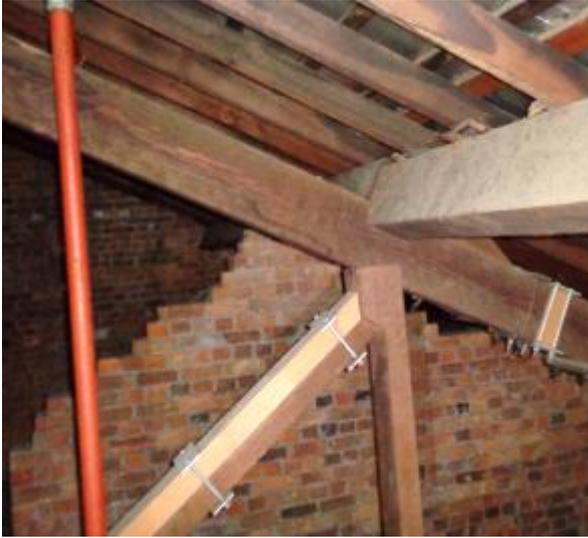
Figure 39: Underpurlin on the farside of the image has lifted off truss in the main hall

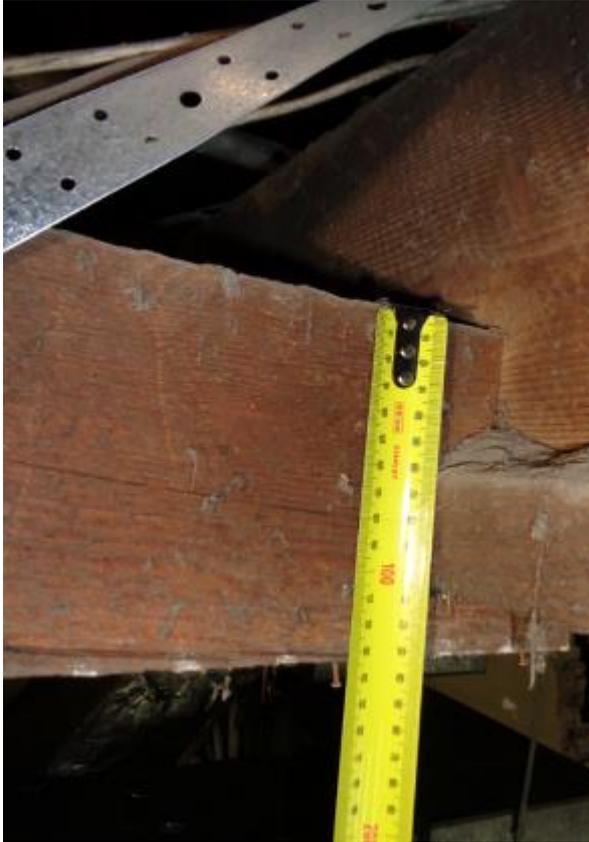
Figure 40: Typical ceiling joist to bottom chord connection through the 1880s East, West and South wings of the building

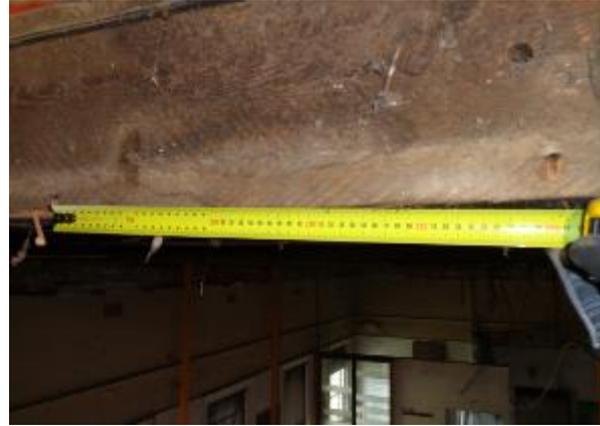
Figure 41: Typical nail spacing for ceiling support batten.

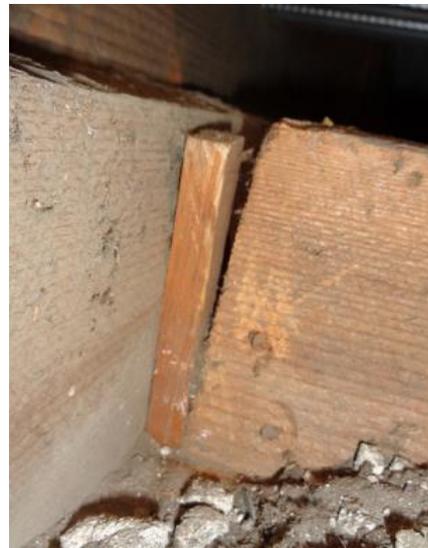
Figure 43: Three skewed nails. One through the top and two through the side.

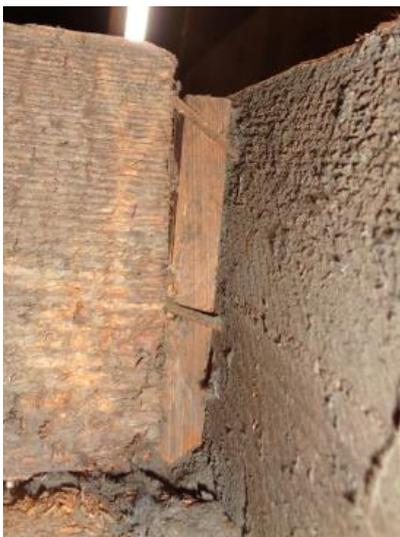
Figure 44: Packing between ceiling joist and truss bottom chord

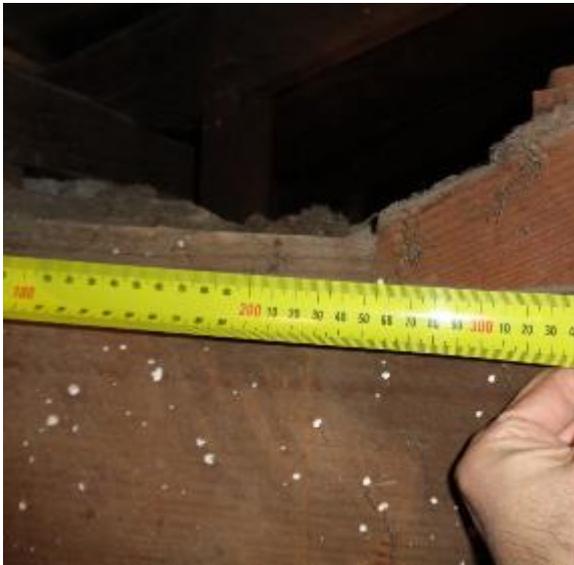
Typically, the length of the bottom chord between the brick wall and the end of the diagonal chord is a minimum of 240mm and therefore the rot observed so far in the end of the trusses will not have reduced the capacity of these joints.

Figure 46: Typical dimension from wall to diagonal chord other than Main Hall which had a longer length of shear plane

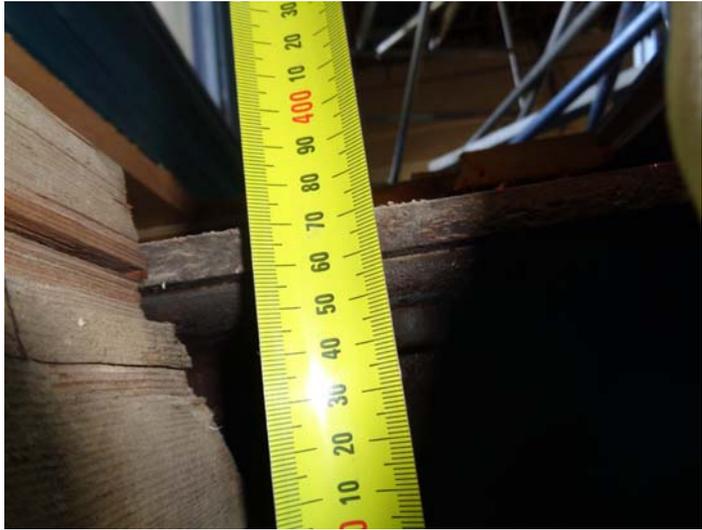
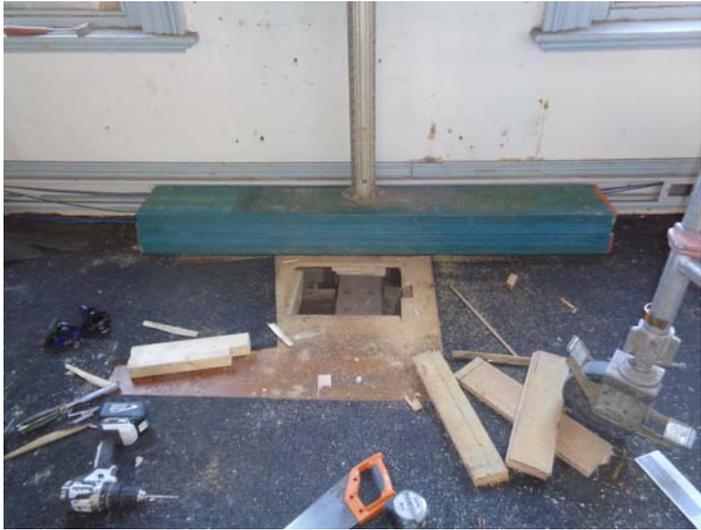
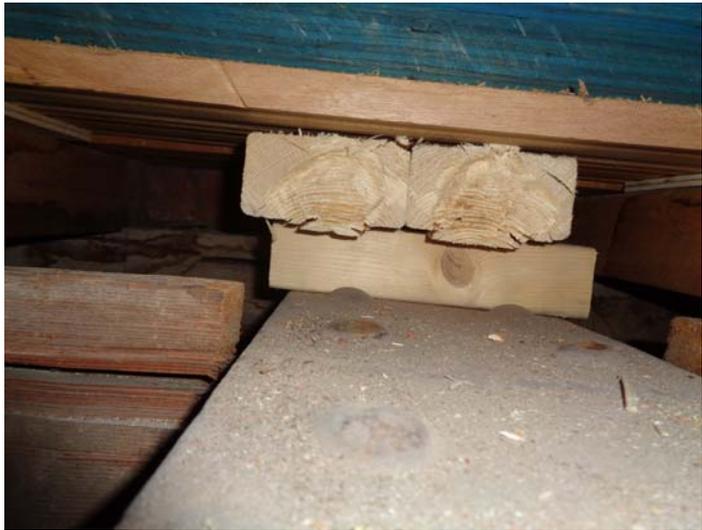
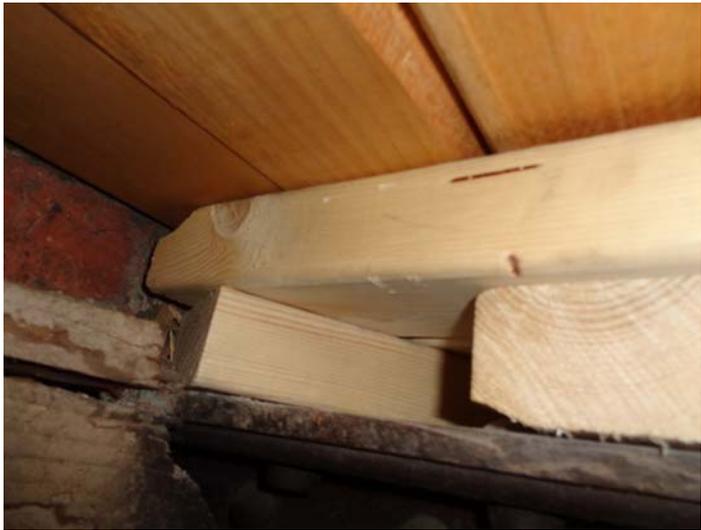
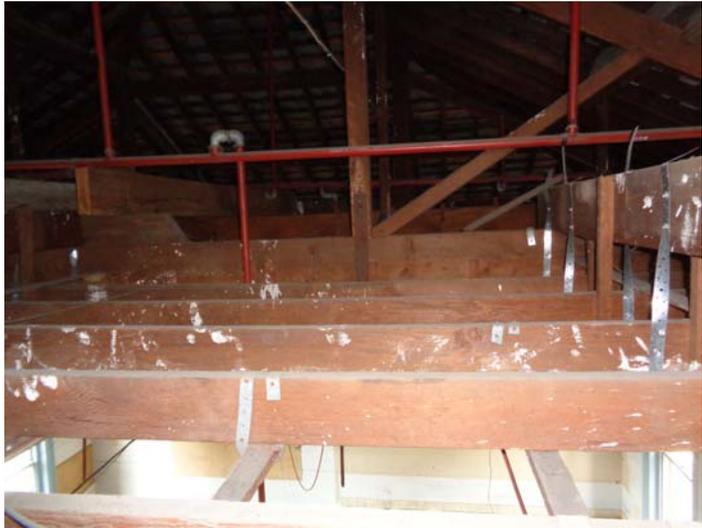
THE END OF THE TRUSS HAS ROTTED AND BORERS HAVE SEVERELY DAMAGED THE END OF THE TRUSS. THE EXTENT OF THE DAMAGE EXTENDED FROM THE FACE OF THE BRICKWORK TO THE END OF THE CHORD LEAVING NO TIMBER BEARING ON THE WALL. THE TRUSS HAS BEEN TEMPORARILY PROPPED DOWN TO A STEEL FLOOR BEAM
